# Portland Cement Stabilized Bases

INVESTIGATION OF THE PERFORMANCE UNDER  
TRAFFIC OF EIGHT ROADWAYS CONSTRUCTED  
WITH PORTLAND CEMENT STABILIZED BASES

M. J. HENSLEY  
OCTOBER 1966

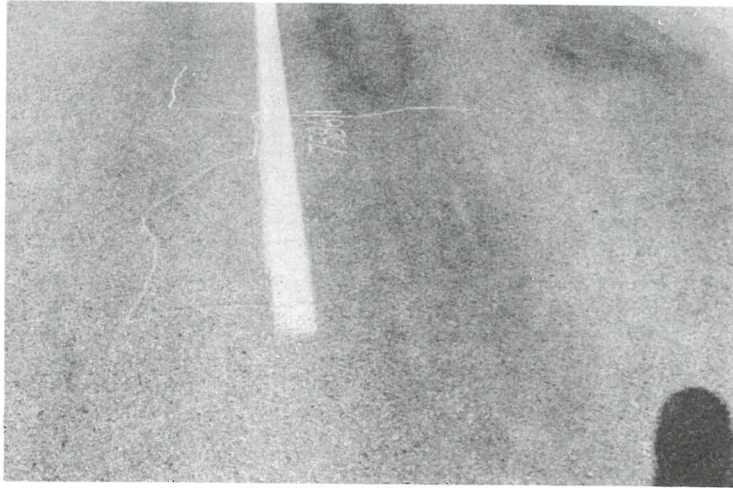
Job 7586 Irregular Cracking at Centerline

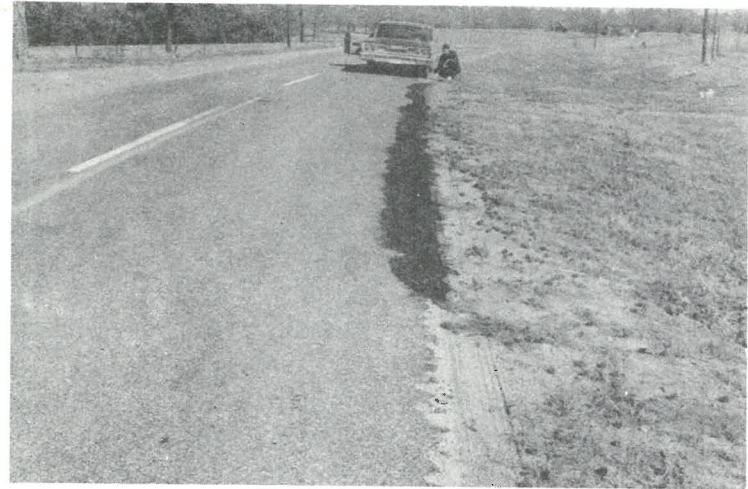
Job 7586 Edge Patching on Inside of Curve

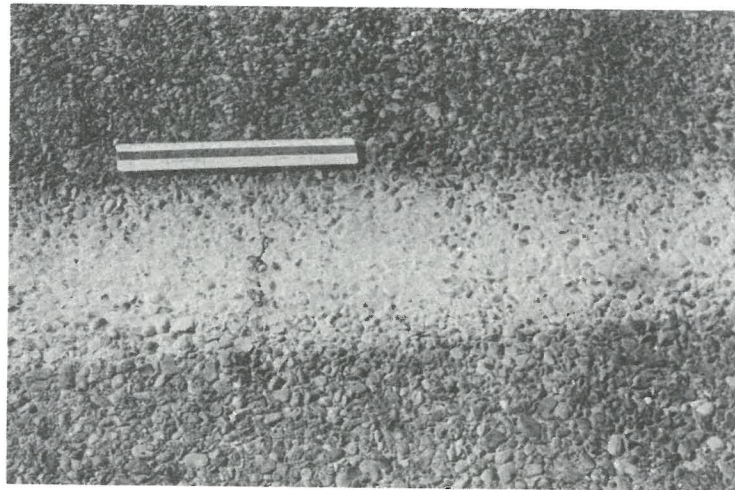
Job 7586 Minor Transverse Crack at Centerline

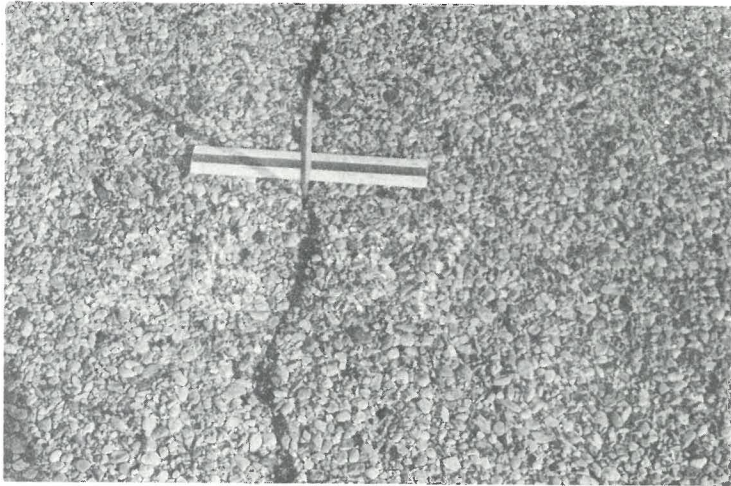
Job 2637 Transverse Crack

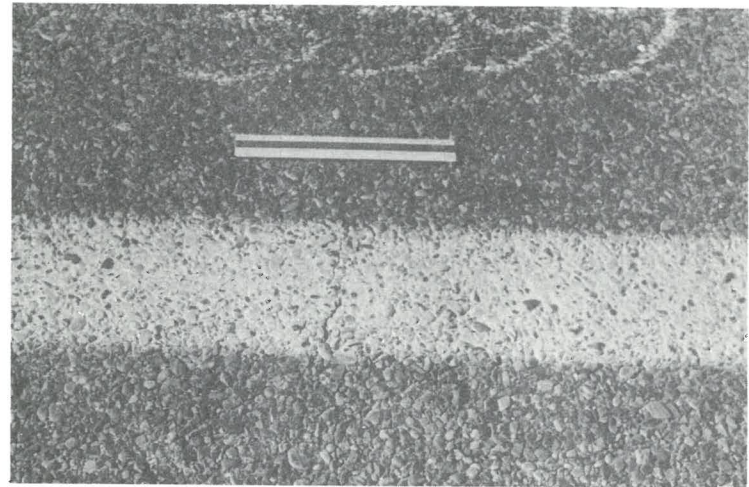
Job 3599 Minor Transverse Crack

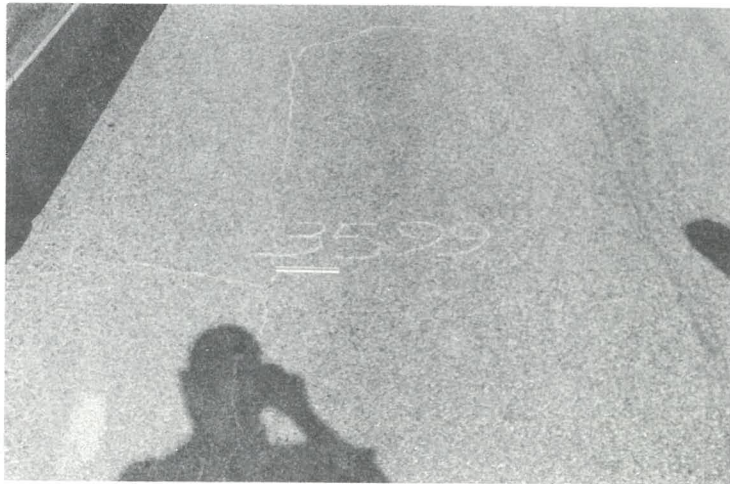
Job 3599 Minor Cracking

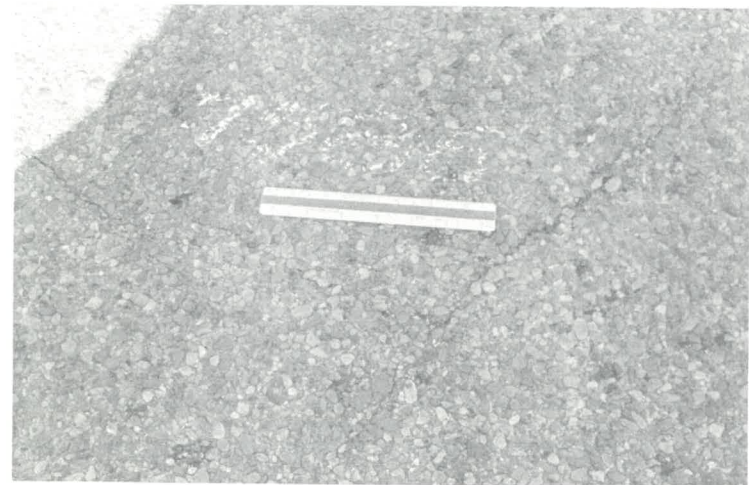
Job 7586 Minor Cracking at Centerline

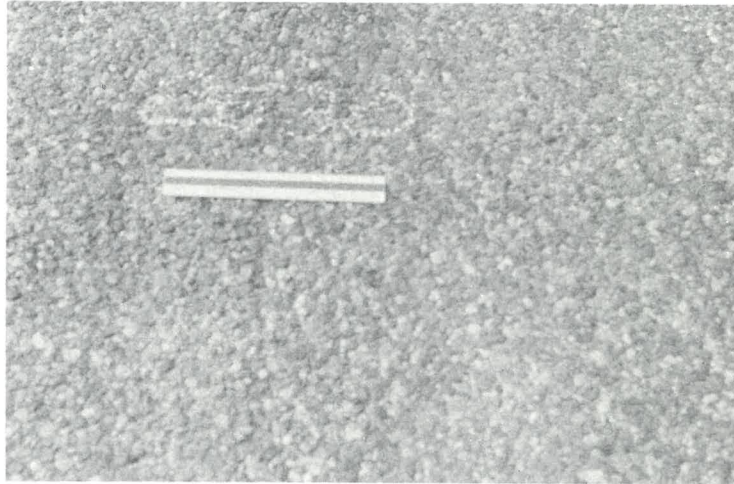
Job 2630 Transverse Crack

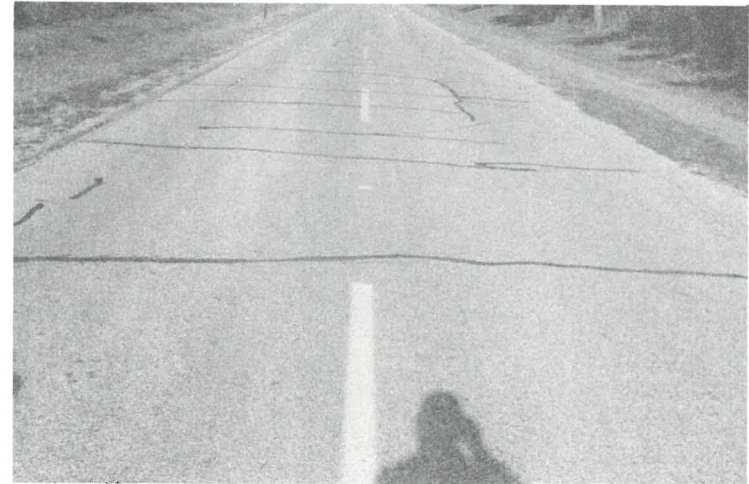
Job 2631 Transverse Crack Pattern of 6' to 12'

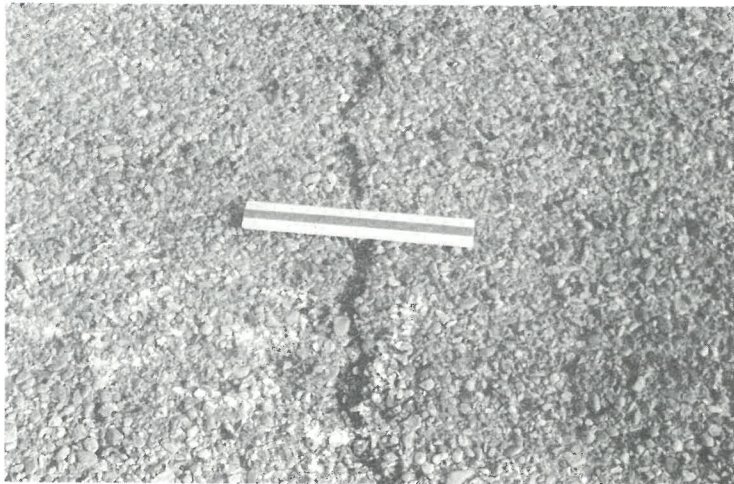
Job 2631 Transverse Crack

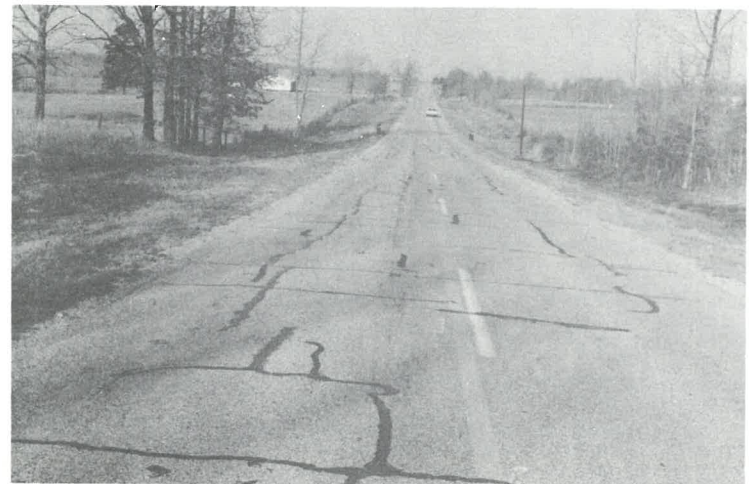
Job 2631 Logitudinal and Transverse Cracks

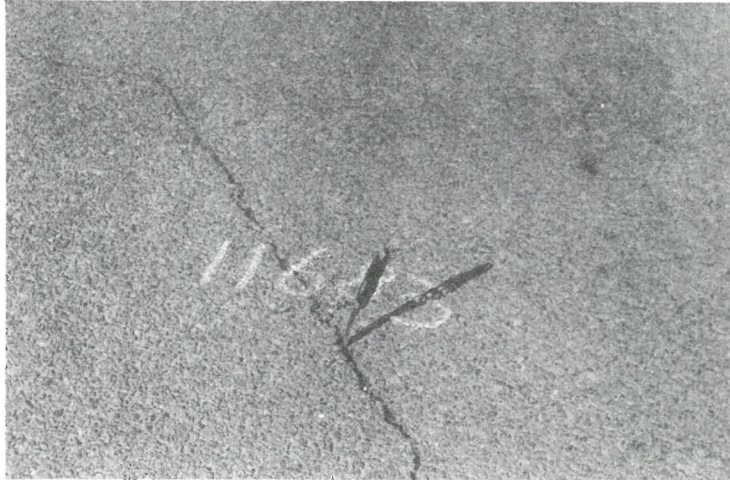
Job 11683 Longitudinal Crack Center of Lane

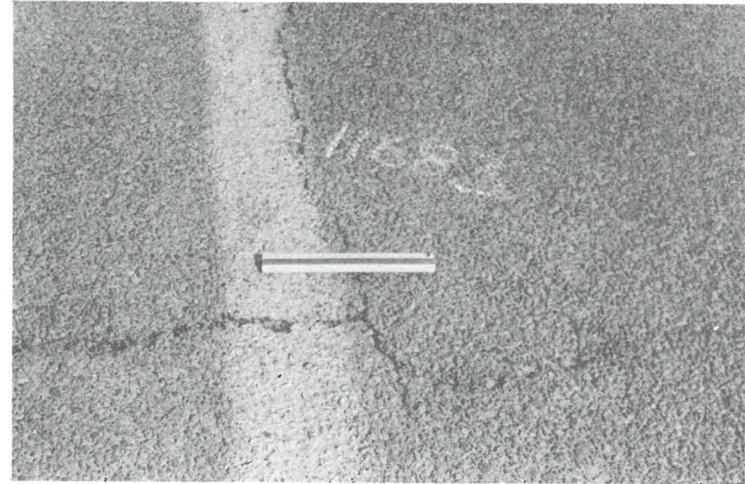
Job 11683 Longitudinal & Transverse Cracks at Centerline

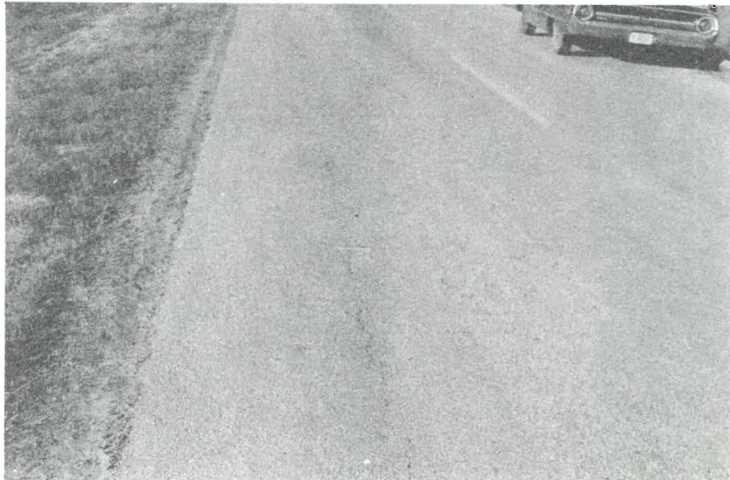
Job 2615 Longitudinal Crack

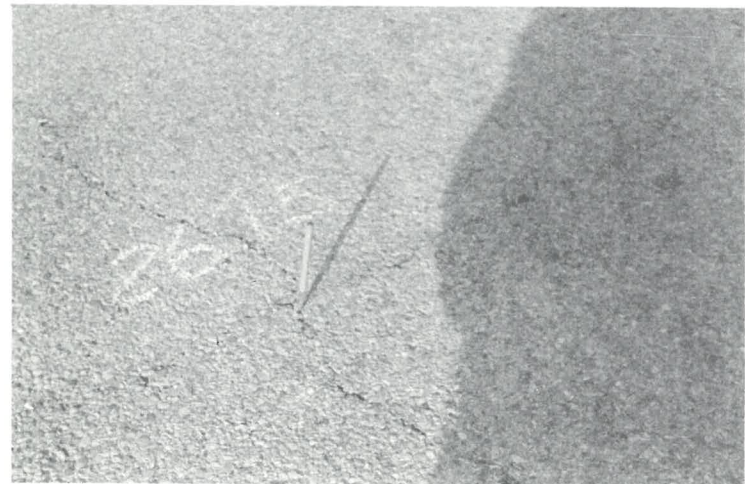
Job 2615 Longitudinal Crack

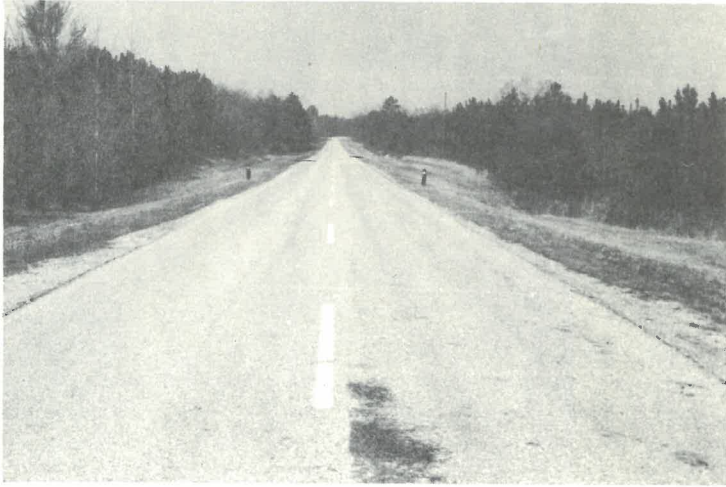
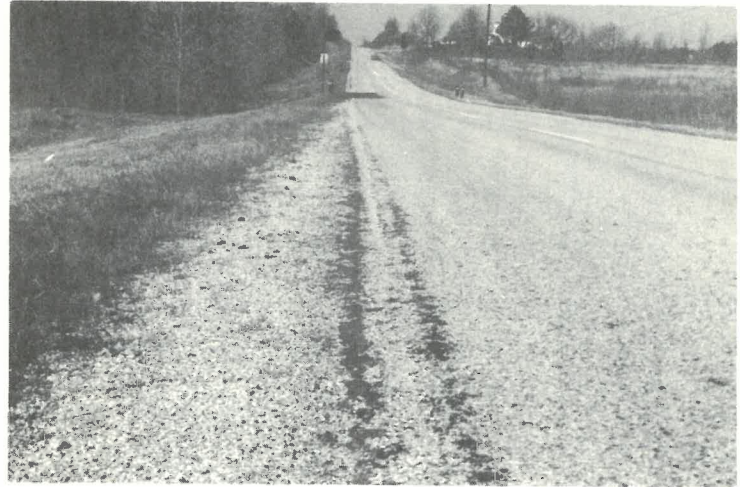
Job 2631 after Resealing

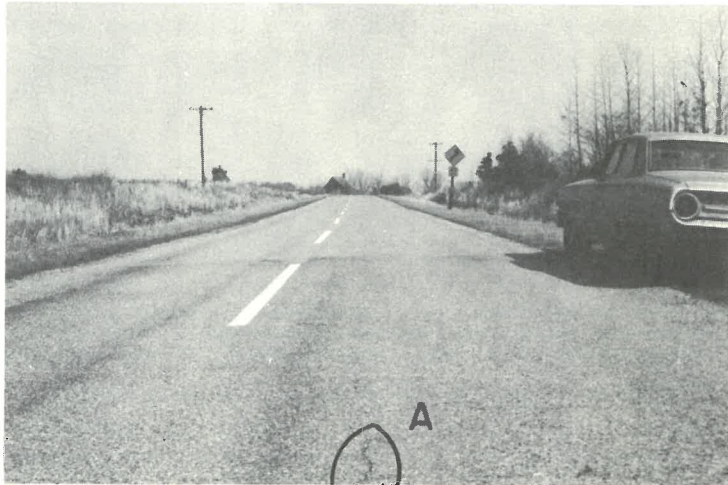
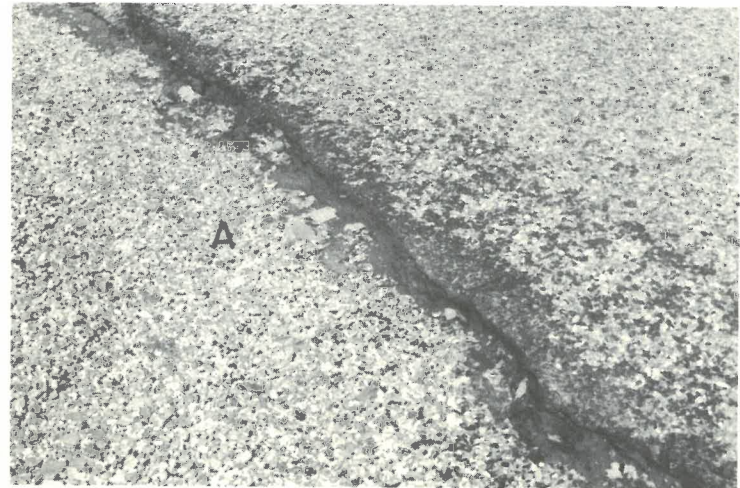
Job 7586 Shows a Change in Texture with Cracking

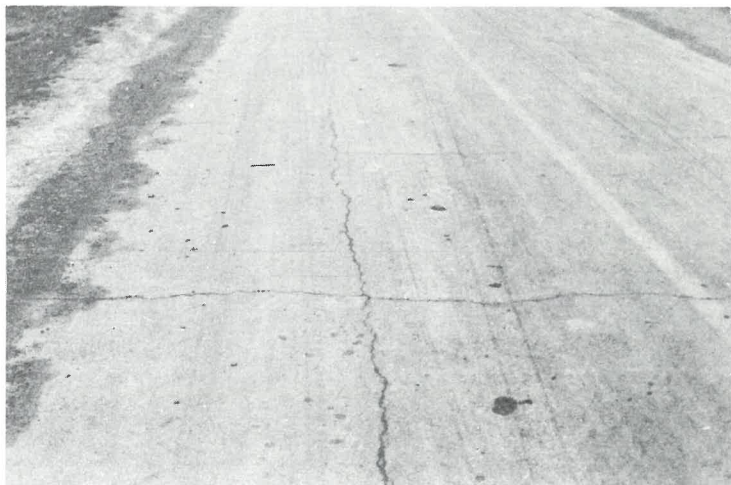
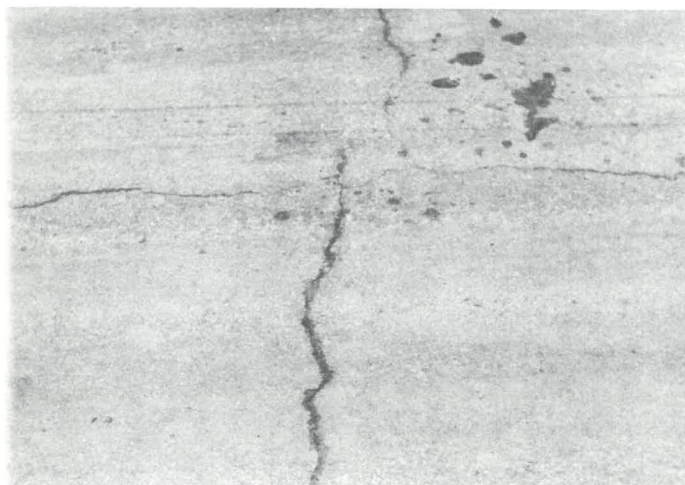
Job 11683 Longitudinal & Transverse Cracks

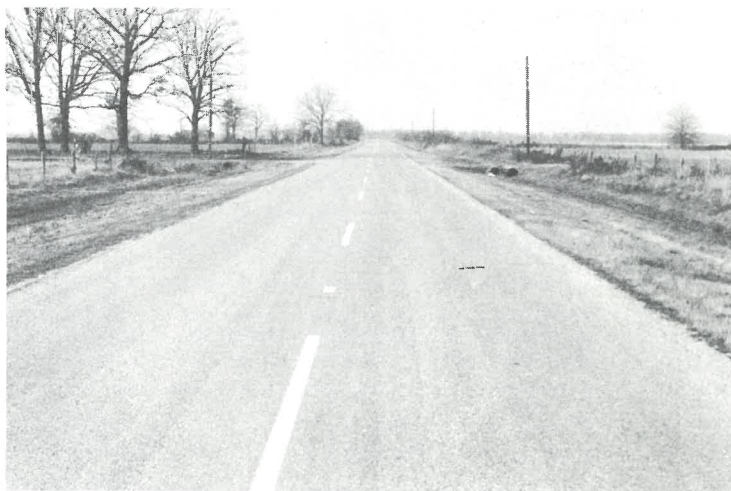
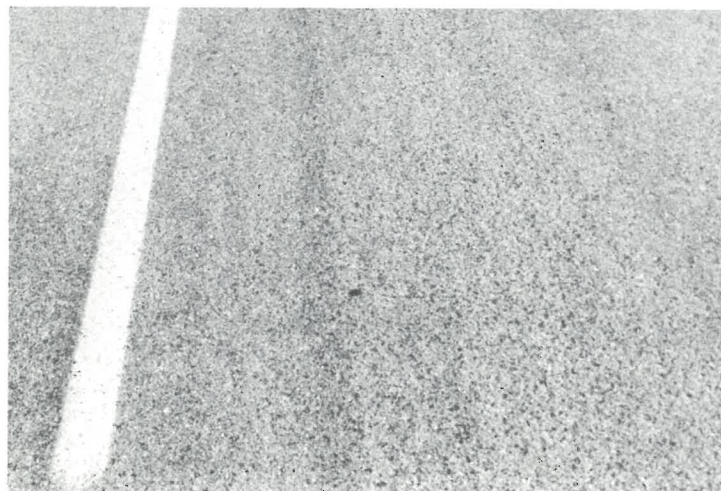
Job 2615 after Resealing

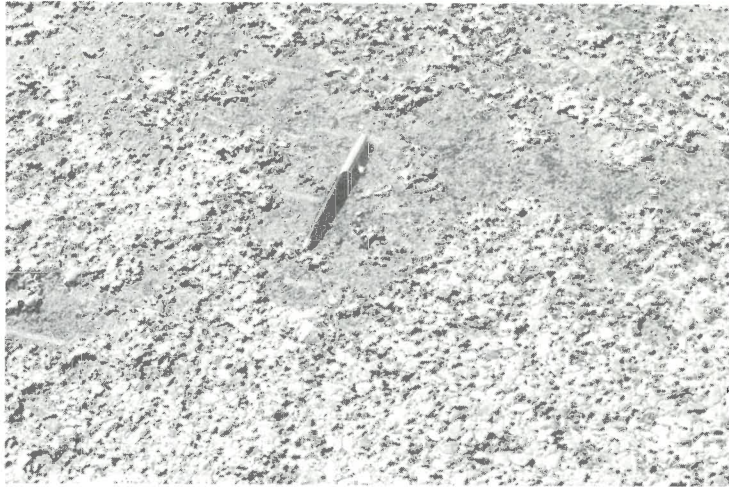
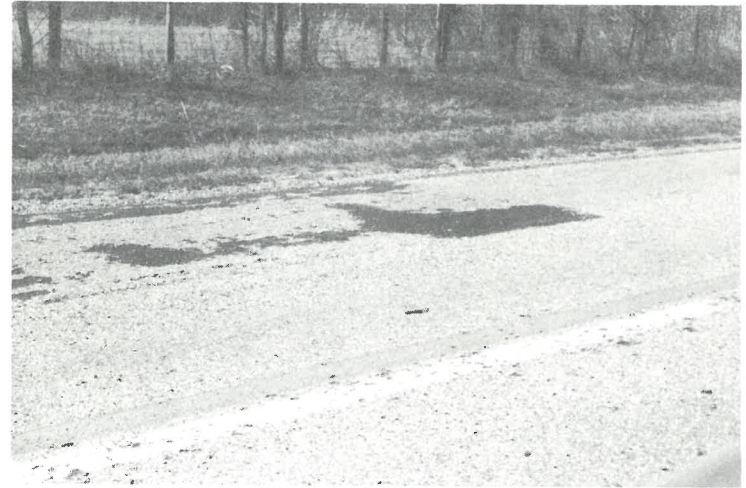
Job 2631 Shows Scaling after Resealing

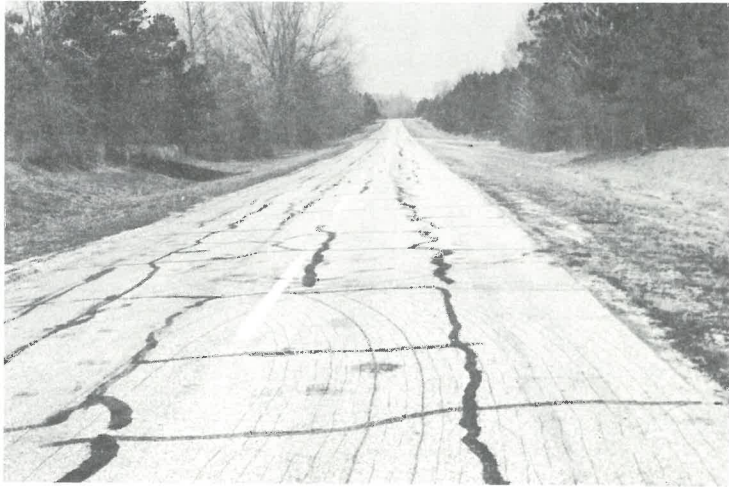
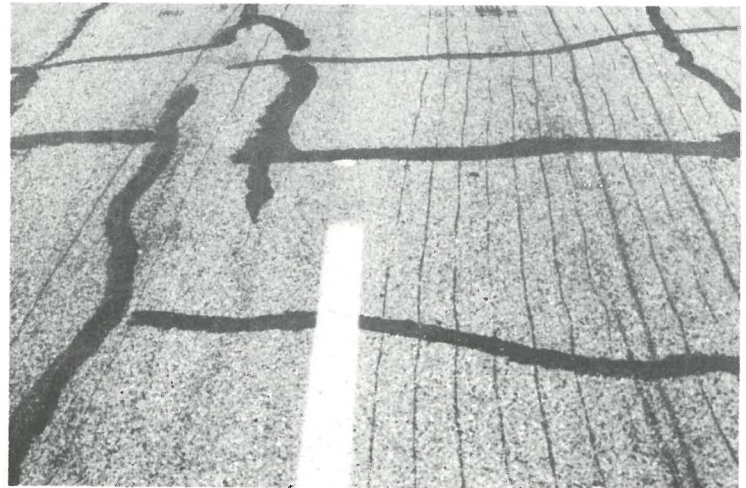
Job 2637 Shows Crack Pattern
