A
STUDY
OF
LANDSLIDES

Highway Research Project 14

FINAL REPORT

May 1964

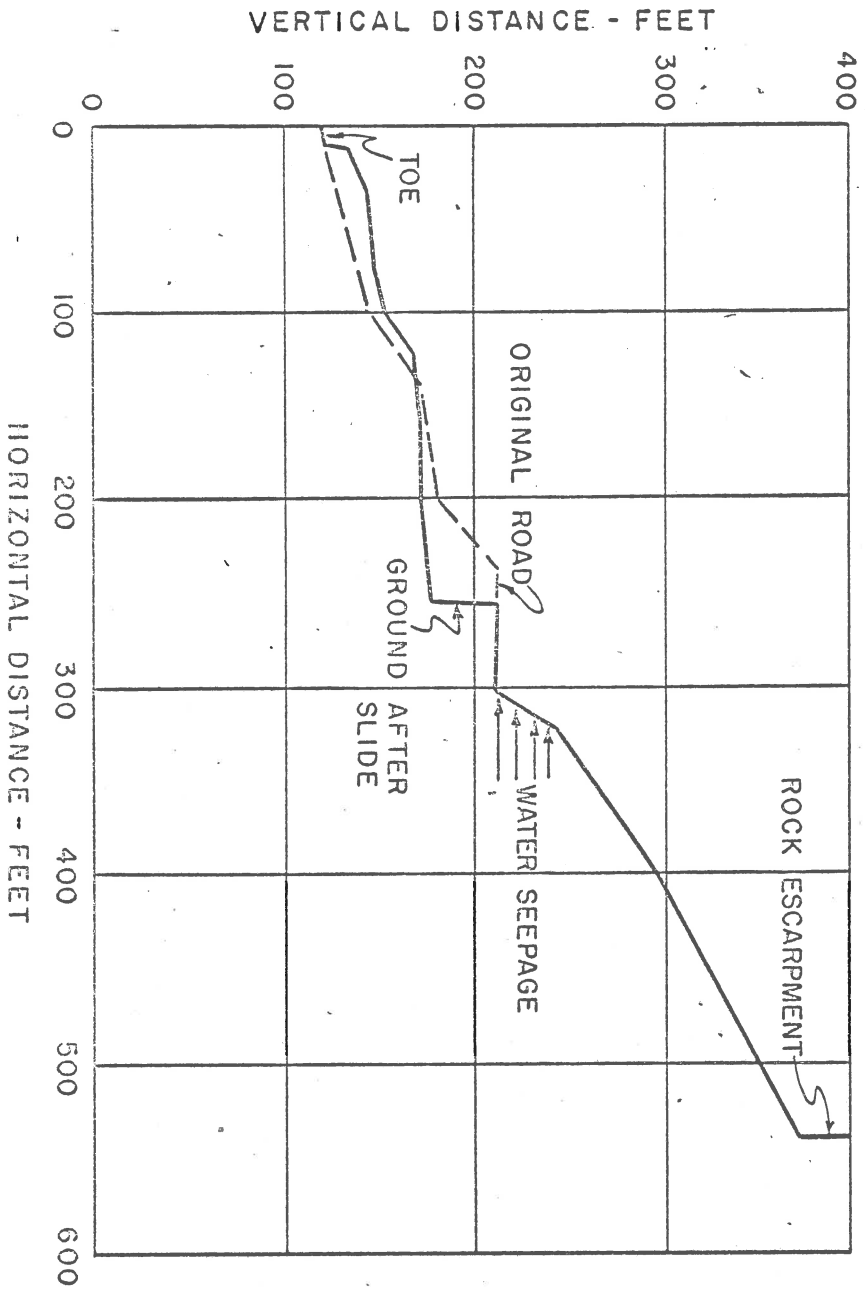
FIGURE 2

This slide is typical of the many slides in Boone and Newton Counties. The highway was rebuilt in 1961-1962 along the location of an existing road. At the site of this slide the road had been in use for some thirty-five years before reconstruction began. During this period no serious sliding occurred; however, the road was narrow and there was very little fill on the hillside. Some movement of the fill side of the highway was observed during construction and shortly after. Within one year considerable movement of the embankment on the side-hill was observed at this location; however, no serious faulting of the highway itself was observed. A few

cracks and a downward movement of approximately two feet occurred before remedial measures were taken. At the time of this movement it was observed that water was seeping from the backslope on the uphill side of the road and running down the roadway ditch. A corrugated metal pipe was installed to take this water across the road and the ditch was paved to prevent the water from seeping downward under the road. This apparently stopped the movement at this particular location.

In March 1964 a large slide occurred in the fill portion of the roadway immediately east of and adjoining the previous slide. In this second movement the outside one-fourth of the roadway dropped down a distance of about twenty feet and the entire mass of soil and rock moved down the slope for a distance of about 250 feet. Figure 2 is a cross section of the road at this slide location. The mass of earth and rock in the slide was very wet and pools of water were observed at several locations within the slide area. Some water was flowing out of the hillside at the upper edge of the slide. At the same time movement of the backslope of the uphill side of the road was observed. It was also observed that water was flowing out of the

CROSS SECTION AT SLIDE NO. 2

All of this movement is at a location where the highway crosses a small gulley. This gulley extends up the hillside to the foot of the caprock. This is a natural drain and water flows off of the top of the hill for long periods of time after rains. Some seepage is noted at the foot of this caprock, even in the driest seasons of the year. The gulley has been partially filled with an alluvium consisting of a mixture of small stone and silty clay soil in a very loose condition.

It appears that the cause of failure at this point is due to the seepage of water from the hilltop. All of the movements appear to be along the interface between the new embankment and the original ground surface under the recent alluvium.

Slide number 2 is typical of the slipouts found in Northwest Arkansas and is a good location for draining by horizontal drilling and installation of perforated pipe. It will be necessary to drill horizontal drain holes in the backslope of the roadway and also near the toe of the slope below the roadway. The chances of this procedure stabilizing the other fills of this group are good. This is especially true in the case of slide number 6 as it seems that all of the water causing this movement is flowing on top of the black shale. In every case of a slide it will be desirable if not necessary to do some vertical drilling to determine the location of the water bearing stratum before a satisfactory horizontal drilling program can be planned. The slides of this type are found on sidehill construction where the slope is covered with a mantle of soil and rock. The soil is usually clay to silty clay and is derived from interbedded layers of shale and either limestone or sandstone. The movement usually taking place on top of the impervious shale. No program of horizontal drilling and drainage should be planned without the help of a geologist. Much saving of time and money can be realized by a geological study of the location before any drilling work is begun.

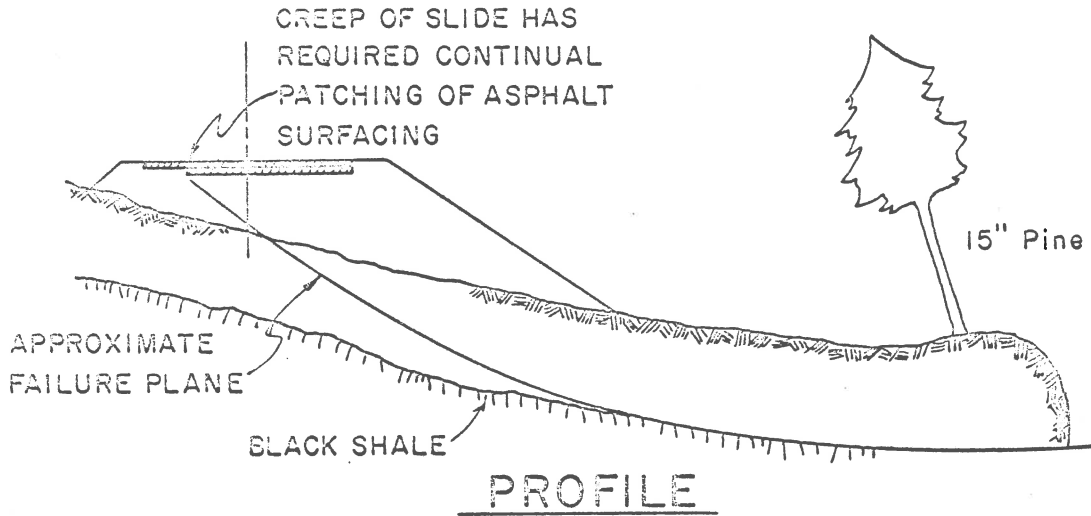
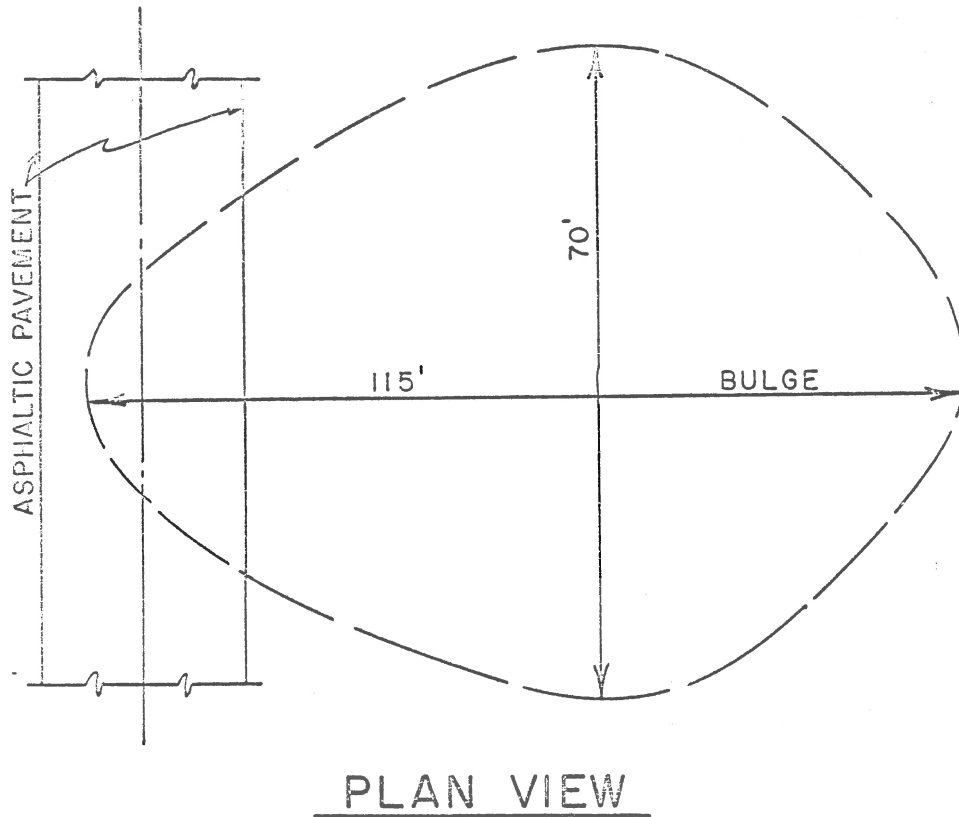
FIGURE 3

This slide occurred in the backslope during construction.

SLIDE No. 6

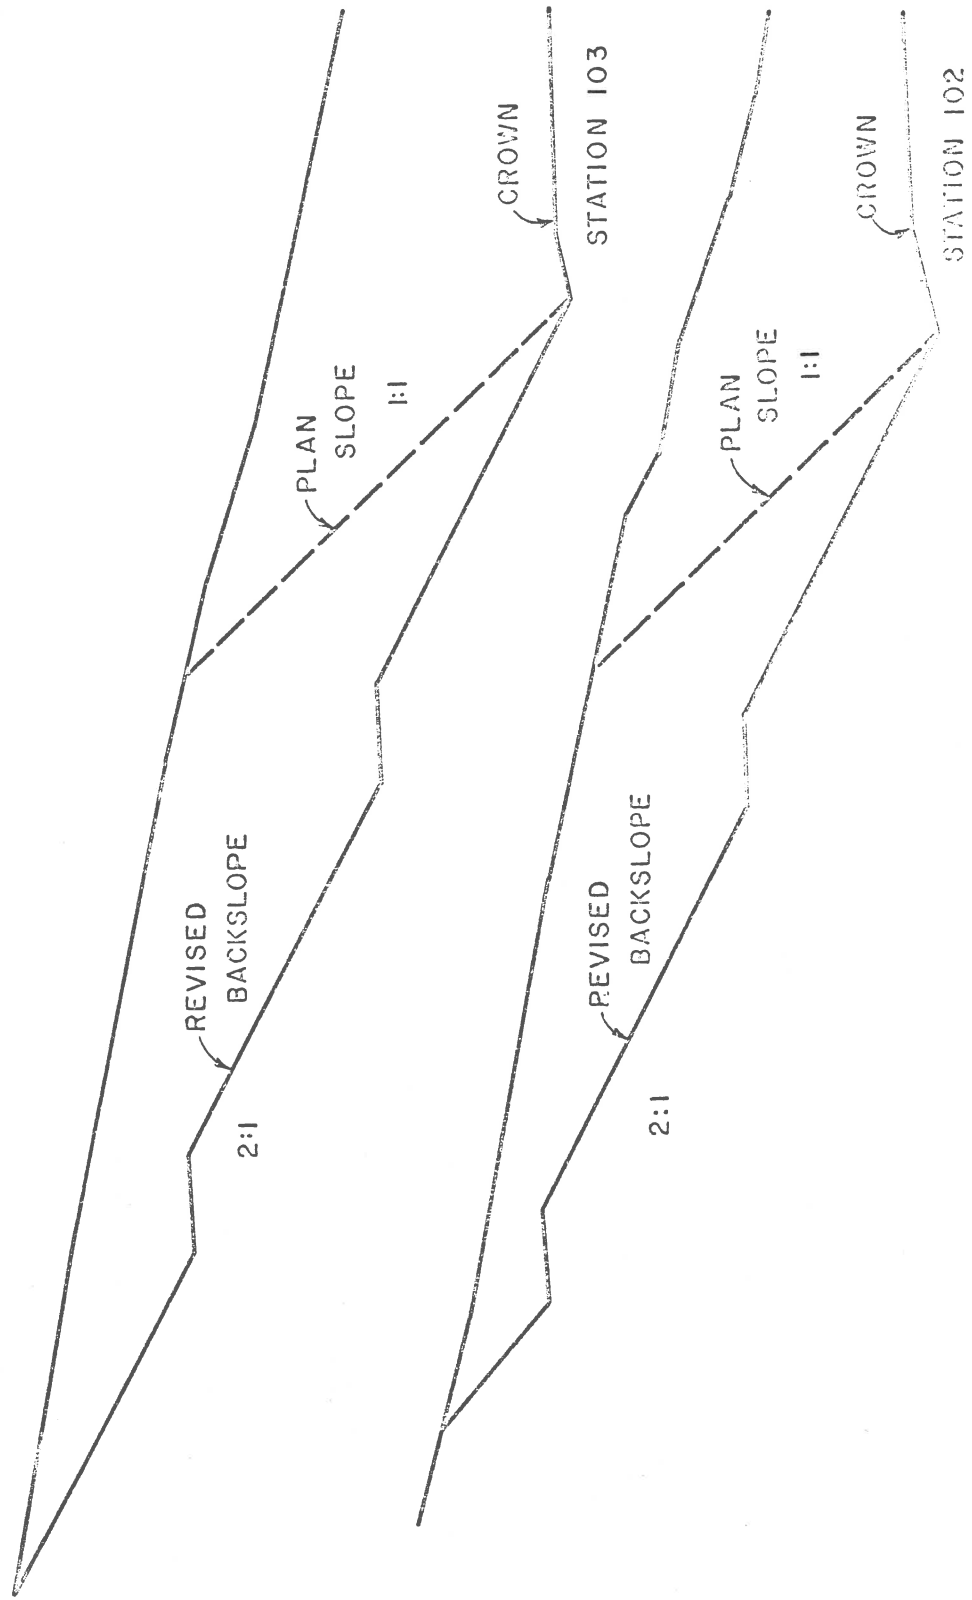
FIGURE 4

Figure 4 shows a cross section of the highway prepared during construction as a part of a field change to the original contract. The original backslope was to be 1:1, as shown by the dashed line. The first slide occurred immediately after the contractor excavated the slope. The slope was then flattened by field change to a 2:1 slope with two 10 foot berms. Again the slope failed almost as soon as it was excavated. There have been some recent movements of this slope. The only work done at this location since the contractor completed the job is to remove the material that slides into the roadway ditch. Figure 5 is a picture of the backslope at this time. The cost of the field change was approximately \$19,855 plus additional right-of-way.

Examination of the slope at this location shows that there is an outcrop of shale near the bottom of the slope. Water is flowing from the backslope along the top of this stratum of shale. The material of the slide is a clay silt with some loose rock.

CROSS SECTIONS SLIDE No. 7

Many of these slope failures occur during construction. The problem then becomes one of determining responsibility and whether the failure is to be corrected by the contractor or to be left for the Maintenance Division. Such a case was slide No. 7. About \$20,000 was spent by a field change but the slide still exists.

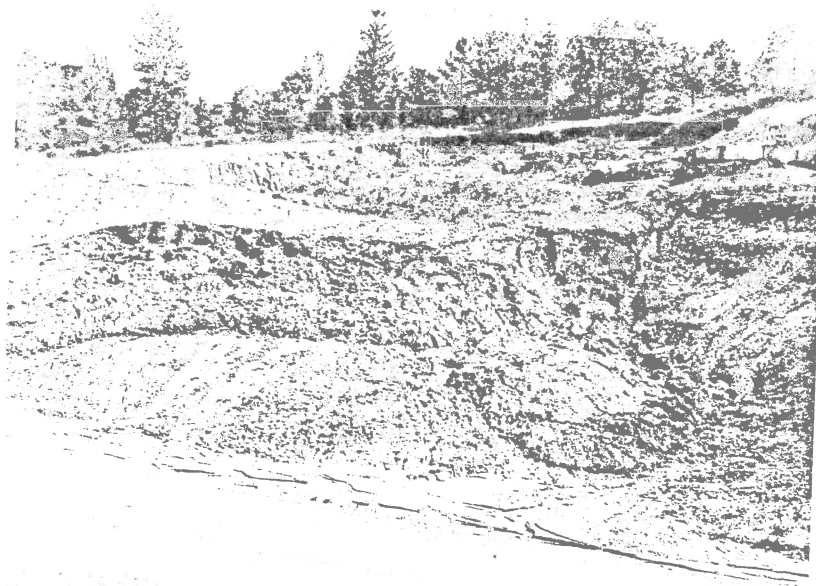
Fig. 5

Slide No. 7

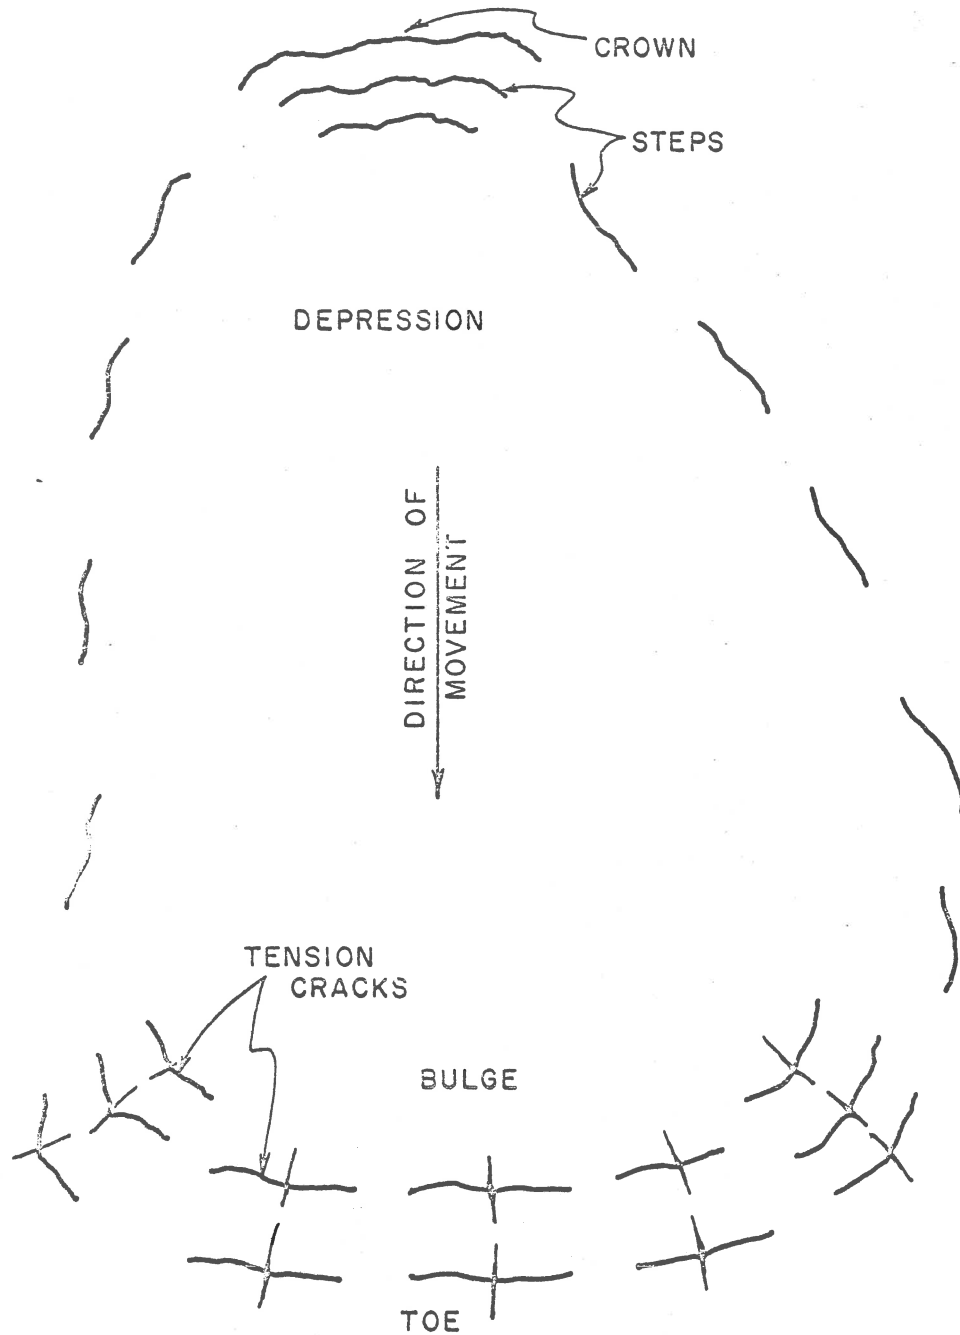
FIGURE 6

The shape of this slide is shown in Figure 6. Figure 7 is a profile of this slide in the direction of move-

LANDSLIDE No. 8

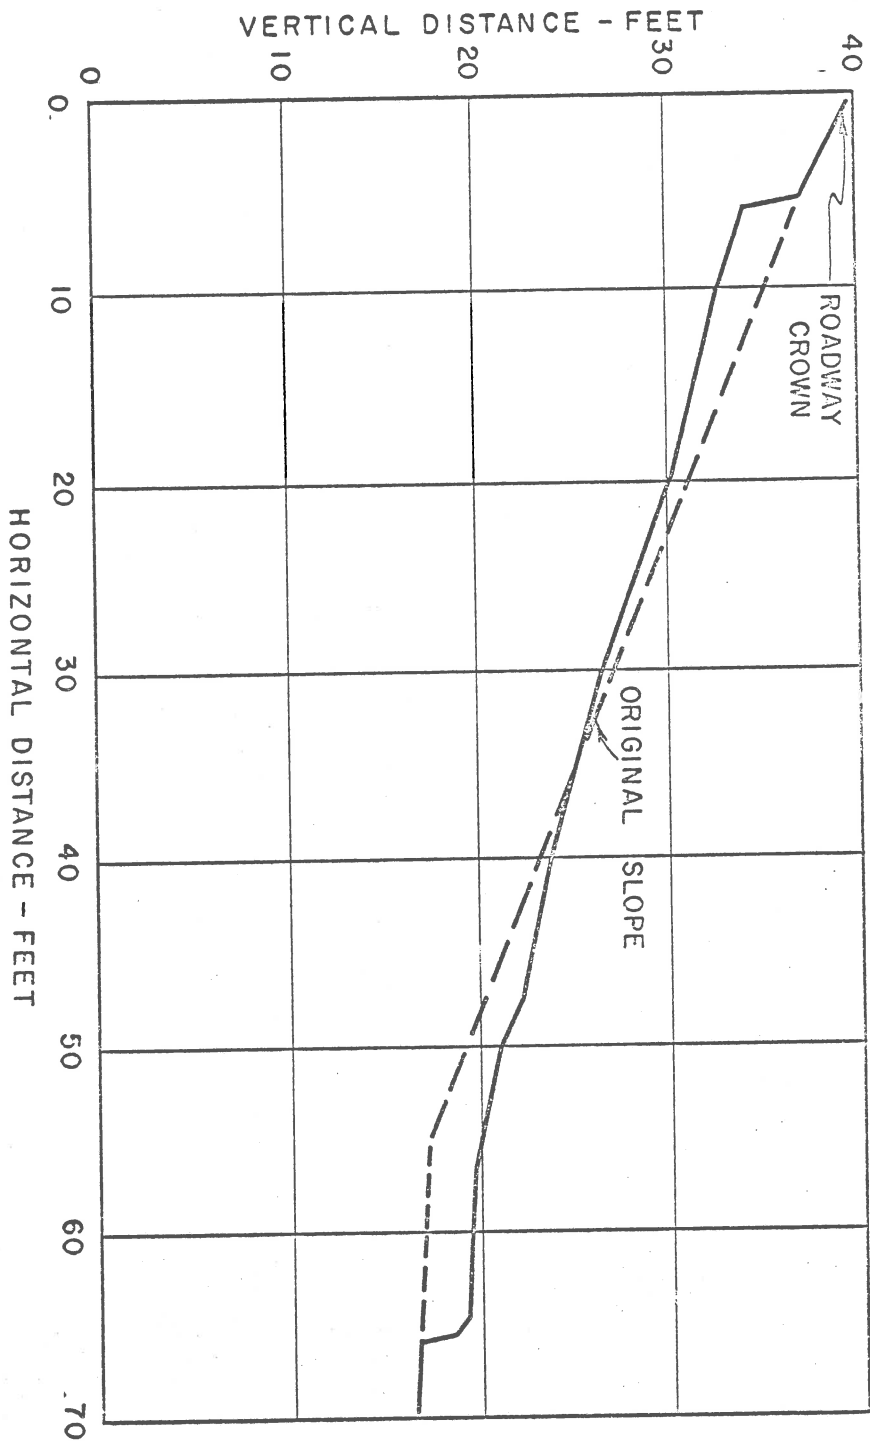
FIGURE 7

PROFILE SLIDE No. 8

ment, and Figure 8 is a picture of this slide. This movement occurred shortly after construction was completed and was comparatively rapid. No one witnessed this slide but all evidence indicates that it occurred in a matter of an hour or less. Tables 1 and 2 present the pertinent test information for the soils in this embankment. Physical evidence at this site indicates that there is considerable water flowing over the embankment at this location. It is the water that falls on the bridge and is concentrated at this point. The only corrective action taken at this location was to redress and reshape the slope. No attempt has been made to add extra stabilization or take any other corrective action.

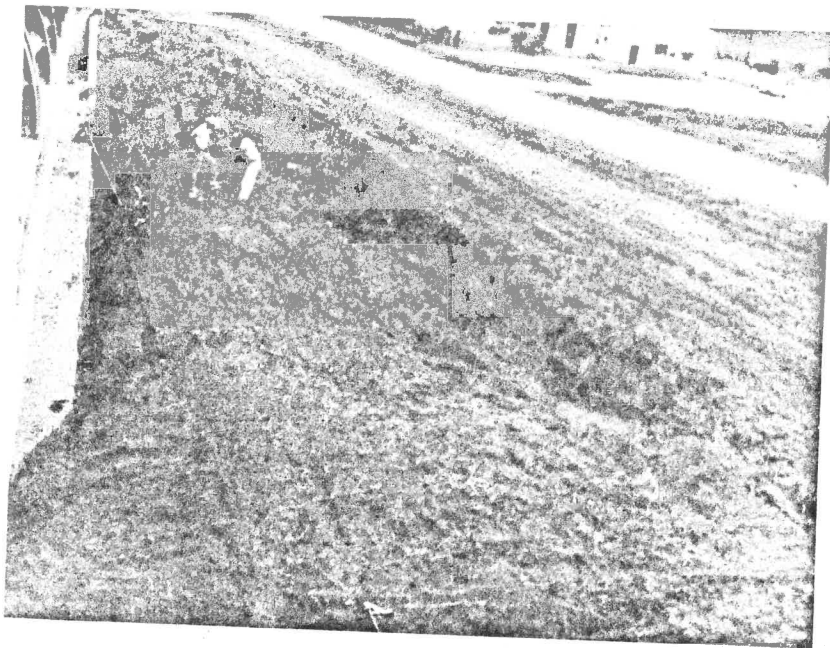
Fig. 8

Slide No. 8

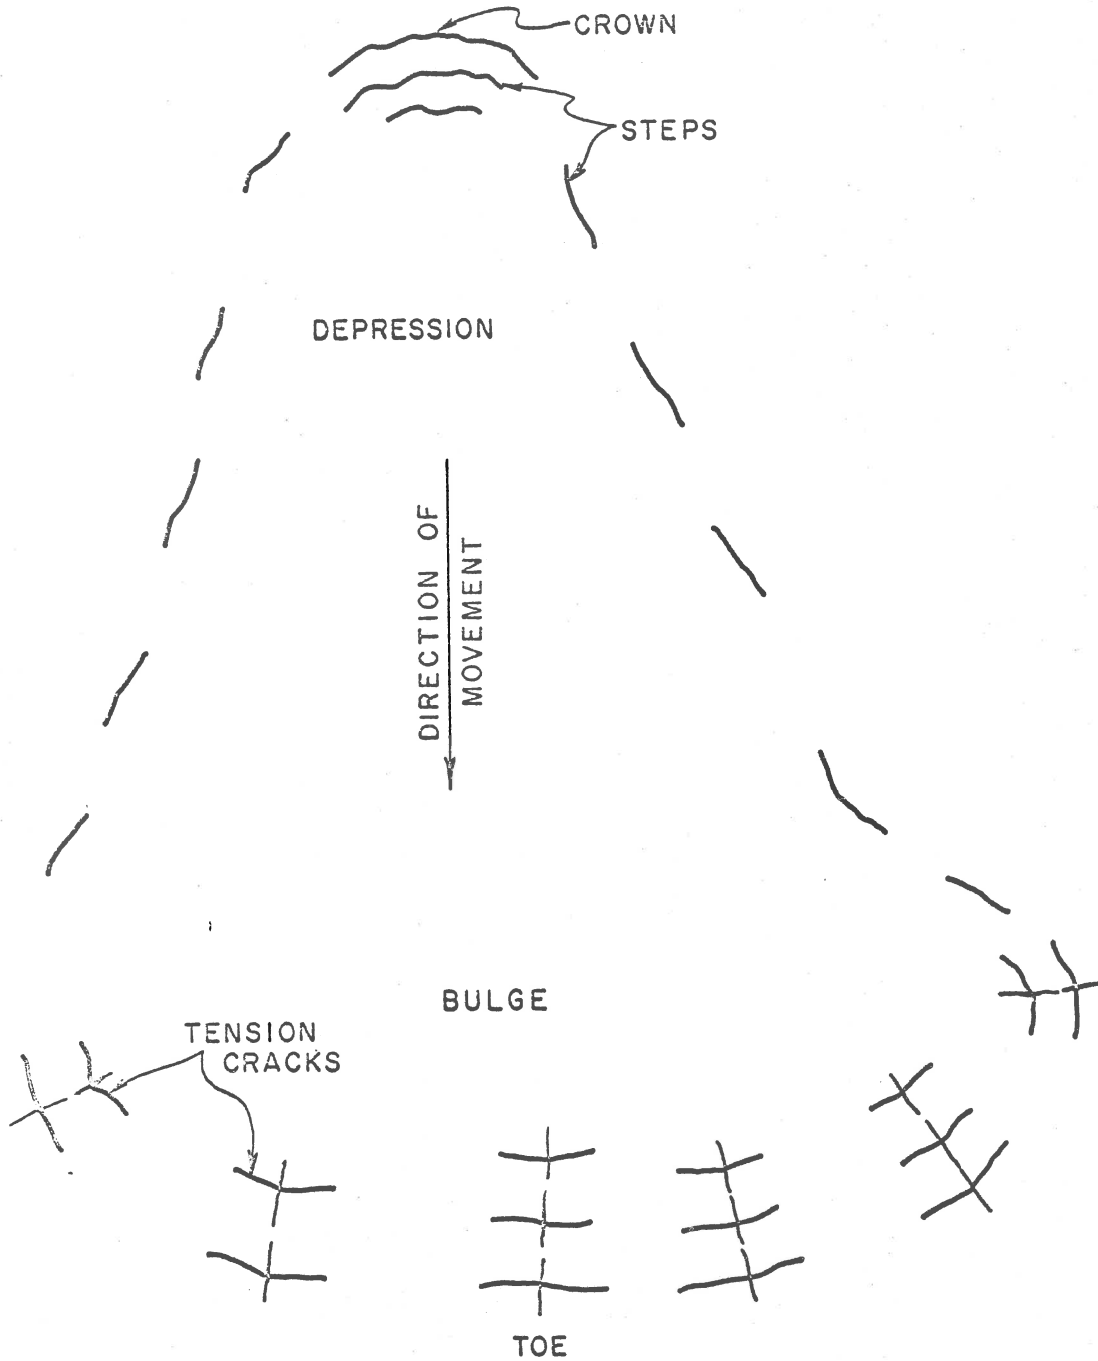
FIGURE 9

The conditions surrounding this slide are identical with those of Slide Number 8. Figure 9 shows the shape of this slide. Figure 10 is a profile of this slide taken along a center line in the direction of movement. Tables 1 and 2 present test data for this soil.

LANDSLIDE No. 9

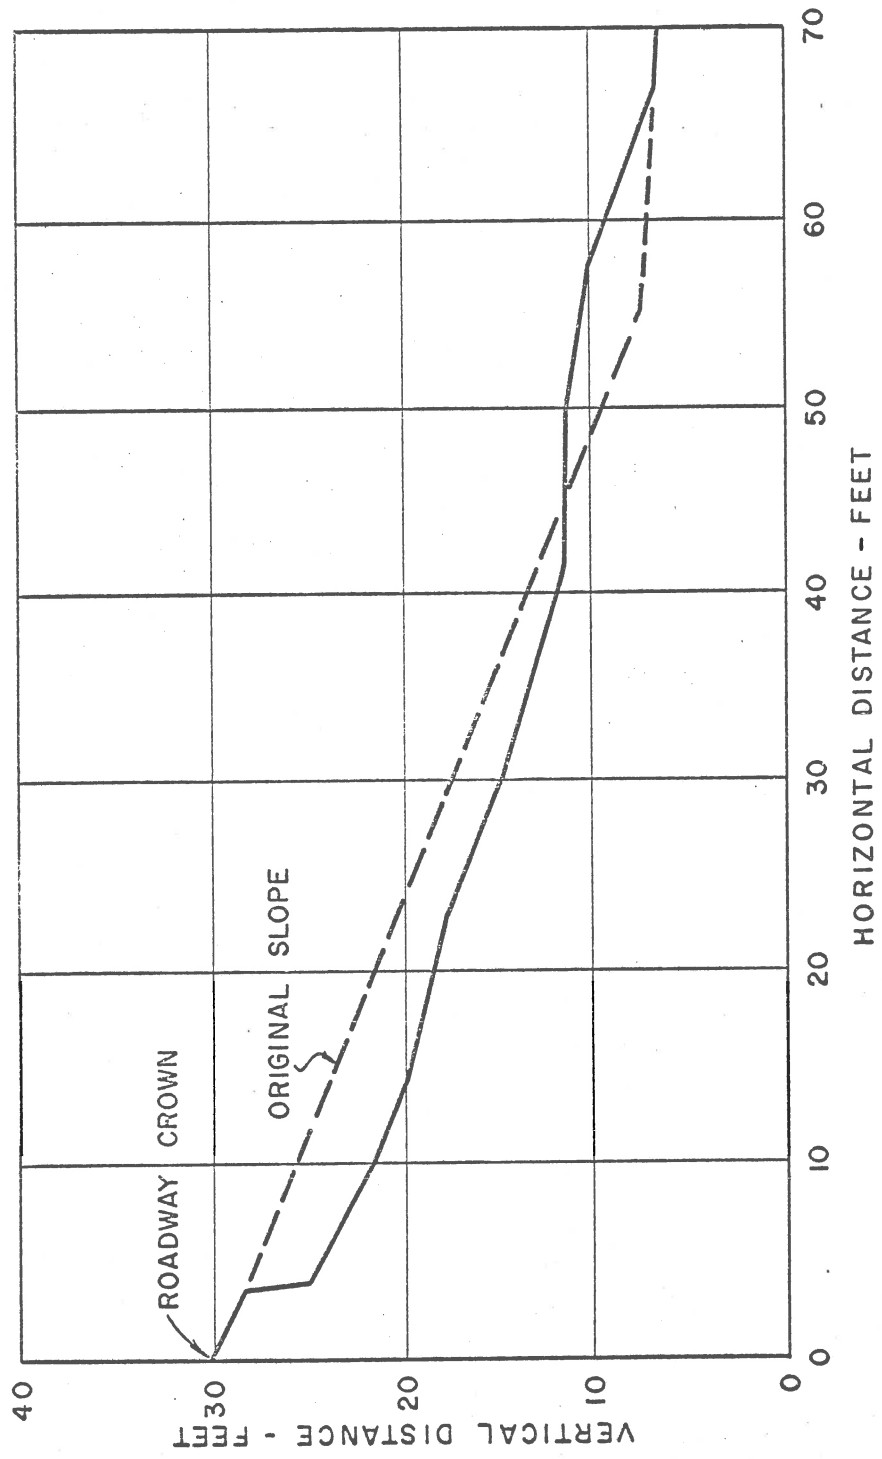
FIGURE 10

PROFILE SLIDE No. 9

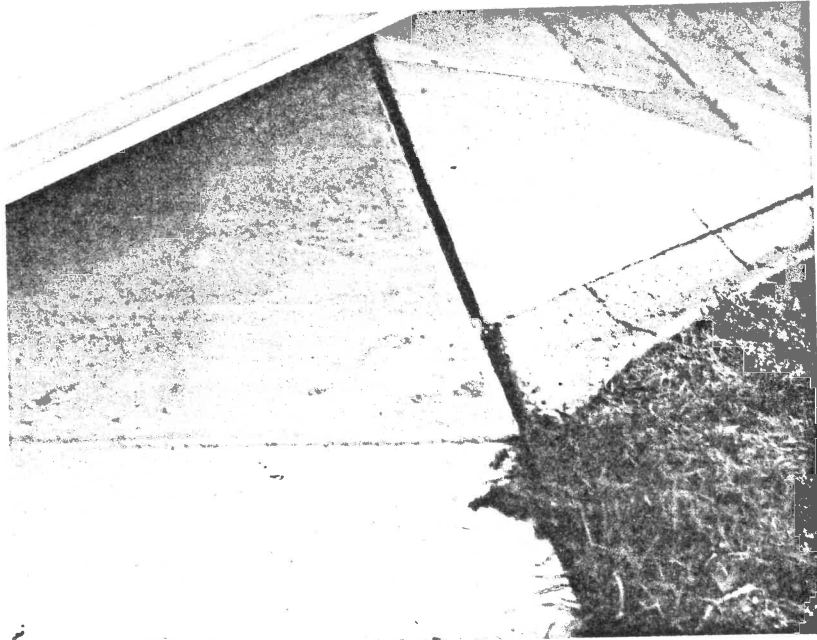
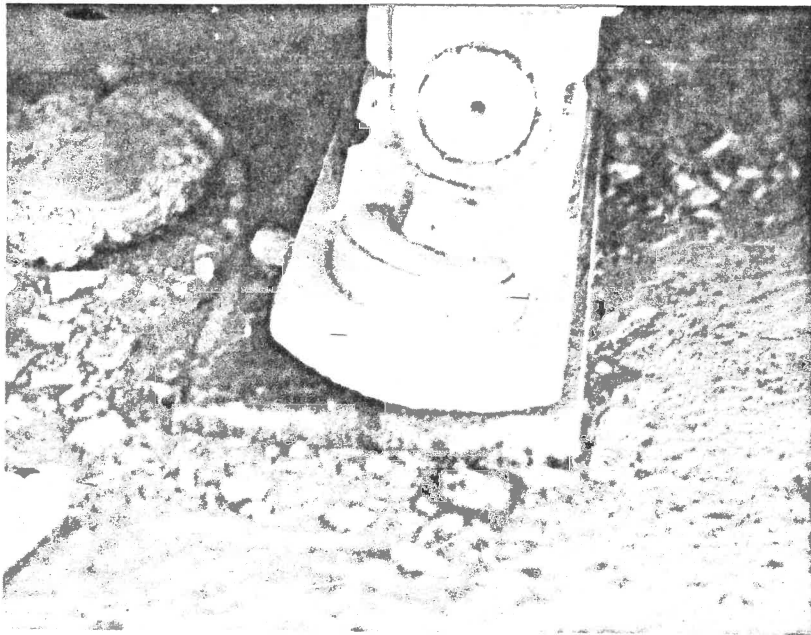
Fig. 12

The conditions surrounding this slide are essentially the same as those at locations 8 and 9. Tables 1 and 2 show the soil test data for samples taken at this location. An attempt was made to take undisturbed samples from the slide material, but this attempt was not successful because the soil was so soft that it could not be retained in a thin wall sampling tube. The water content of the material in the slide varied from 50 to 53 per cent on three samples. The undisturbed samples for shear

test were taken from the embankment approximately five feet from the edge of the slide and at a depth of twenty-four inches below the surface of the slope. Much of the slide material completely liquified during the movement and flowed past the toe of the slope and across State Highway 181 which passes close to the toe of the slope at this point. The evidence of excess water flowing down the slope at this point is very pronounced. The concrete slope protection under the bridge shows considerable movement. See cracks shown in Figure 11. This movement of the slope protection appears to have pushed the first interior bent out of line as indicated by the position of the expansion shoe shown in Figure 12. The expansion joint at the end of the bridge is of the sliding plate type and has opened much wider than normal. This apparently is funnelling all of the water from the end span of the bridge onto the bridge head at this location.

The amount of water during any one shower is not excessive but the end bridge span has no scuppers so that all of the water from even a light shower flows onto the embankment. The embankment at this point is kept much wetter than the remainder of the embankment.

Slide No. 11

Figure 12 shows another result of water running through the expansion device at the end of the bridge. The expansion shoe on the first interior span is on the first interior bent and is leaning in the opposite direction, indicating that the first interior bent has moved away from the abutment. This is on Interstate Highway 55 grade separation over Highway 181 two miles south of Keiser. The embankment under the bridge is protected by precast concrete rip-rap. It appears that this rip-rap is moving downhill as indicated by the crack that has opened, see Figure 10. The force of this rip-rap pushing against the first interior bent appears to be moving the bent away from the abutment thus causing the expansion joint at the end of the bridge to open unduly wide.
