TRC0703

Evaluation of Silicone Sealants on Bridge Deck Expansion Joints

R. Taylor Robertson, W. Micah Hale

Final Report

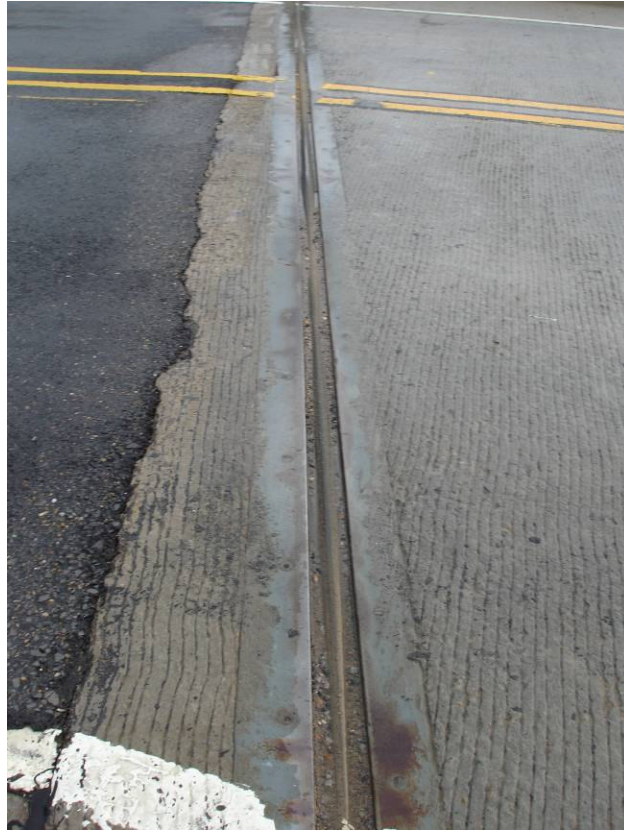
The bridge expansion joints located on Lee Creek Road were not in good condition. The existing silicone sealant was concave up in the middle as shown in Figure 16. These middle sections presented a problem due to the fact that vehicles could come in contact with the silicone and possibly rip or tear the silicone which would allow water and debris to make its way through to the understructure of the bridge. No re-inspection has been made since September, but if snow plows were used on the bridge over the past winter, the blades may have torn the sealant.

Figure 16: Silicone Concave Up in Middle

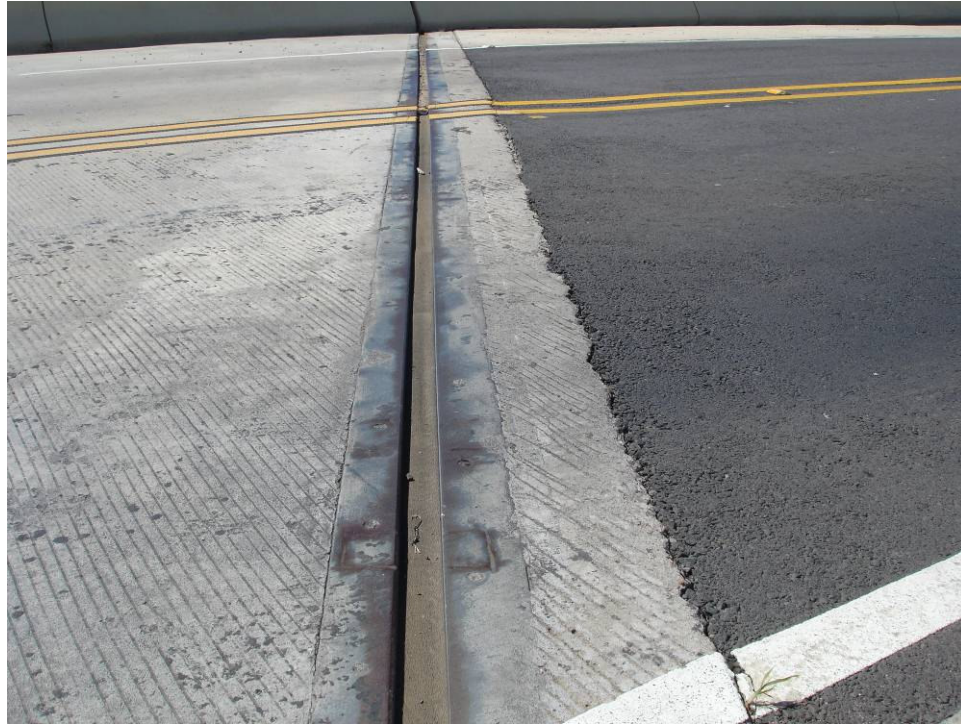
The joint width on both expansion joints for this bridge was 2 inches and the recess depth of the silicone was $\frac{3}{4}$ of an inch throughout the entire joint. The joint looked to be in great condition with a small amount of debris build up on the shoulders, due to turning up the ends of the backer rod and silicone. The existing sealant was actually the second installation since the first installation failed immediately. No reasons were given for the first installation failure, but it was most likely due to some poor installation techniques. Below in Figure 17, one can see a picture of the joint, and the excellent condition it is in as well as the uniformity of the silicone depth. Figure 17 can be taken as an example for an excellent looking and performing joint.

Figure 17: Mill Creek Road Bridge Deck Joint

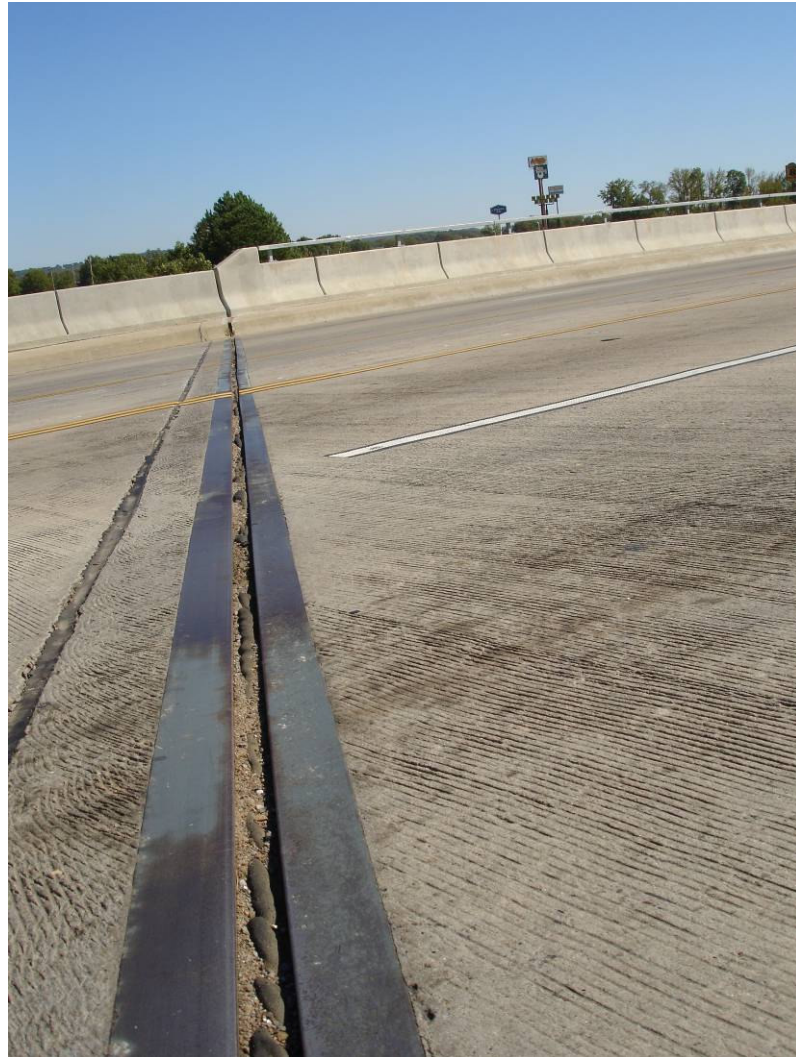
installation since the first installation failed immediately. No failures had occurred as of October 2006.

Figure 18: Highway 7 over I-40 Bridge Deck Joint

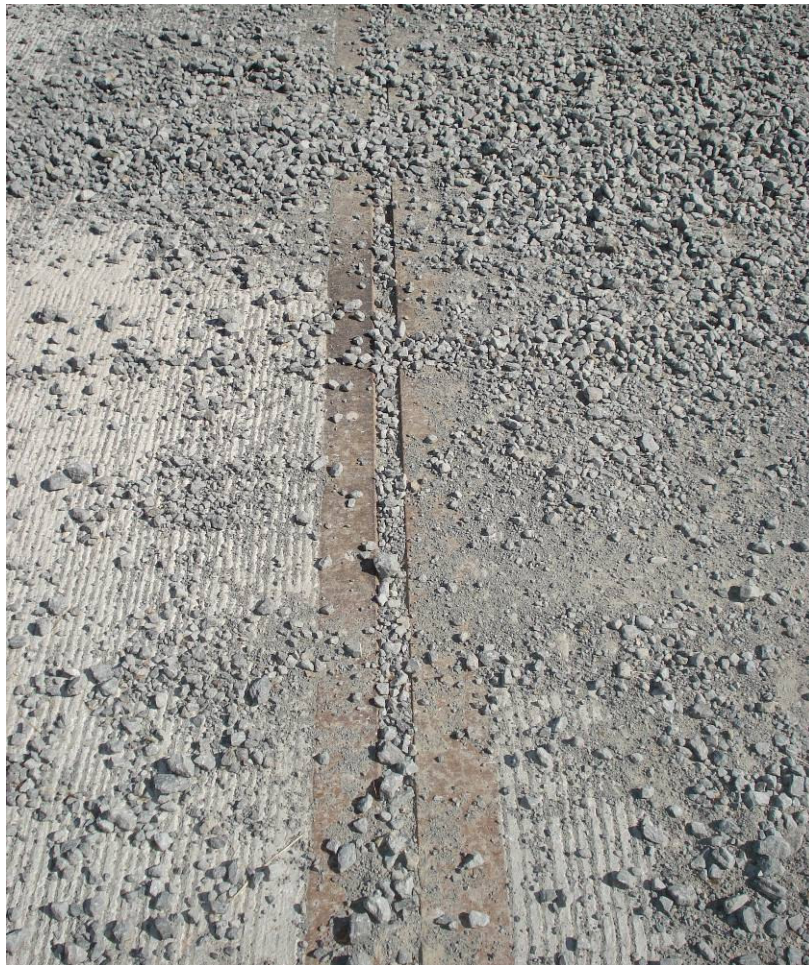
support loads from vehicles and so should not be used on dirt roads where debris can infiltrate the joint and be pushed through the silicone. Other than problems from debris and gravel, the joint looked to have been installed rather well and no other types of failures were found.

Figure 19: Debris in Joint at Cadron Creek Bridge

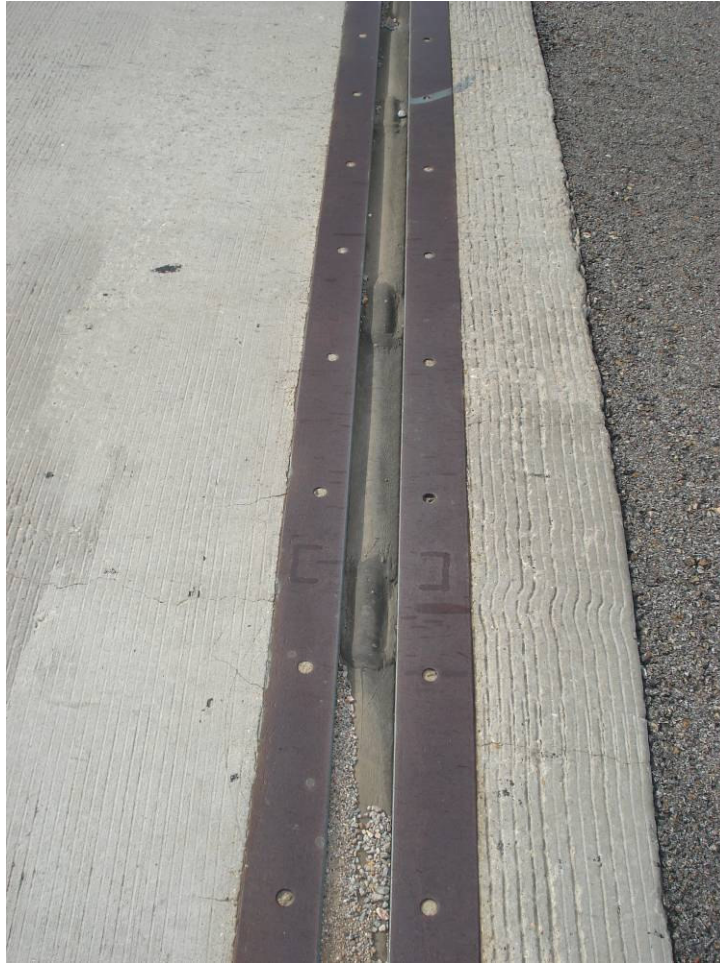
The width of this joint was about 3 inches with a recess depth of the silicone around $\frac{3}{4}$ of an inch in most areas. One major thing to note about this joint is that the highway department had patched the joint in many places due to failures that had already occurred. These patches were done in the winter of 2006. The patches appeared to have bonded well to the older silicone, but the problem that occurred is that the silicone was now very uneven and debris was trapped in many areas. Also, the patches appeared to have been done at regular intervals, or where the silicone tubes may have been switched out during the original installation. Figure 20 below shows the intervals where patches were done and the non-uniformity of the silicone. This bridge was a 5 lane bridge that was subjected to a lot of heavy truck traffic.

Figure 20: Highway 63 Bridge with Interval Patching

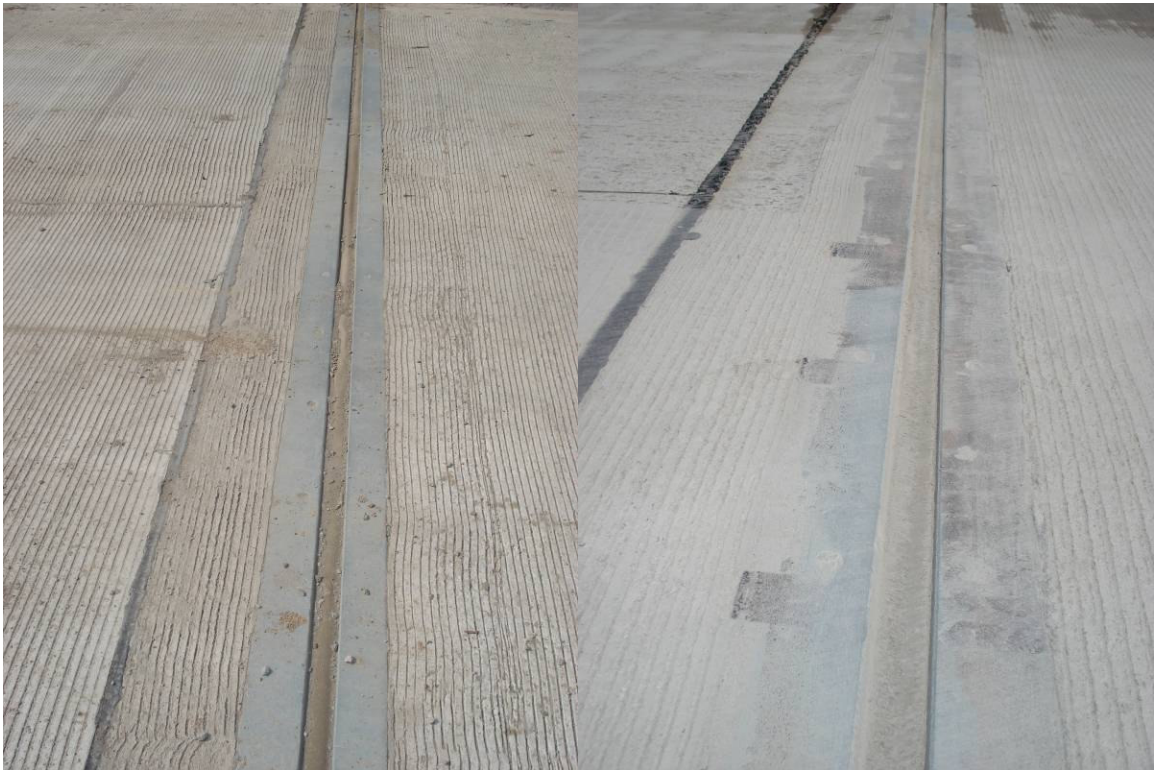
with a depth to silicone of $\frac{1}{4}$ of an inch. The recess depth of the silicone was somewhat shallow and this could pose some problems in the future. However, further protruding of the silicone is unlikely since the silicone was placed in May at warmer temperatures where the width of the joint is close to its smallest. Also, the silicone appeared to have been poured with the correct thickness in mind, unlike the first pour. In Figure 21, one can see a comparison of the originally poured joint versus the replacement.

Figure 21: Shilcott Creek Bridge - Original Joint (left) vs. Replaced Joint (right)

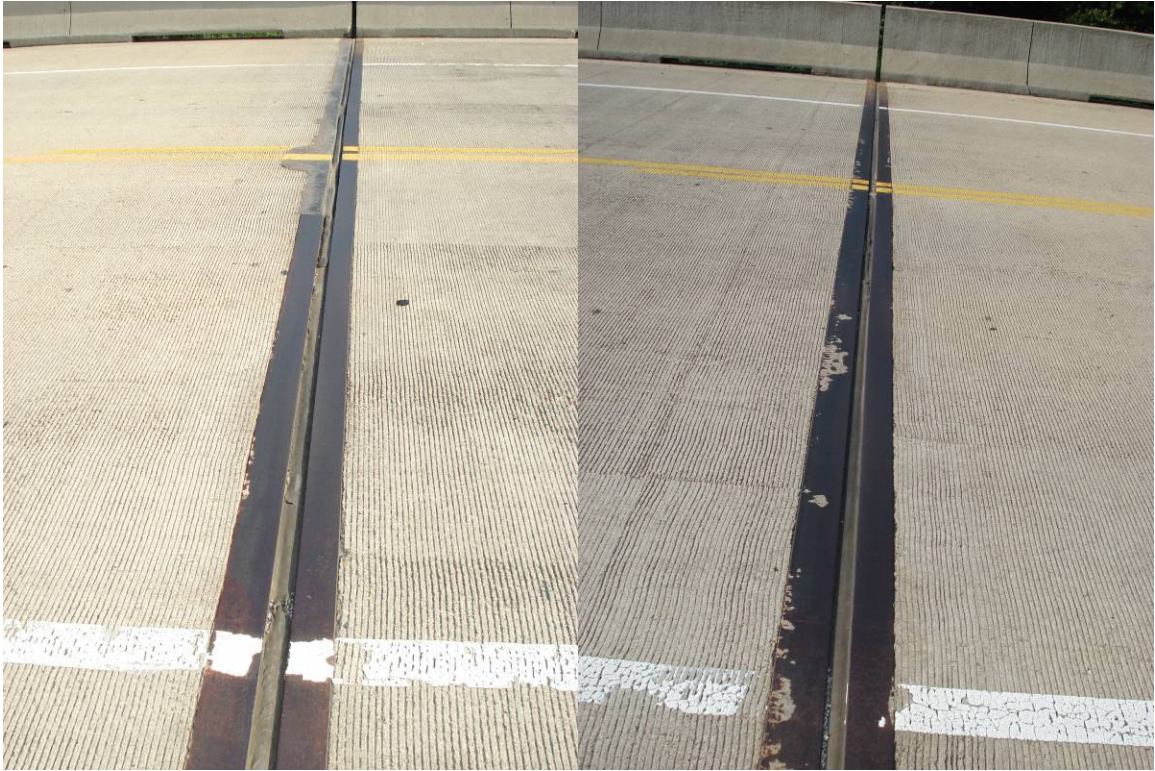
The width of the joint was 1 ½ inches on the eastern side with a joint width of about 2 inches on the western joint. The recess depth of the silicone on the eastern joint was 3/8 of an inch while the western joint was between 0 and ½ inches. The western joint was in poor condition and contained many failures. There was also small stretches of joint that contained no sealant. The joint was 8 years old, so it was only to be expected to find some failures in the joint. On the other hand, the eastern joint was still in decent shape for its age. This may have been due to the fact that it looked to have a more uniform pour throughout and was not skewed at all creating different joint widths and depths. One final thing to take notice of was that the joint ends were not turned up, and no problems had developed with the understructure. A comparison of the eastern joint to the western joint can be seen in Figure 22. In Figure 22, one can see the non-uniformity of the silicone in the western joint when compared with the eastern joint.

Figure 22: Hwy. 270 over Saline River West Joint (left) vs. East Joint (right)

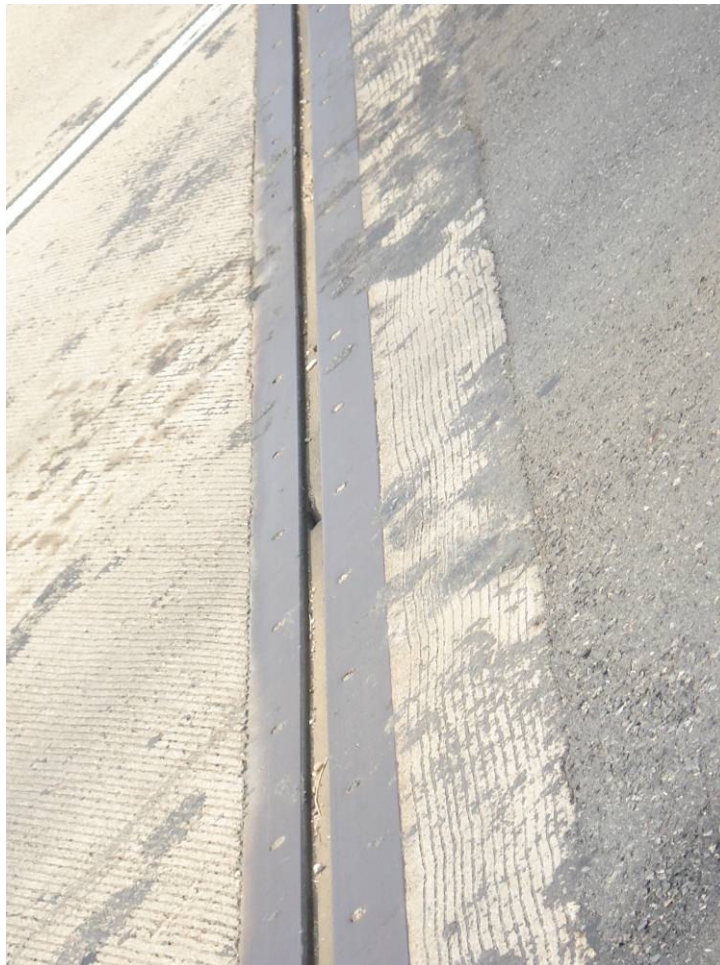
Figure 23: Grisby Ford Silicone Puncture

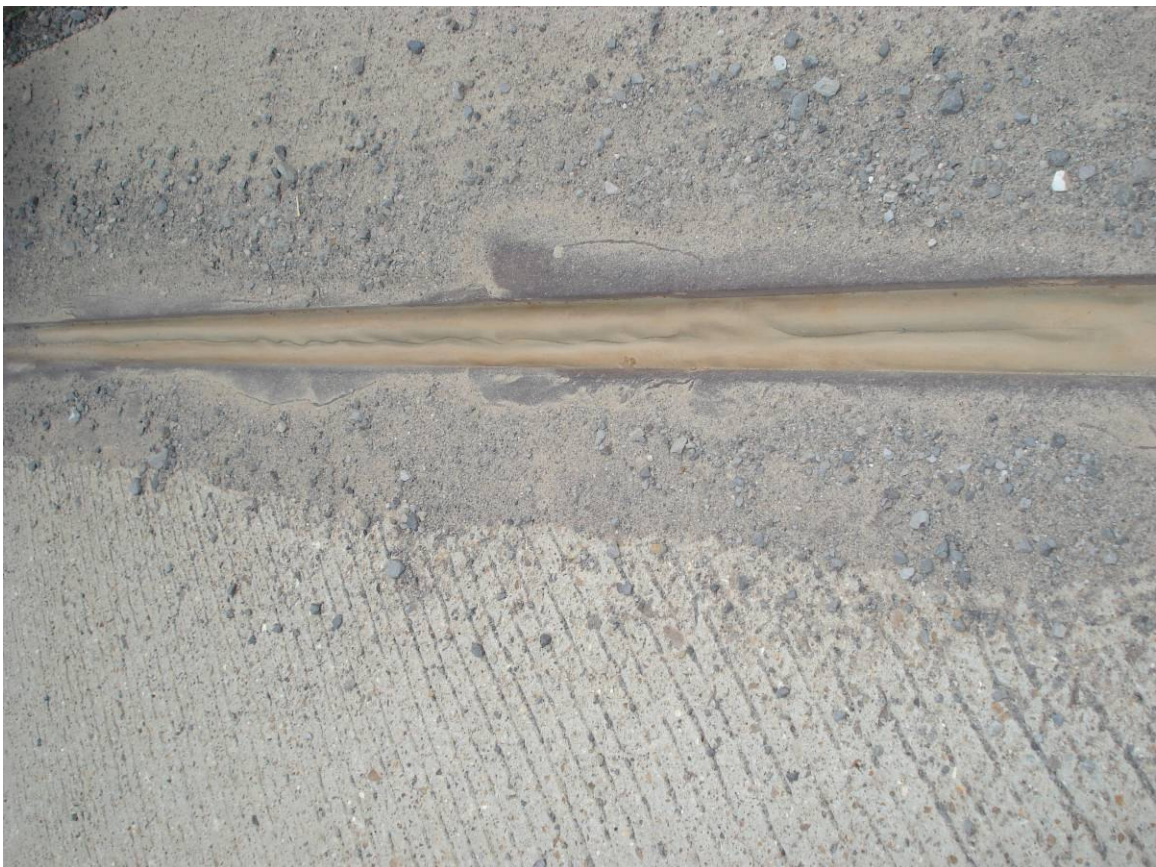
the dirt road. Remarkably, no failures were found in either of the joints. No rocks or debris had been able to puncture through the sealant. Both joints looked to have had a proper placement and were only somewhat “wrinkly” in a few areas which can be seen in Figure 24 below. The southern joint contained one area that was trying to detach from the joint side, but had not done so yet. Expansion of the joint could lead to a failure in the future. All in all, the joint was in good shape for being on a dirt road for 4 years. Even though this joint had performed well, installing silicone sealants on dirt roads is not recommended due to the likelihood of debris puncturing the sealant under vehicular loads.

Figure 24: Caddo River County Road "Wrinkly" Joint

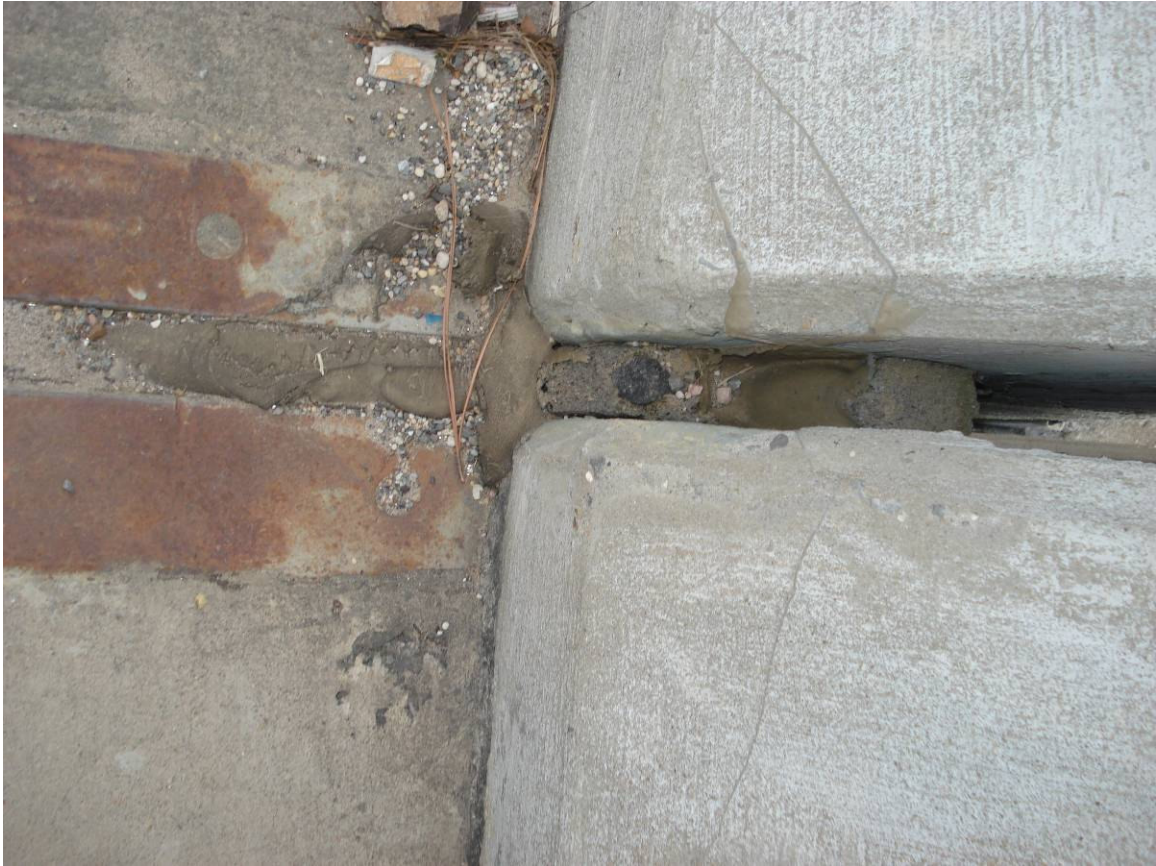
One of the interesting things seen on these joints was that on the shoulders of the bridge, two backer rods had been used as can be seen in Figure 25. This may have been done to help raise the silicone on the ends of the joint to keep water and debris from washing off onto Highway 67 below. The shoulders of the road did allow debris to accumulate in the joints but very little debris was found in the joints located in the traffic lanes. All in all, the condition of the joints was fairly good except for the small detachment and the few small depressions.

Figure 25: Pecan Street Double Backer Rod in Joint

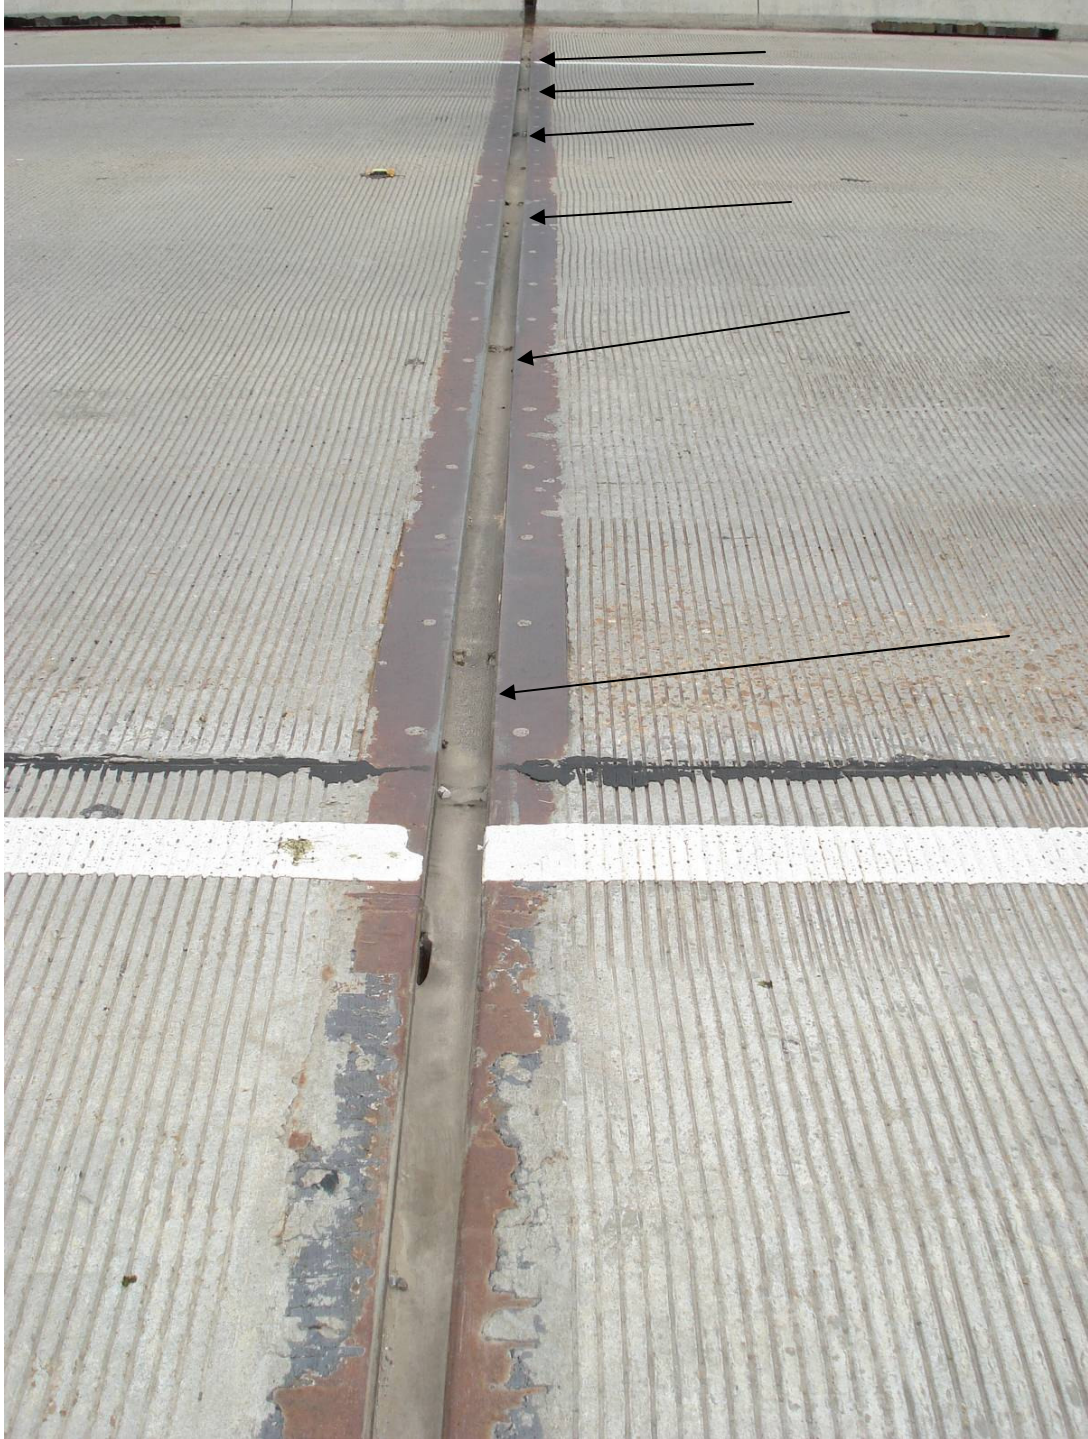
In all five of the joints, many problems were noticed with detachment of the silicone from the sides of the joint and tears in the middle of the silicone joints. On most of these joints, the spacing of these tears and detaching areas was about every 2-3 feet, which may have been the distance where tubes were changed out during the installation of the joints. Figure 26 presents a picture of the interval tearing. Many of these areas where tears and detachments were found were completely through the entire joint constituting a failure. Some though had not broken through the silicone completely and were still operating fine. Very little debris was found on the joints. Finally, one of the joints contained the two backer rods on the end which had probably been used to push up the ends of the silicone. All in all, the joints were in pretty bad shape for being only 2 ½ years old and many would need to be replaced.

Figure 26: Cache River Interval Tearing/Detaching of Silicone Joint

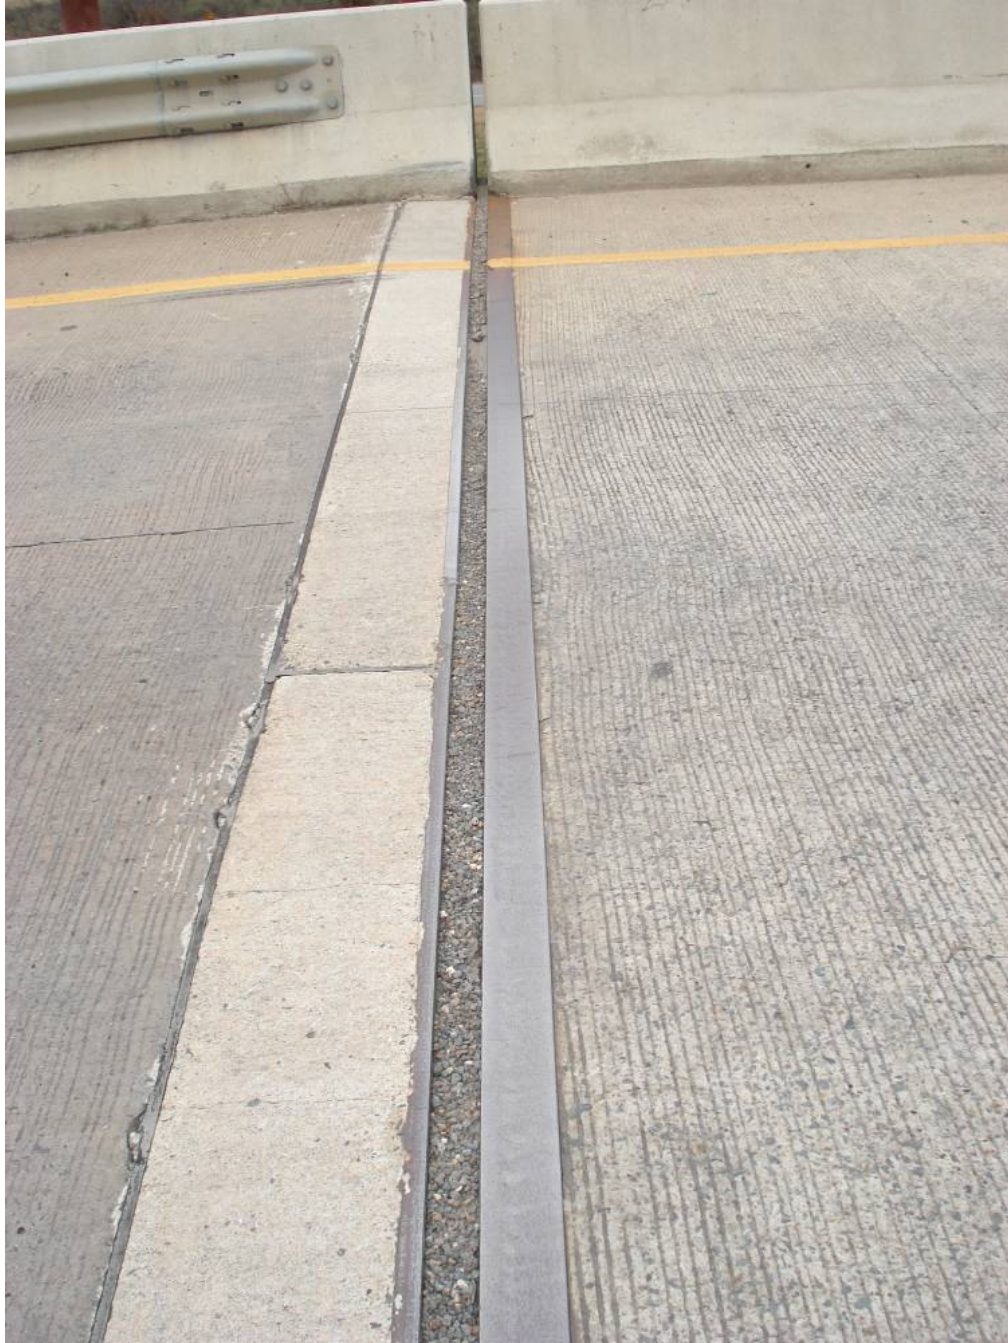
Only one joint was examined and the width of the joint was an even 2 1/8 inches throughout. The depth to silicone on the joint was about 1 1/4 inches, but there was a level of debris or asphalt that covered the silicone with a thickness of about 1/2 inch which can be seen in Figure 27. After removing this debris/asphalt covering, several holes and detachments were found in the silicone constituting many failures. This debris covering was nearly bonded to the silicone and was particularly hard to remove from the joint. An AHTD official thought that calcium chloride used on the bridge deck may have allowed the debris to bond together over the top of the silicone to create the layer of debris and make it hard to remove. This layer was particularly heavy on top of the silicone as well. In summary, this joint will need to be replaced due to the many failures.

Figure 27: I-440 Interchange Debris Build-up on Joint

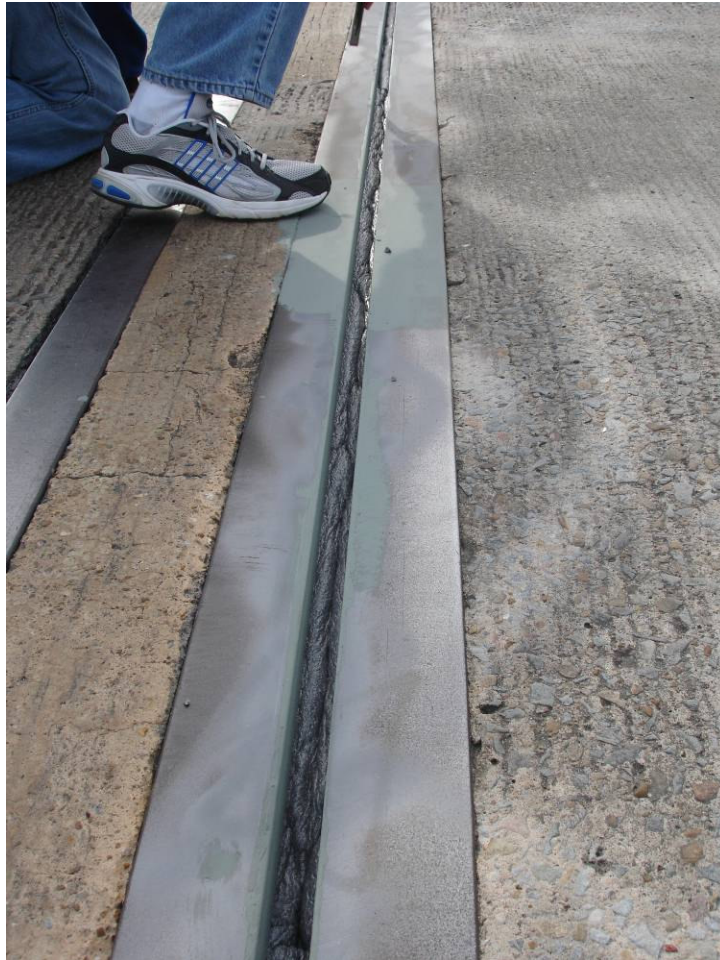
Figure 31: Bald Knob Exit 54 "Wrinkly" Backer Rod in Joint

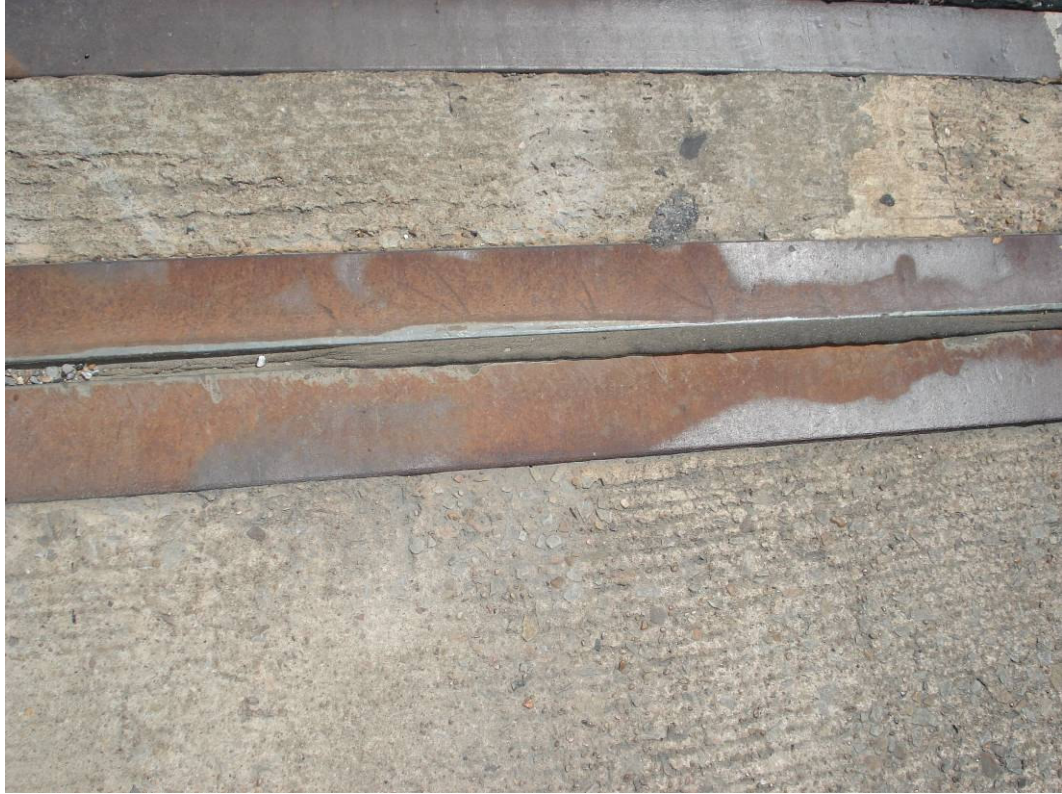
top surface of the joint. The depth of the sealant during this period did not change much from the depth it was installed at except as stated above. On one end of the bridge, there is no depth due to the turn-up of the sealant and the small amount of space available to push the backer rod into place. The silicone depth increases as one moves across the width of the bridge until it gets to a maximum depth around ½ an inch. Due to the width becoming so small during the summer months, the sealant was pushed up somewhat toward the roadway, and began to take on several of the characteristics of the backer rod including a “wrinkled” and “curly” texture. Figure 32 below shows a picture of the sealant being pushed up to the roadway near and on the shoulder. Also, the sealant is uneven in depth throughout its entire span. Finally, several places in the joint contain embedded debris which may be due to allowing traffic on the joint immediately after it was completed when the silicone had not set-up entirely.

Figure 32: Bald Knob Exit 54 Joint Sealant Pushing Up to Roadway (8-9-07)

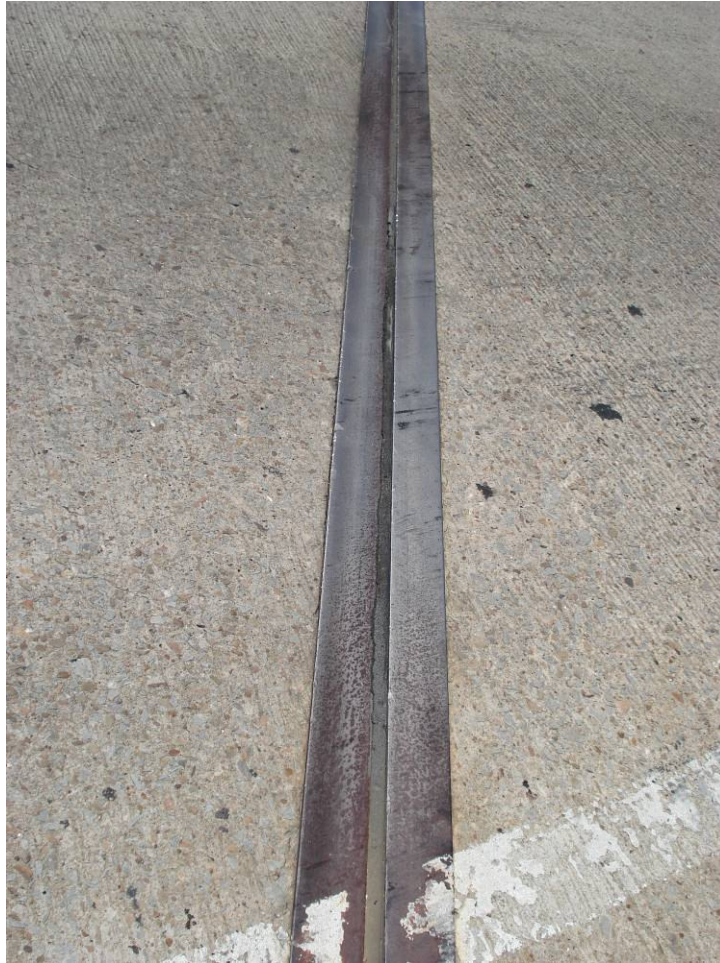
The monitoring of this joint showed that the silicone has continued to protrude upwards toward the roadway surface and as of August 2007, many spots are higher than the surface of the roadway in traffic lanes as well as the shoulder of the road. These areas are even in traffic spots and this has allowed traffic to start tearing the joint. From August 2007 to January 2008, the sealant began to recess some as the joint widened, but the depth at most was ½ inch from the roadway. The spot that was being hit by vehicles recessed enough so that it was no longer at roadway height. No failures had occurred in the joint, as one can see in Figure 33, the joint did take some significant damage.

Figure 33: Southbound Creek Bridge Joint Damage (8-9-07)

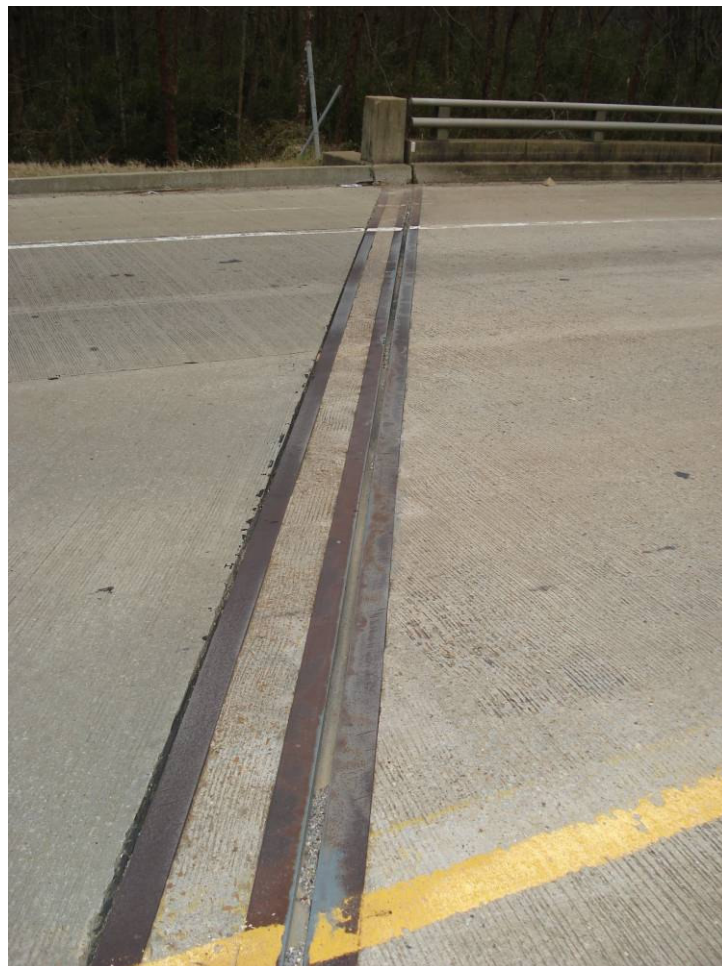
January 2008 where the depth stayed at $\frac{5}{8}$ of an inch throughout. The original depth to the silicone sealant was between $\frac{5}{8}$ and $\frac{3}{4}$ of an inch, so the depth has not changed over the months since installation. Also, the sealant has maintained a very uniform depth throughout the width of the bridge and throughout the months since installation as can be seen in Figure 34. Very little debris has been found in the joint in the roadway area, but there is still a build-up of debris on the shoulders, even after the turn-down of the ends of the joints.

Figure 34: Bald Knob Northbound Creek Joint (1-16-08)

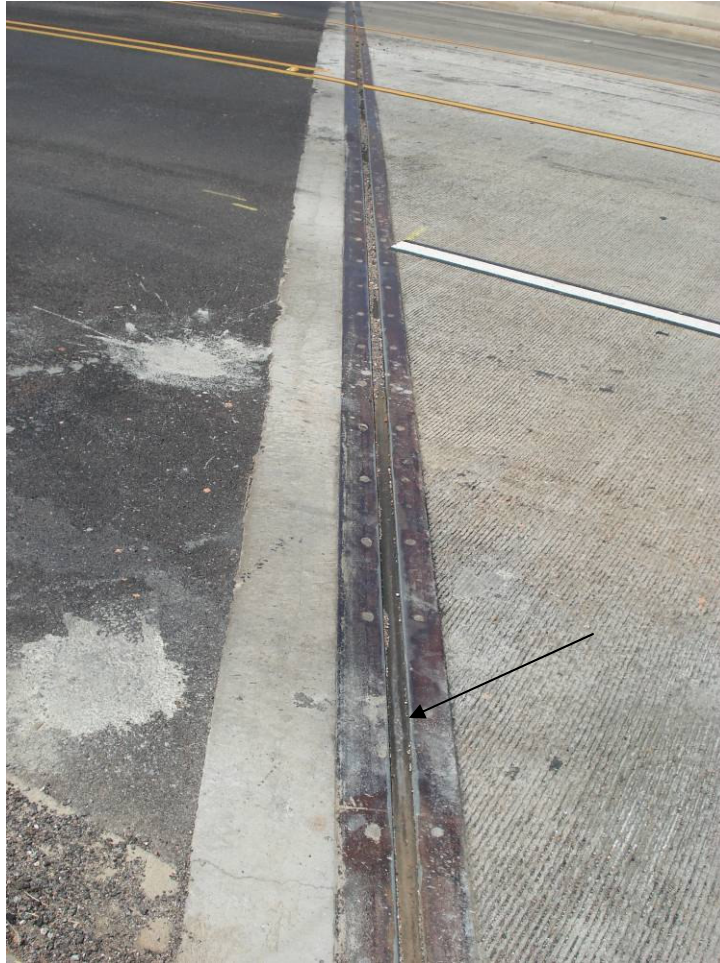
Further monitoring of the joints showed that no problems were found to have arisen due to the excess debris within the joints. The only noticeable things found on the joint were a few soft spots which may have been from inadequate thickness of the sealant. Also, during the summer months the western joint had one spot that got up to the roadway height and allowed traffic to hit it some as can be seen in Figure 35. No damage was caused to the sealant since it did not go above the roadway.

Figure 35: Blossom Way Creek Joint with Sealant at Roadway (8-14-07)
