**TRC 84**  
**SLOPE STABILITY**  
Interim Report

Construction on Job #110066  
Lehi - West Memphis Structures and Approaches  
July 1986

## SLOPE STABILITY

Job #110066

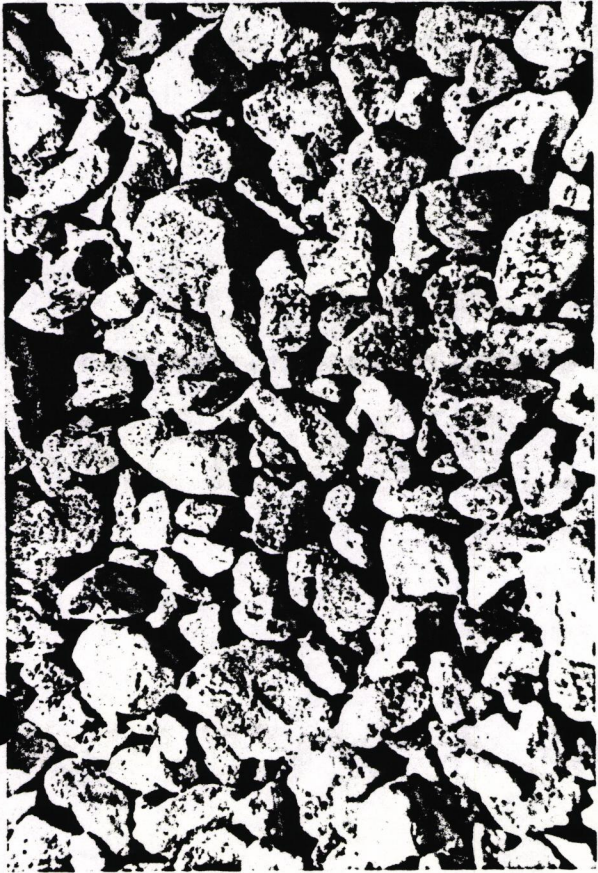
Lime pellets maximum size, approximately 1" diameter.

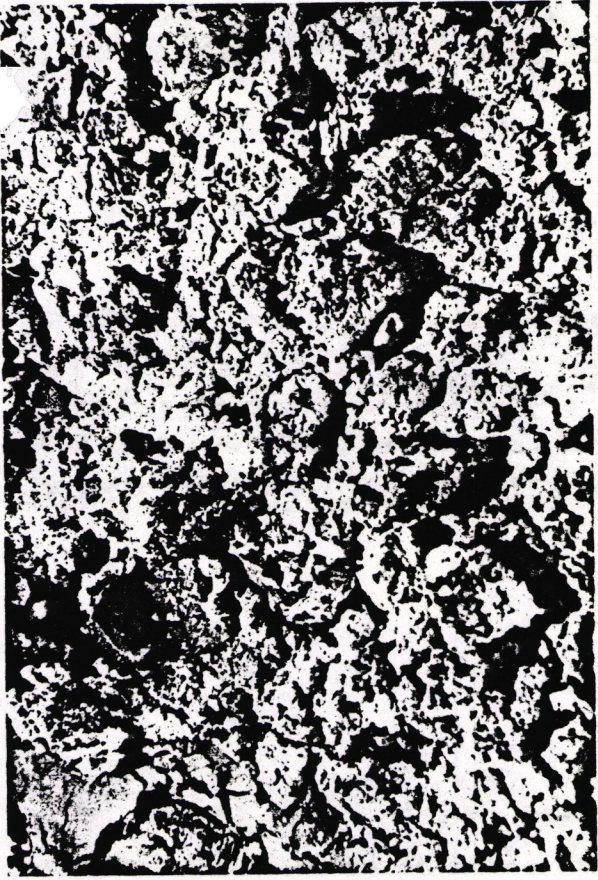
Lime pellets after addition of water.

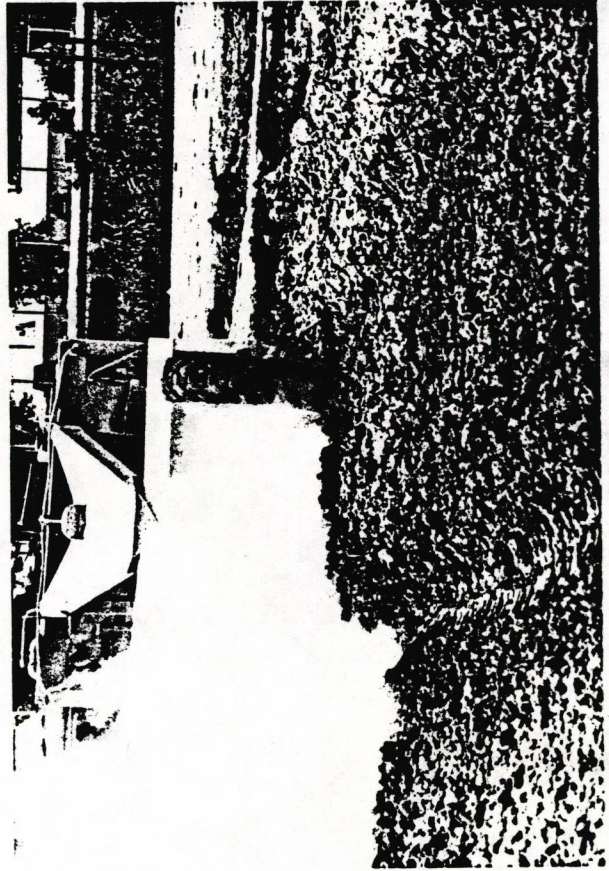
Lime being mixed into the subgrade. A total of three passes are made.

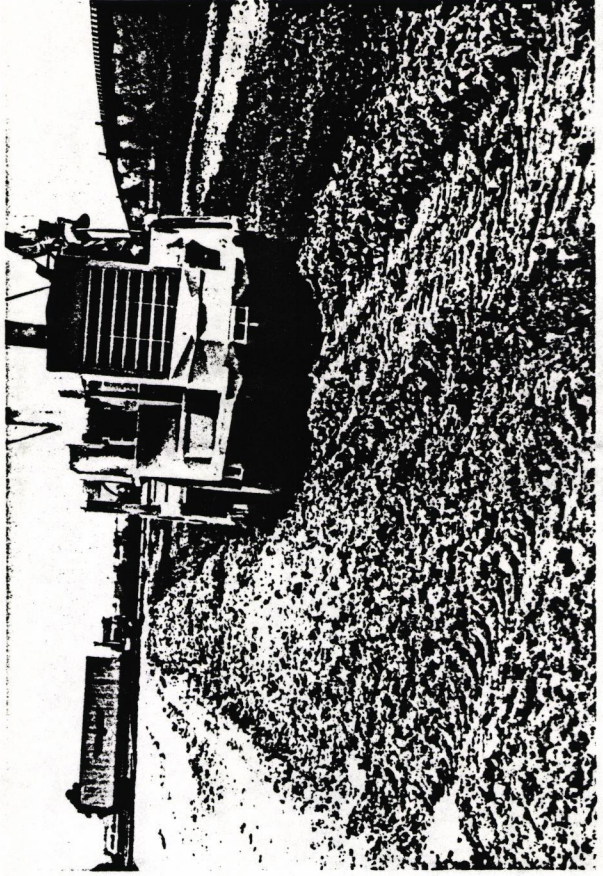
Mixing of lime into the subgrade.

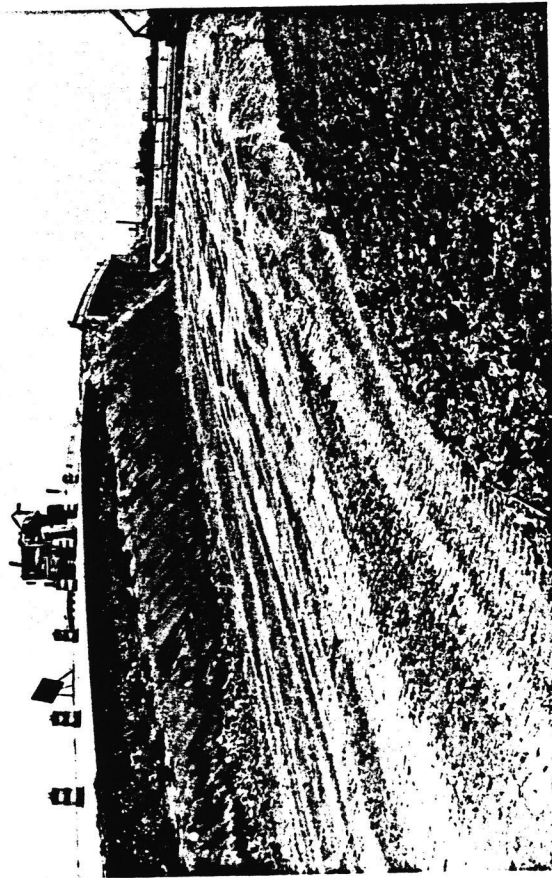
South approach southeast side, lime treated subgrade partially installed.

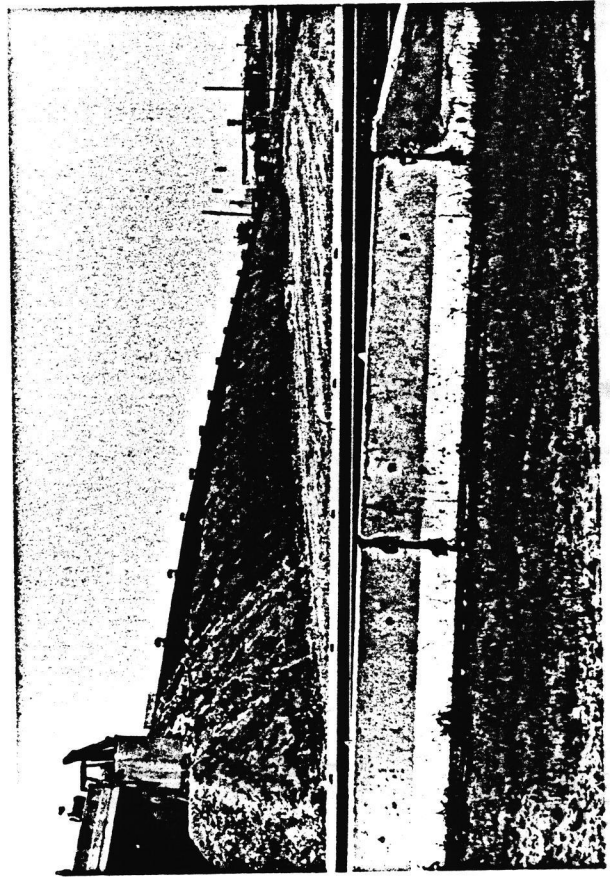
North approach northeast side, lime treated subgrade partially installed

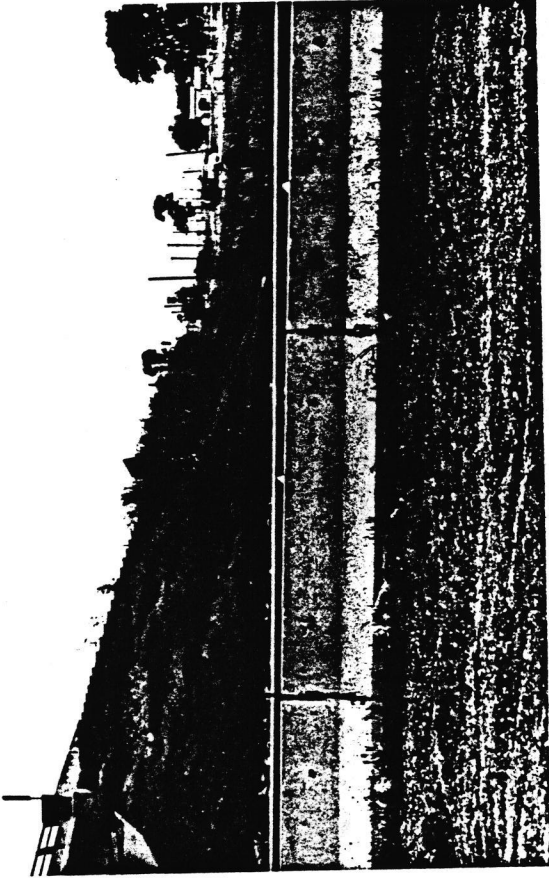
South approach southwest side, existing slope still in place. Lime treatment process underway in background.

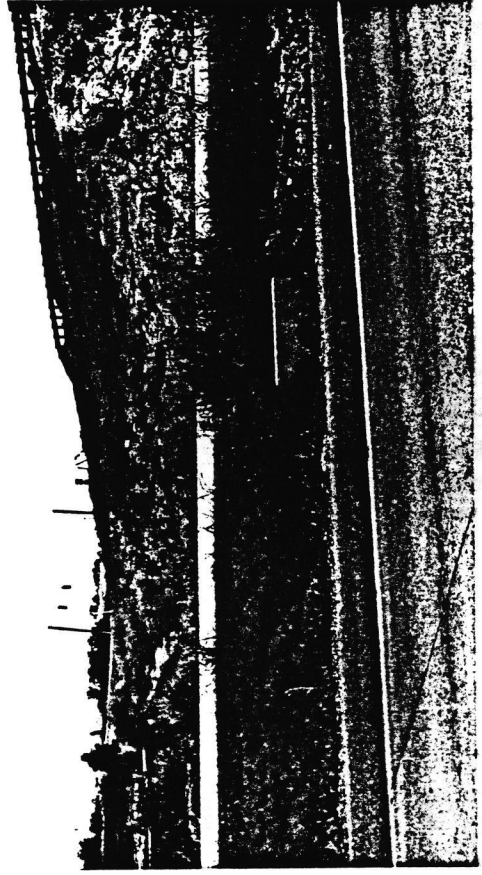
North approach northwest side, existing slope still in place.

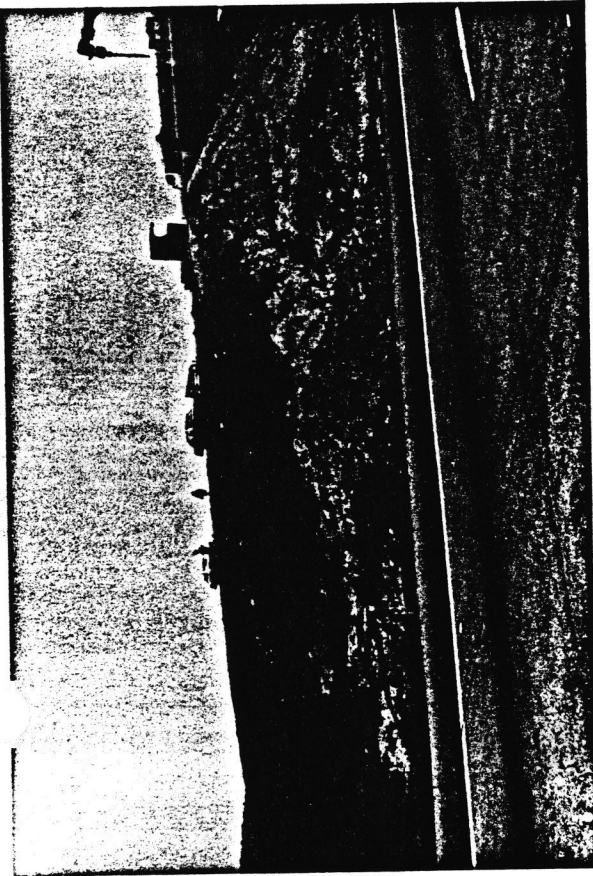
South approach southeast side, embankment reconstructed with select material.

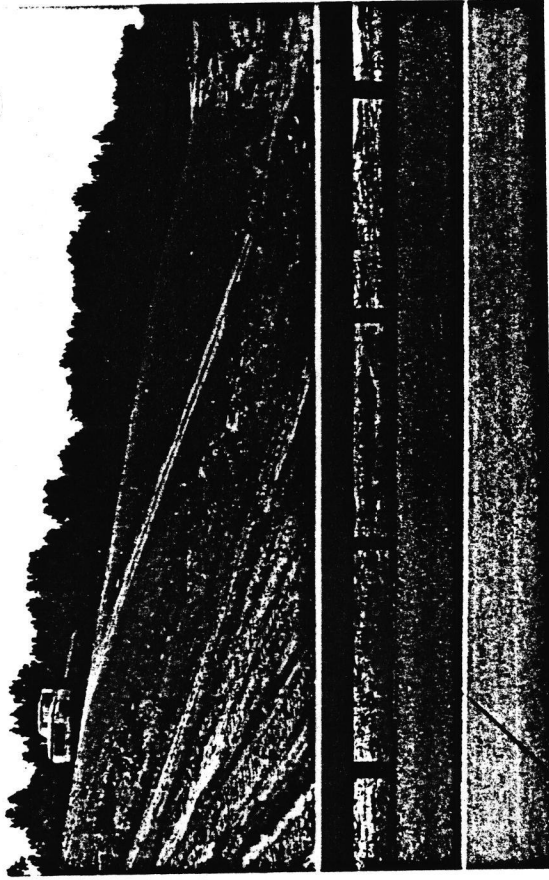
South approach southwest side, embankment reconstructed with select material.

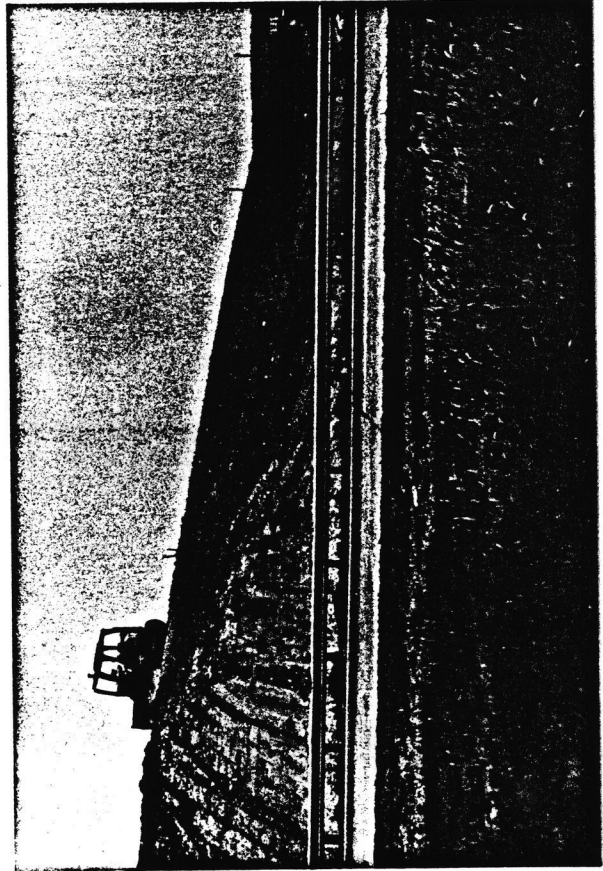
North approach northeast side, final grading for top soil underway.

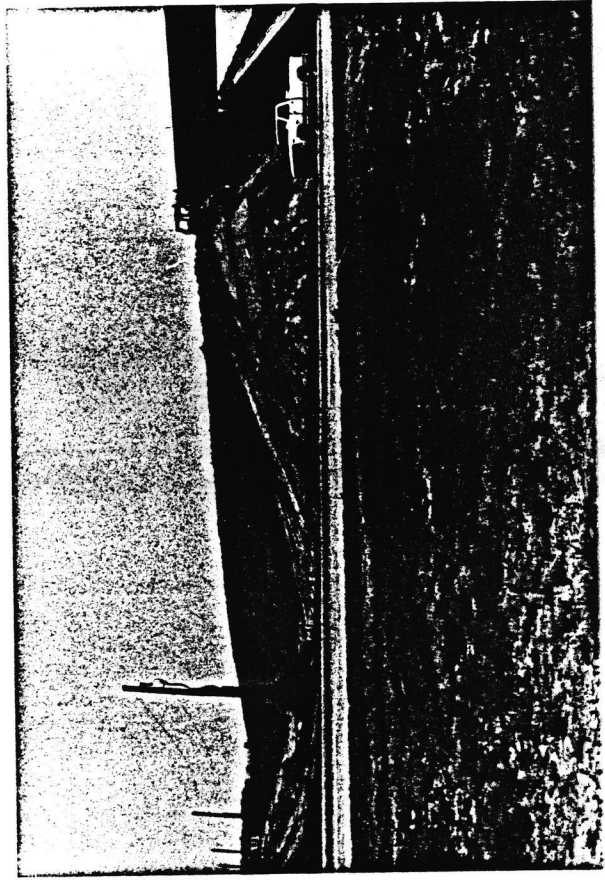
North approach northwest side, final grading for top soil nearing completion.

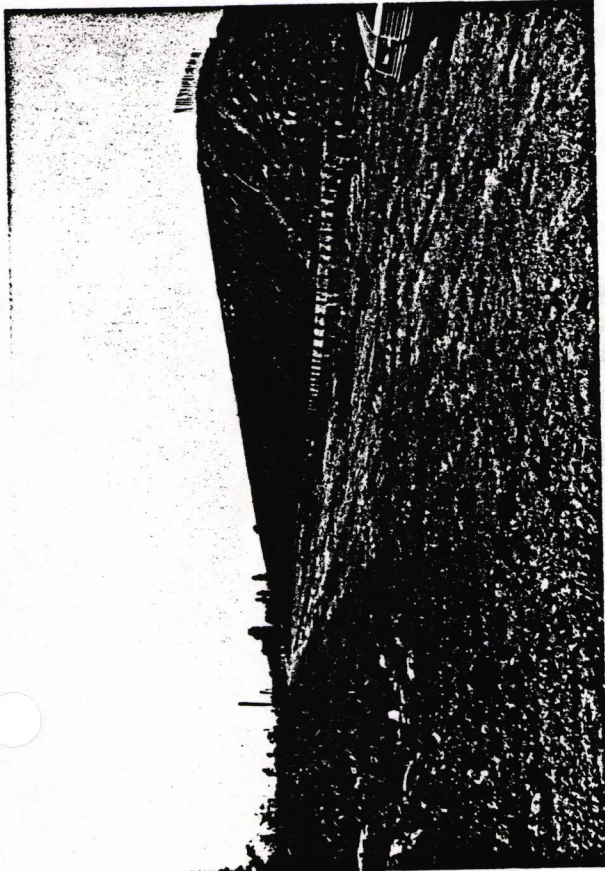
South approach, southeast side existing side slopes removed ready for placement of wire mesh.

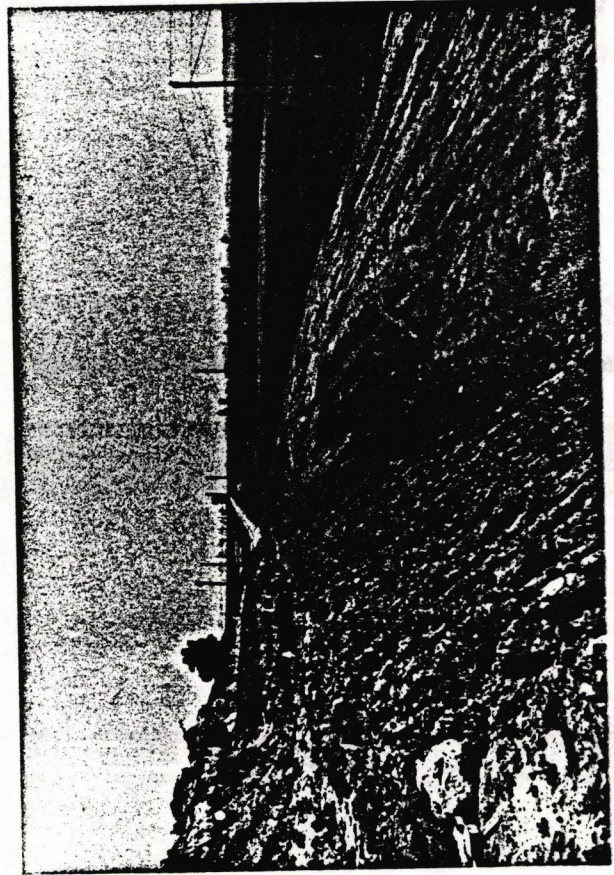
Ebony Road overpass has had three out of four embankments cut out (See Figure 6). The slopes in the northeast quadrant appear to be steeper than the 1:1 required. No significant erosion or failure have occurred on these exposed slopes. According to the Resident Engineer these slopes will not be replaced this year. Plans call for wire mesh on the south side placed at 2 foot vertical intervals. Fabric reinforcement will be used on the north side slopes, also at 2 foot intervals. An area of ponding was noted at the edge of the previous slope on the northwest side.

North side, northeast side existing slope cut out and back to a steep angle.

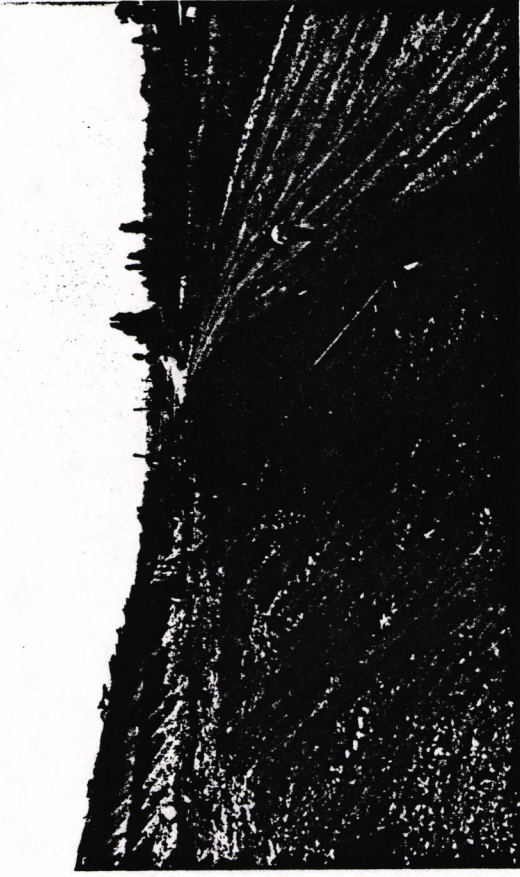
Southside, southwest side existing slope cut out, and back to 1:1

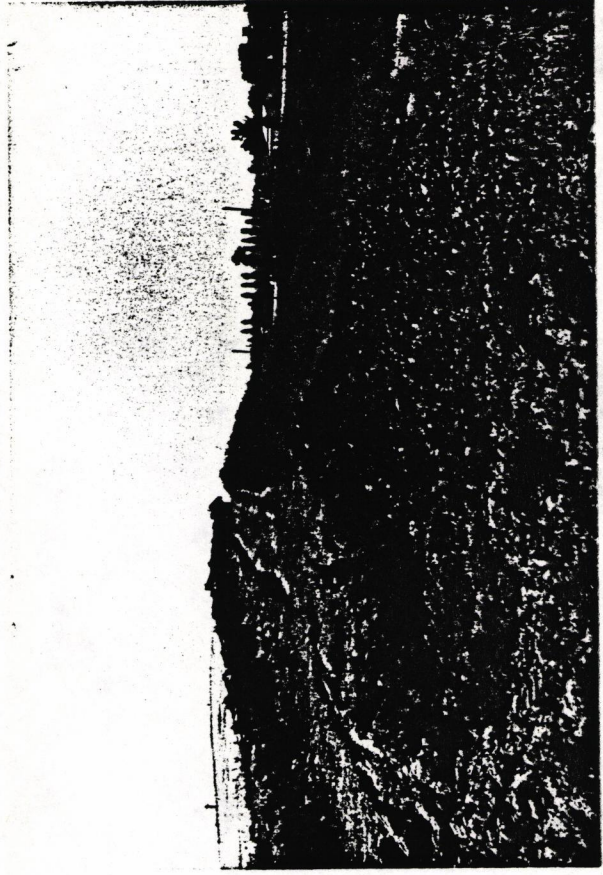
Northside, northwest side existing embankment partially removed. Evidence of ponding at corner of picture.
