RE: AHTD Job Number BR3714  
Little Bodcau Creek Str. & Apprs. (S)  
Lafayette County

**SUBJECT:** AHTD Job Number BR3714  
FAP Number BRO-0037(33)  
Little Bodcau Creek Str. & Apprs. (S)  
Bridge Number 21873  
Lafayette County  
Tier 2 Categorical Exclusion

WETLANDS AND STREAM ASSESSMENT  
PURSUANT TO SECTION 404  
AHTD JOB NUMBER BR3714  
LITTLE BODCAW CREEK STR. & APPRS. (S)  
LAFAYETTE COUNTY

DATE REVISED	DATE FILMED	DATE REVISED	DATE FILMED	FED. RD. DIST. NO.	STATE	FED. AID PROJ. NO.	SHEET NO.	TOTAL SHEETS
2/05/2016				6	ARK.			
						JOB NO.	BR3714	0
						4 TYPICAL SECTION OF IMPROVEMENT

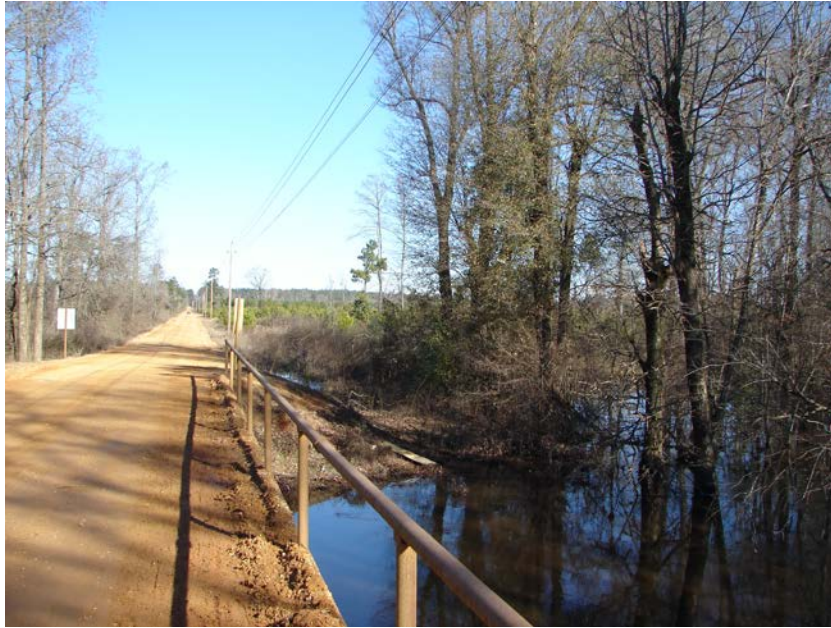
**Figure 2. Bottomland Hardwood Wetlands East of Co. Rd. 25 (Wetland 1)**

**Wetland 1** is a bottomland hardwood wetland located on the east side of Lafayette County Road 25 (Figure 2). The wetland is dominated with water oak (*Quercus nigra*), overcup oak (*Quercus lyrata*), American hornbeam (*Carpinus caroliniana*), and erect dayflower (*Commelina erecta*). Soils in this wetland are listed as Guyton Silt Loam, which are considered hydric (Hoelsher, 1987). The matrix of the soils in this wetland at 0-4 inches have a color of 10YR 5/2 (60%) and 10Y/R 4/3 (40%); 4-8 inches matrix of 10Y/R 6/2 (70%) with redox features of 10Y/R 5/8 (20%) and 10Y/R 4/6 (10%); and 8-12 inches matrix of 10Y/R 6/2 (75%) with redox features of 7.5Y/R 4/6 (20%) and 5Y/R 4/6 (5%). Hydrology was determined by using the primary indicators of water marks, sediment deposits, and presence of reduced iron.

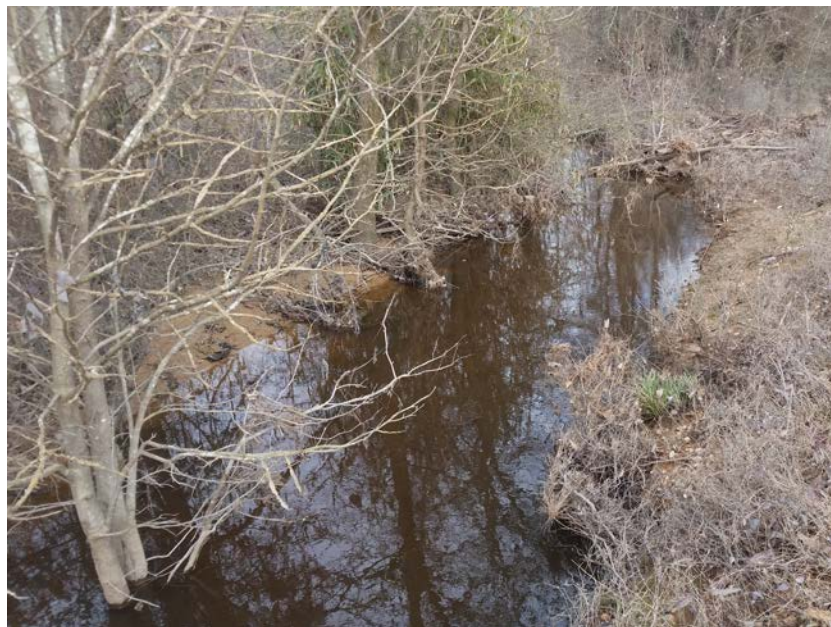
**Figure 3. Bottomland Hardwood Wetlands West of Co. Rd. 25 (Wetland 2)**

**Wetland 2** is a bottomland hardwood wetland located on the west side of County Road 25 (Figure 3). Wetland 2 is dominated by overcup oak, bald cypress (*Taxodium distichum*), and redvine (*Brunnichia ovata*). Soils in this wetland are listed as Guyton Silt Loam, which are considered hydric (Hoelsher, 1987). The matrix of the soils in this wetland at 0-2 inches have a color of 7.5YR 3/1 (100%); 2-9 inches matrix of 10Y/R 3/2 (98%) with redox features of 10Y/R 3/6 (2%); and 9-12 inches matrix of 10Y/R 6/2 (78%) with redox features of 10Y/R 5/8 (20%) and 10Y/R 4/6 (2%). Hydrology was determined by using the primary indicators of water marks, sediment deposits, high water table, and presence of reduced iron.

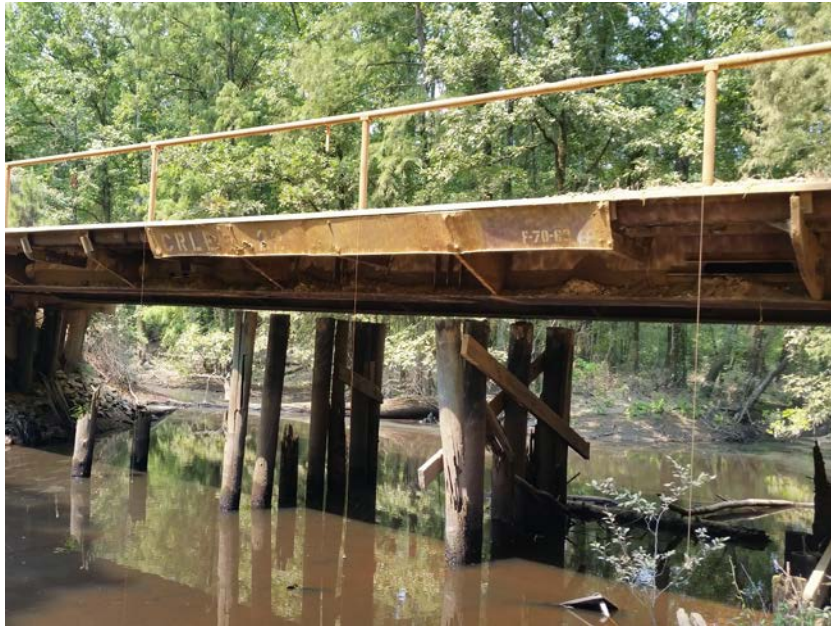
**Figure 4. Little Bodcau Creek at bridge crossing (Stream 1)**

**Stream 1** is the main stem of Little Bodcau Creek flowing west to east at the bridge crossing (Figure 4). Little Bodcau Creek is tributary to Bodcau Creek within the Red River Basin (HUC 11140205). Streams within this watershed are characterized by braided channels and gravel/sand substrate bottoms.

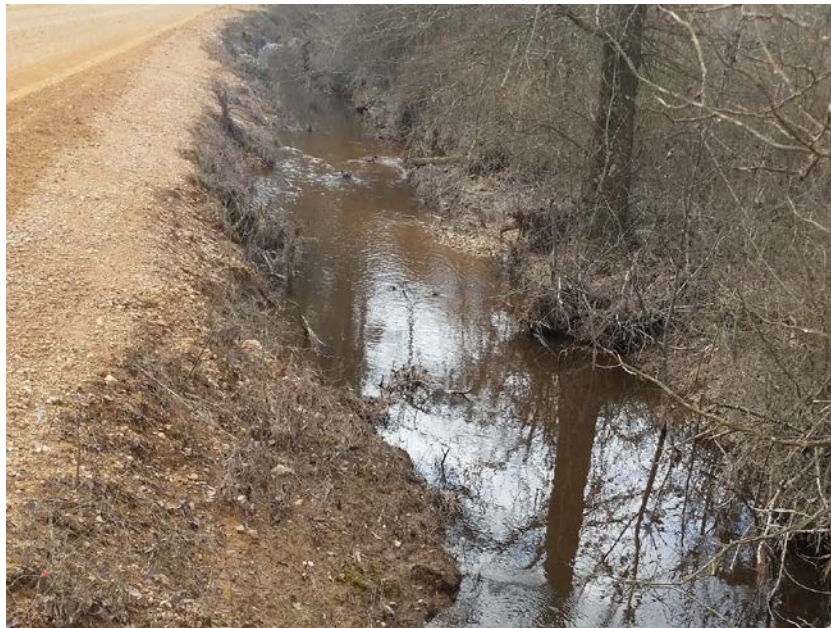
**Figure 5. Unnamed Intermittent tributary along roadside (Stream 2)**

**Stream 2** is an intermittent tributary to Little Bodcau Creek flowing generally from the southwest to northeast until being confined along the current roadside ditch (Figure 5). The channelized stream flows for 620 within the project limits. It is relatively incised and degraded with an abundance of sediment likely due to silviculture in the area and road maintenance practices. On average the channel is 5 feet wide with an ordinary high water mark averaging 6 inches from the stream bottom.
