TRC1202

Evaluation of New Technology for Traffic Monitoring

EVALUATION OF NEW TECHNOLOGY FOR TRAFFIC MONITORING

ADAS Version 1 and 2 Data Collection Report

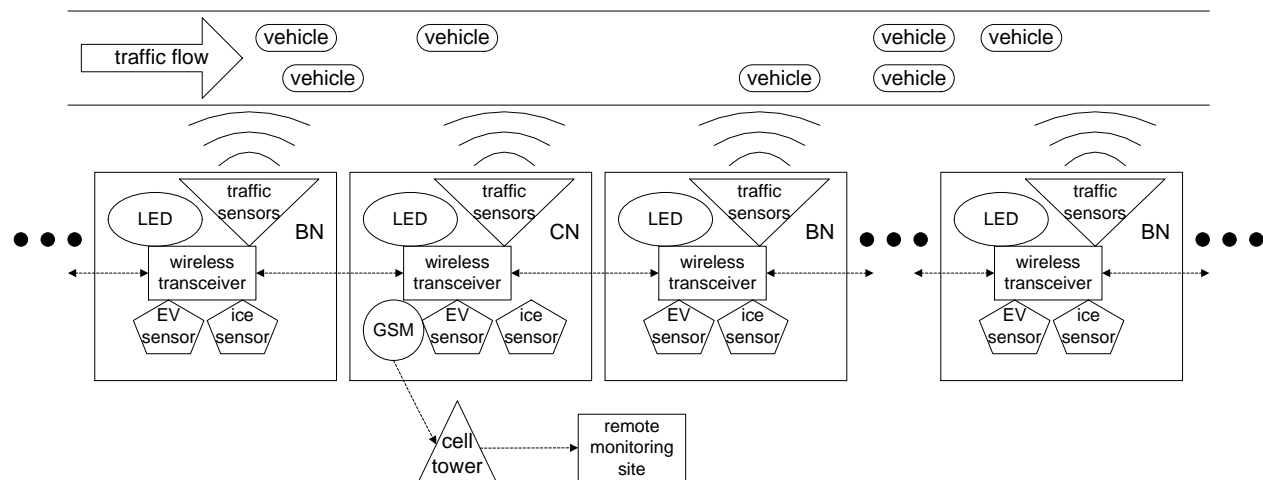
The Automated Detection and Alert System (ADAS), senses hazardous road conditions such as stopped traffic, slowed traffic, pulled over or upcoming emergency vehicles, and icing conditions, and visually forewarns drivers in advance of the hazard. ADAS utilizes electronic nodes placed alongside a highway, with sensors to detect traffic congestion and other hazardous conditions, a multi-colored LED to visually notify drivers of a detected hazardous condition, and a wireless transceiver to wirelessly communicate the hazardous condition to neighboring nodes in order to notify drivers well in advance of the hazard, as depicted in Figure 1. A detected hazardous condition can also be transmitted through the existing cellular network to enable remote traffic flow monitoring and notification of detected hazardous conditions, in order to support a real-time traveler information system. VLT recommends node spacing of $1/8$ to $1/4$ of a mile to enhance driver exposure and to provide a robust wireless communication network in various conditions, but can be extended to 1 mile or greater based upon line of site from one node to the next, geographic and man-made obstacles, or through the use of repeater nodes. Drivers can expect to see this forewarning in the form of a small, mounted box placed at sub-mile intervals that will deliver a high-powered, color-coded light depending on the specific hazard.

Figure 1: ADAS Overview

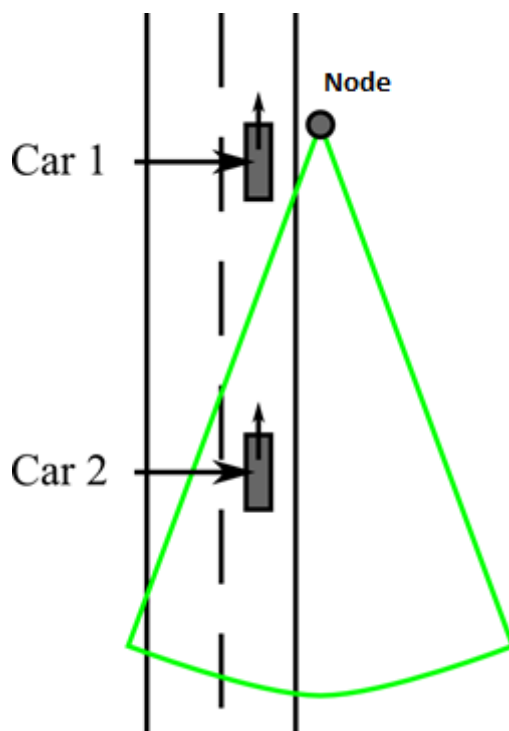
Two methods were used to sample the traffic radar data. The first was a moving average filter, and the second was a moving average filter which ignores any zero speed measurements from the radar [2]. The moving average filter is produced by keeping some finite number of speed data points, $\{x_1, x_2, \dots, x_N\}$, measured from the radar. N is the number of data points. This set of data may be referred to as a window. As a new speed data point is measured, it replaces the oldest data point in the list of overall points. Thus, the total number of data points in the filter remains constant. This action may be referred to as the window sliding forward in time. Fig. 2 shows an example data set where two cars have recently passed by the radar unit during some 60 second time span or window. Fig. 3 shows a spatial representation of what occurred to produce the data shown in Fig. 2.

Figure 2: Node data collection

The second method or Moving Speed is similar to the first, but ignores any zero radar speed measurements. In Fig. 2, there are multiple data points which have zero value in the spaces between where Car 1 and Car 2 passed within the range of the radar system. If an average value for the speed of moving vehicles is desired, these zeroes need to be removed because they do not truly represent vehicles travelling at zero speed on the road. These zeroes only represent the absence of moving vehicles on the road. Moving Speed S_m is calculated by the following formula:

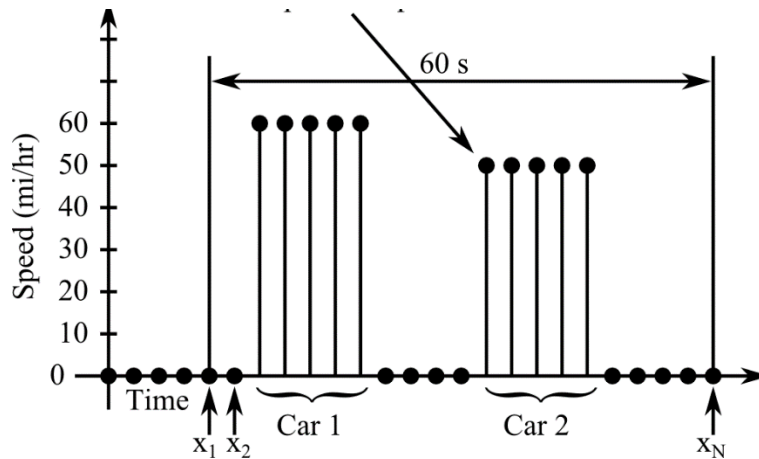
Figure 3: Speed data collection example

The first method which takes the average of all of these stored data points, even zero entries, is named Average Speed. The Average Speed is the conventional output of a moving average filter, namely the average or mean of all data points in the window. The equation to produce Average Speed S_{avg} is as follows:

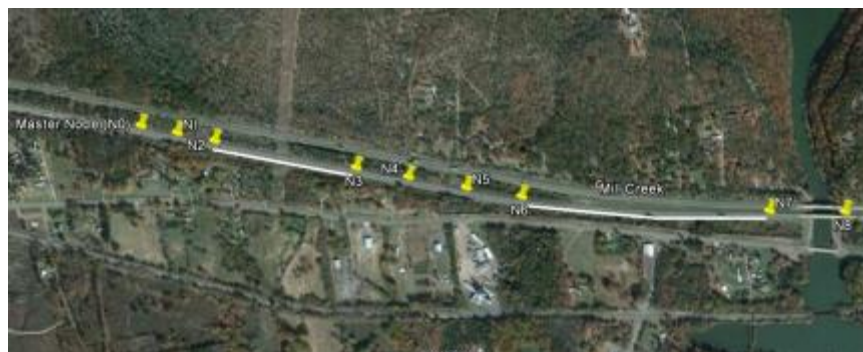
AHTD and VLT selected the same testing location as ADAS version 1 for consistency and since version 2 was required to be installed behind guardrails, as seen in Figure 8. The central data hub was placed out of the clear zone 1.53 miles from the I-40 eastbound entrance ramp, Exit 74. There is a notable spacing increase between nodes 2 and 3 (0.24 miles) and nodes 6 and 7 (0.41 miles).

Figure 8: ADAS Version 2 Location
