ARKANSAS STATE HIGHWAY DEPARTMENT
PLANNING AND RESEARCH DIVISION
IN COOPERATION WITH
U.S. DEPARTMENT OF COMMERCE
BUREAU OF PUBLIC ROADS

RESEARCH PROJECT 10

THE STUDY OF PAVEMENT BLOWUPS

JANUARY 1966

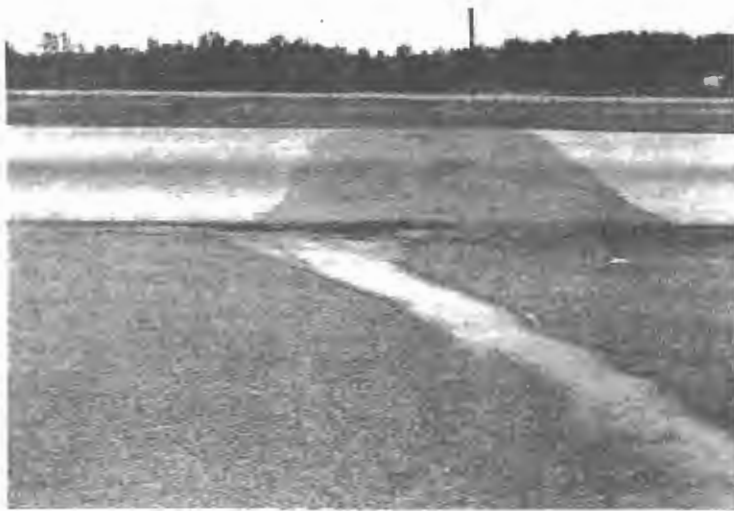
FIGURE 1

ROUTE 70 - SECTION 11 - SBL

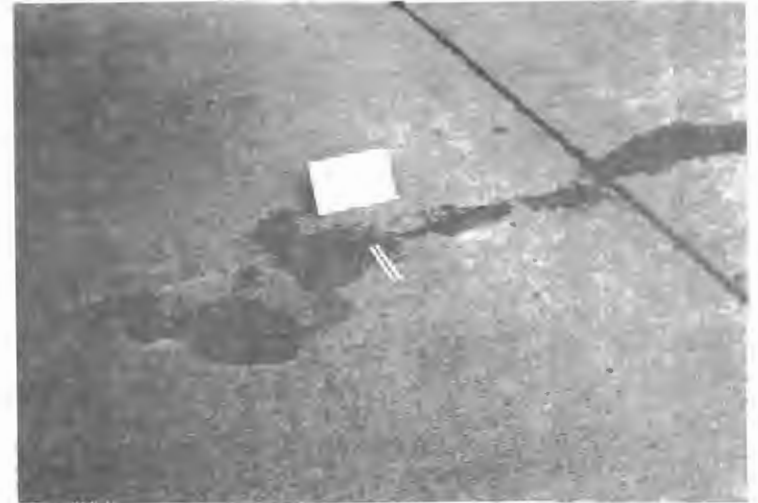
FIGURE 2

The type spalling discussed in the foregoing is relatively isolated, in that this could be attributed to joint placement. This type of deep spalling is associated with the corrugated metal joint, as it was vibrated into the pavement after it was poured. This vibration caused a highly differential stress in the continuity of the 25-foot slab. Trouble spots were located by the aid of a Swiss compression hammer; the pavement was profiled across the joints for soundness of the pavement. The results of such a profile are shown in Figure III, page 16. From observing the figure: The stress is about equal at each joint where the corrugated metal joint was vibrated into the pavement, whereas a decrease is shown at the center of the slab. The centerline in Figure 2, page 14, was a sawed joint; no spalling is evident along this centerline.

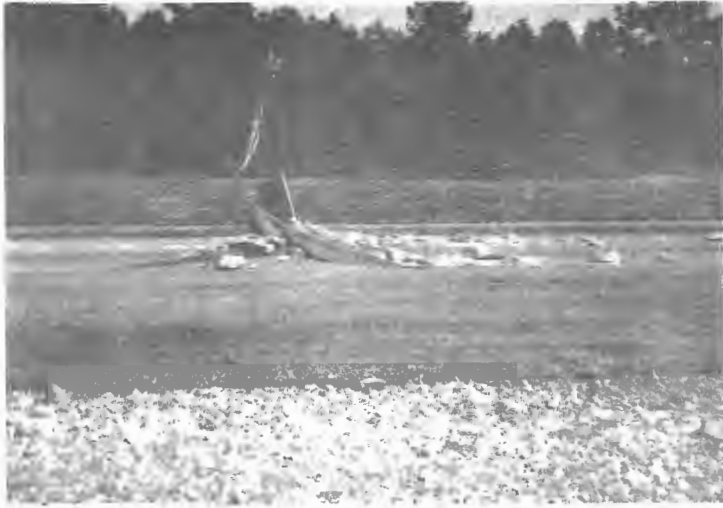
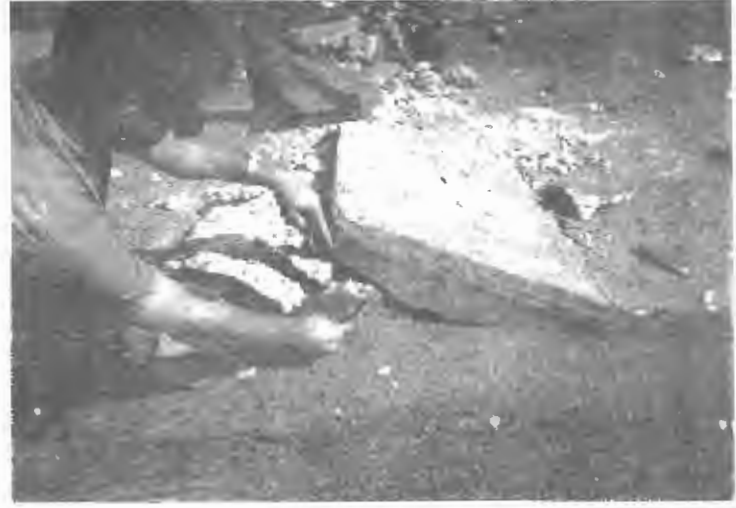
ROUTE 70 - SECTION 11 - SBL

The pictures on pages 17 and 18 were made at a typical blowup site. On page 17, the typical four-inch portion can be seen in the raised position in figures 1 and 2. The blowup occurred on the entire width of the 24-foot pavement, and again the four inches of raised slab can be seen in figure 4 on page 17. The piece of concrete in figure 3, page 17, was hurled 95 feet from the joint at which the blowup occurred. This joint had no dowels; however, the wire reinforcement that was used

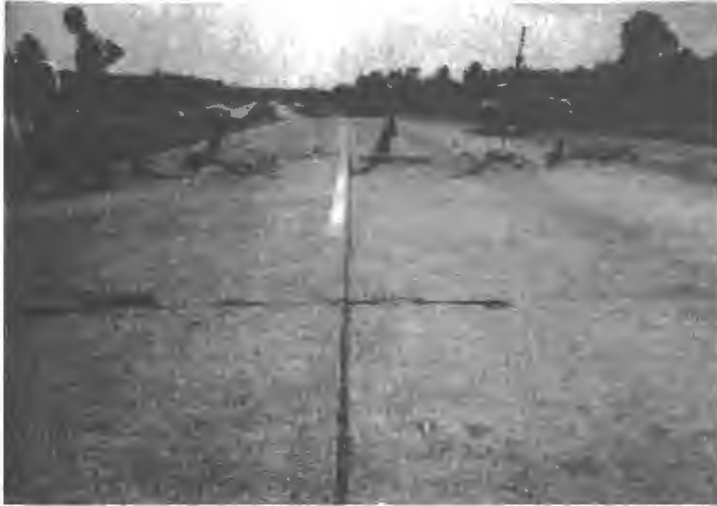
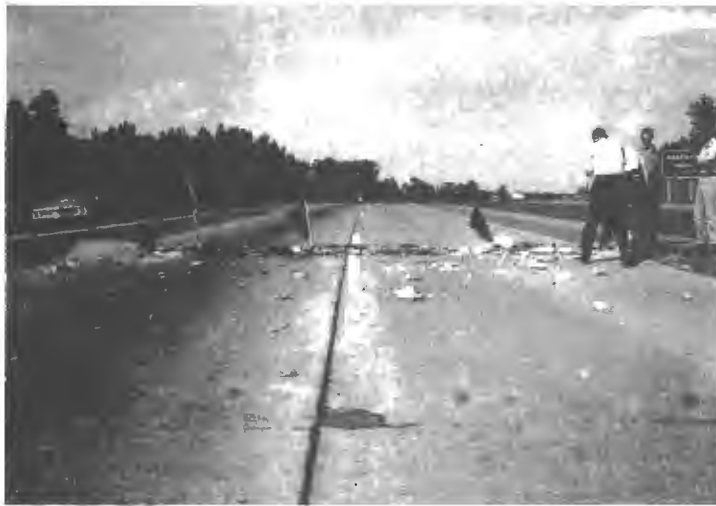
ROUTE 70 - SECTION 11 - SBL

failed in tension. In checking back with the laboratory, it was found that in testing this wire, it usually fails at about 90,000 p.s.i. Using this and the 95 feet that the piece of concrete was hurled indicates a tremendous force, very instantaneous. This joint was of the corrugated metal type.

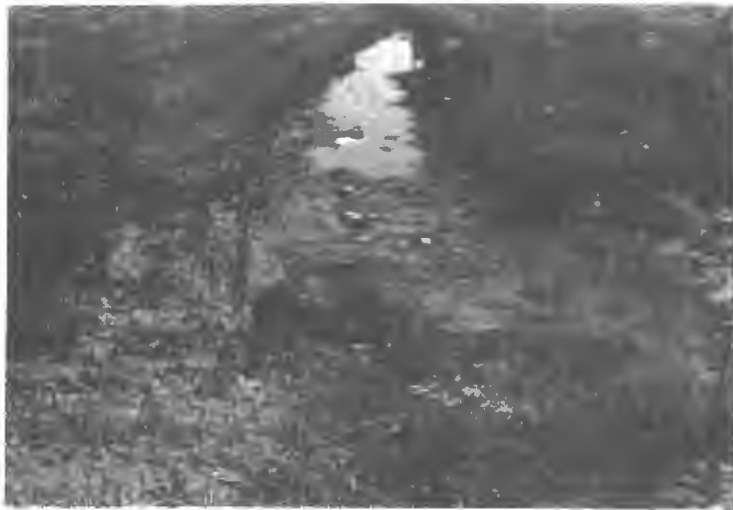
FIGURE 1.

Figures 1 and 2, page 20, illustrate poor drainage of the subgrade material in a blowup-prone pavement. These photos were made during a drought period. The water grass seen in the ditches illustrates a moderately impermeable subgrade material. A high water table is very characteristic of this area.

POOR DRAINAGE EXISTENCE
