TRC1404

**Evaluating Performance of  
Asphalt Pavement  
Based on Data Collected During IRP**

Final Report

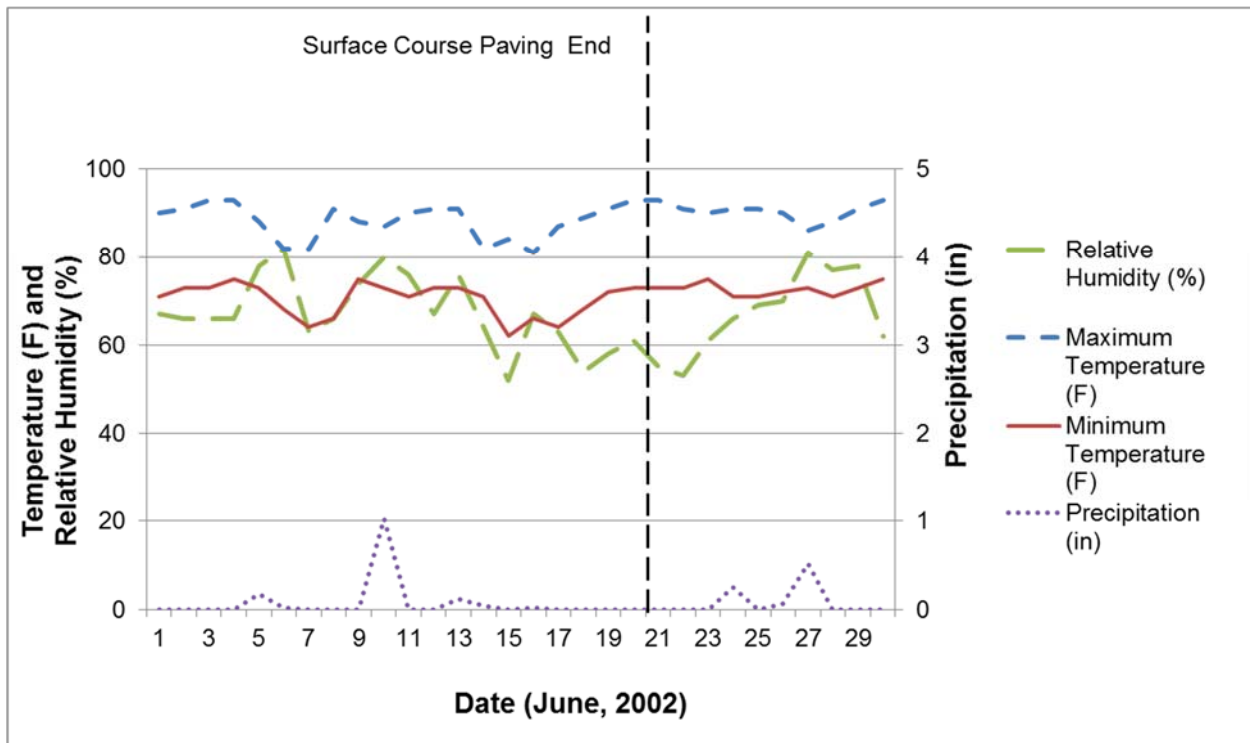
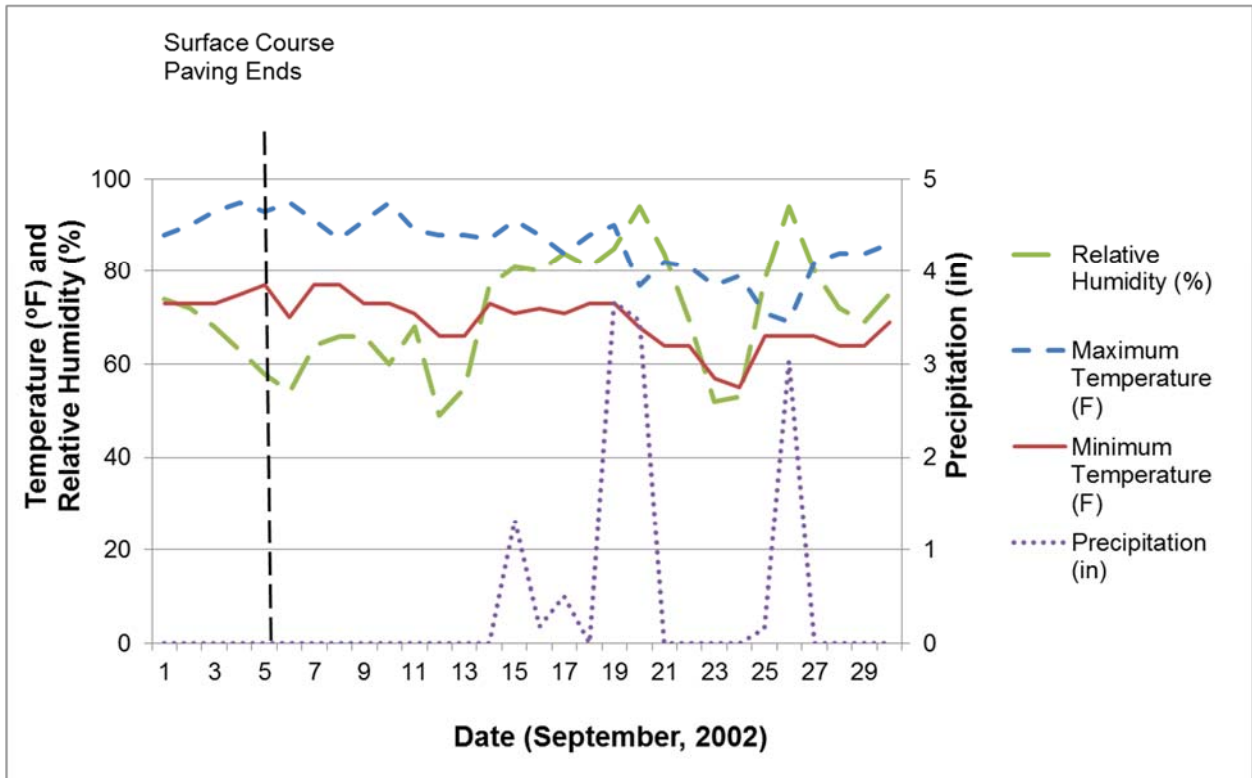
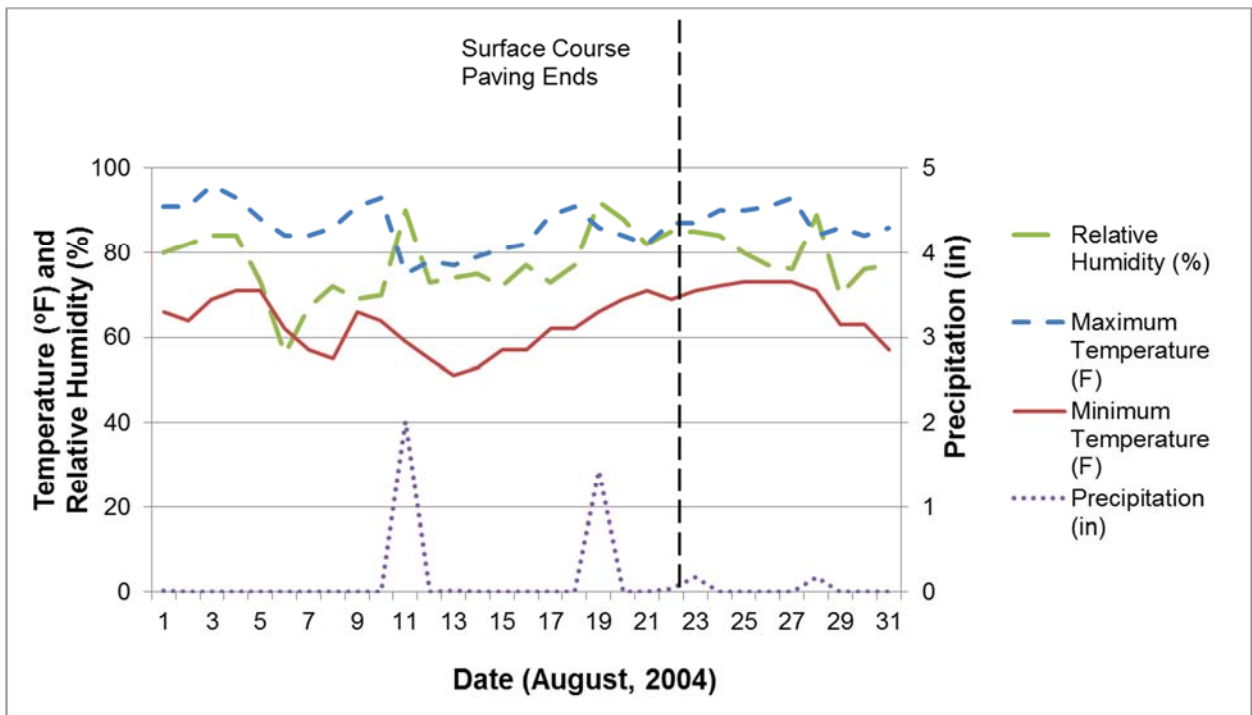
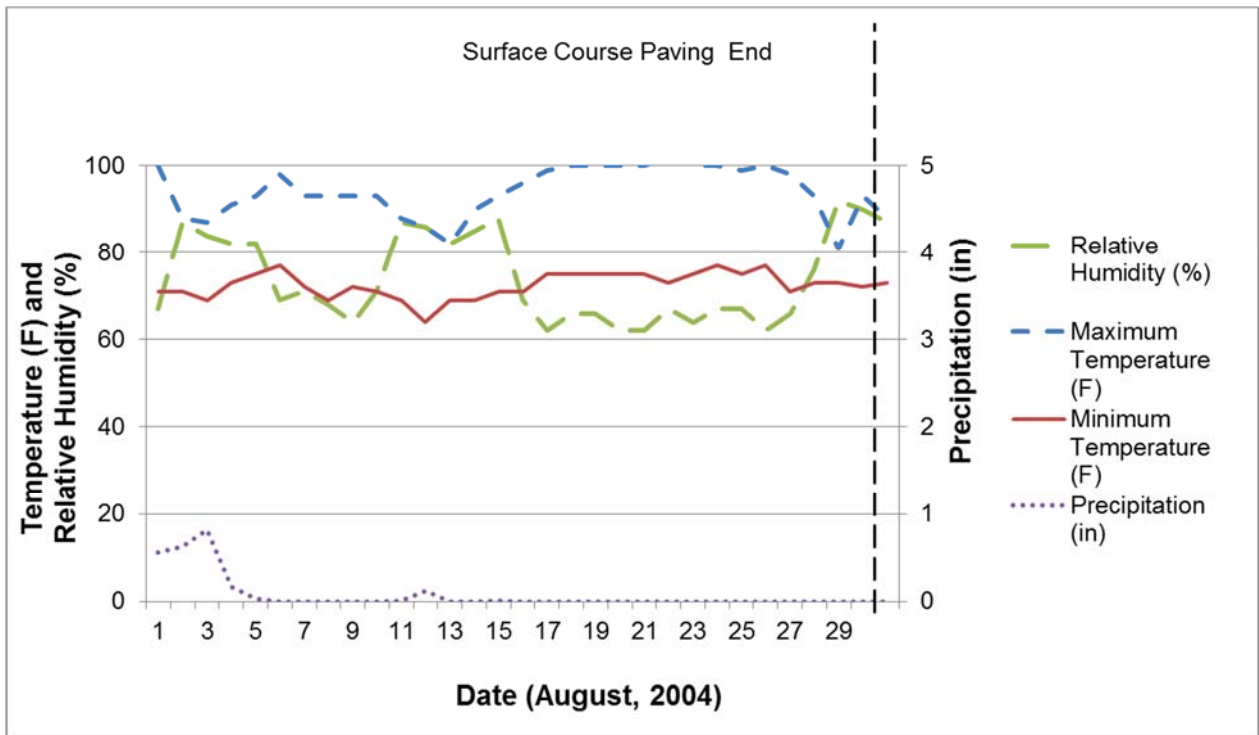
Figure 3.1 – Weather Summary at End of Surface Course Paving (B10102, Section G4)

Figure 3.2 – Weather Summary at End of Surface Course Paving (B10103, Section M1)

Figure 3.3 – Weather Summary at End of Surface Course Paving (BX0103, Section M2)

Figure 3.4 – Weather Summary at End of Surface Course Paving (B40102, Section P1)

Figure 3.5 – Weather Summary at End of Surface Course Paving (B80108, Section P2)

Figure 3.6 – Weather Summary at End of Surface Course Paving (B80105, Section P3)

While there are some potential issues with the weather around paving, for example, there was significant rain immediately after the surface course paving ended in Section P3, there was no clear relationship between relative humidity, maximum temperature, minimum temperature, or precipitation and pavement performance. While it is unfortunate that no relationship was found between weather and performance, it is still important to investigate as many avenues as possible for a complete research effort.

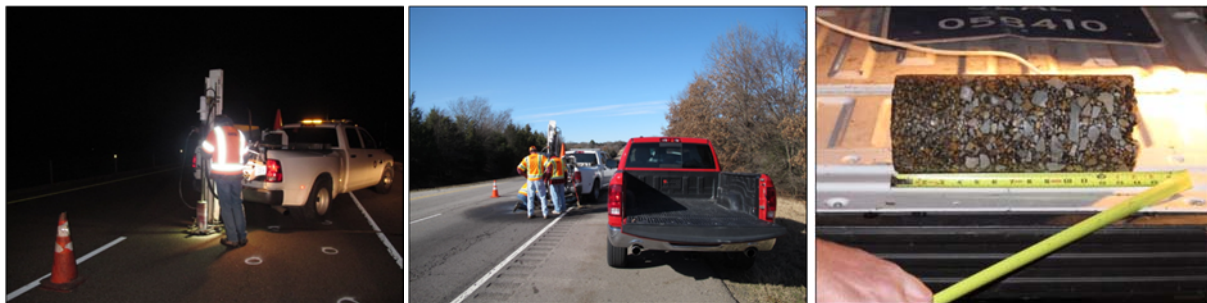
Figure 3.17 – Collecting Samples in the Field

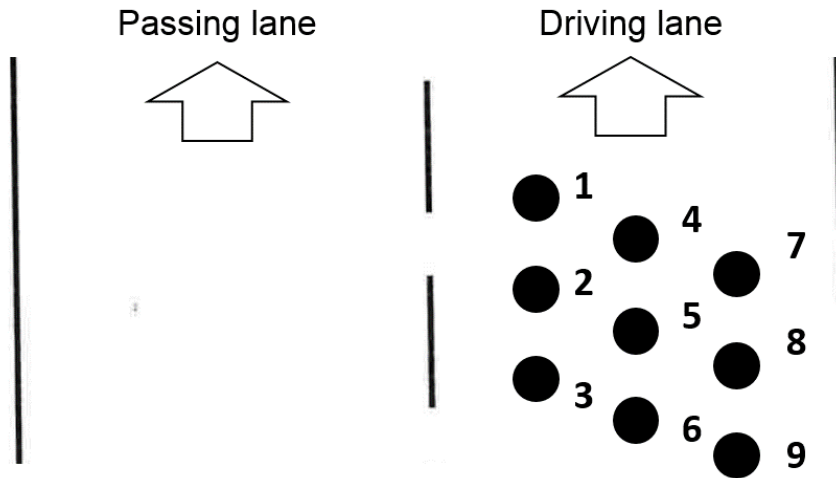
Coring operations were consistent in the field, with three sets of nine cores collected. Within each set of nine, six cores were taken from the wheel path and three from between the wheel path. Figure 3.18 diagrams the standard coring pattern, which was repeated two more times for a total of three sections across 0.4 miles and twenty-seven cores from each interstate section.

Figure 3.18 – Collecting Pattern for each Interstate Section

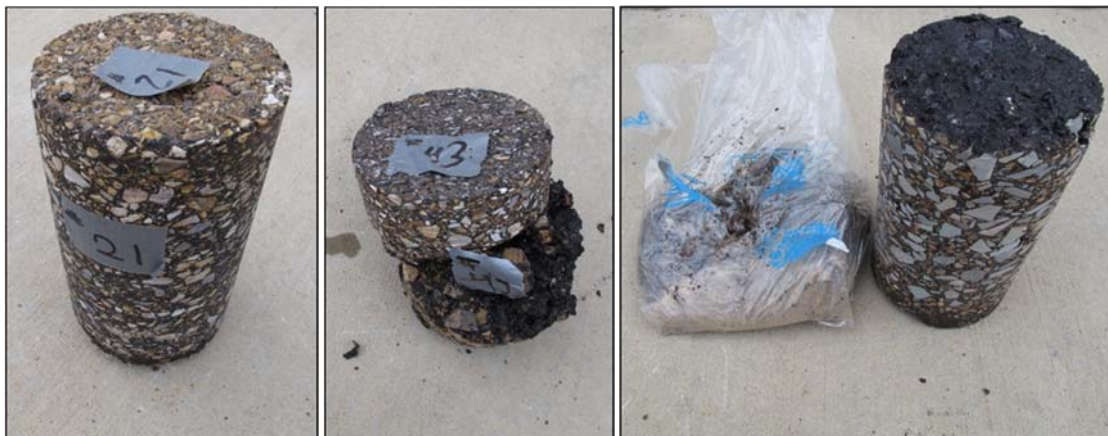
Figure 3.19 – Various Conditions of Cores on Arrival at Lab

Once the samples were collected, they were brought back to the lab at the University of Arkansas for full processing. Each core was labeled and placed into a spreadsheet to determine which laboratory tests would be performed. Because of the wide range of conditions of the cores (Figure 3.19), the research team was not able to consistently test either within wheel-path or between wheel-path samples. This is unfortunate, as behavior may change depending on whether the material was under traffic or between wheels. However, this was another function of working with field sites and field samples.

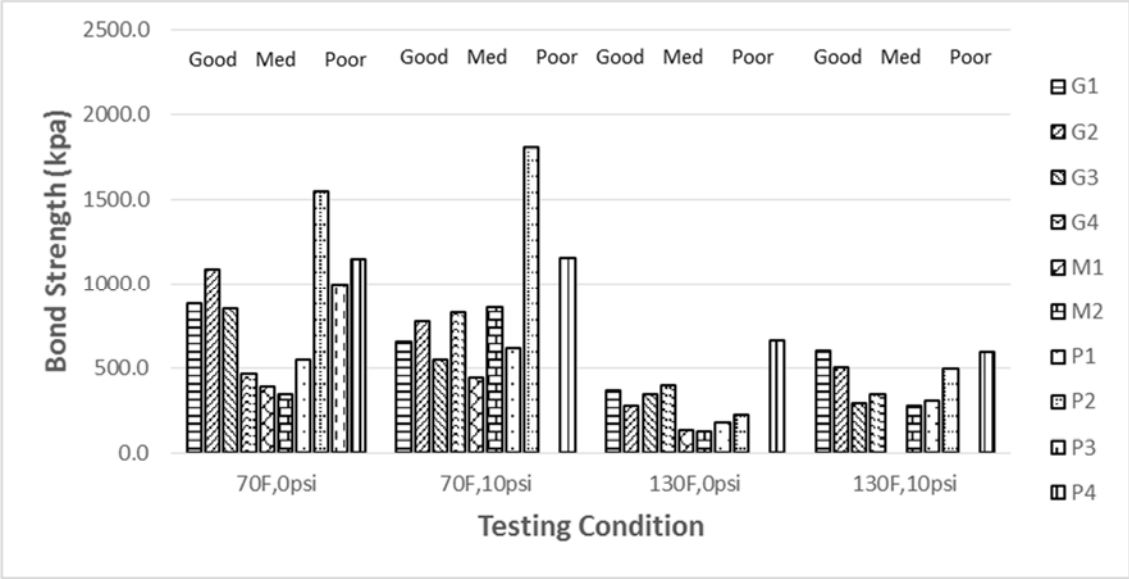
Figure 4.1a – Bond Strength Between S2 and S1

Figure 4.1b – Bond Strength Between S1 and B2

The bond strength test was run at two temperatures and two pressures, on the interface between both S2 and S1 (the two surface courses) and S1 and B2 (the bottom surface course and the top binder course). Figures 4.1a and 4.1b show the bond strength values. In these figures, it was apparent that higher test temperatures and lower confining pressures produced lower bond strength values. In addition, there did not seem to be a significant difference between the bond strength values at the two different pavement depths. A disadvantage of this test, however, is it can only be run on intact cores. Many of the poor sections arrived in the lab already debonded, as the layers were either debonded before coring or the coring process sheared the layers apart in the field during sampling. Therefore, Figure 4.2 shows the percentage of debonded cores upon arrival. A significantly higher number of the poor cores were debonded upon arrival, as were a decent number of medium sections, indicating that the good sections were strong in the field. In addition, more samples were debonded between the two surface layers versus the bottom surface and binder course.

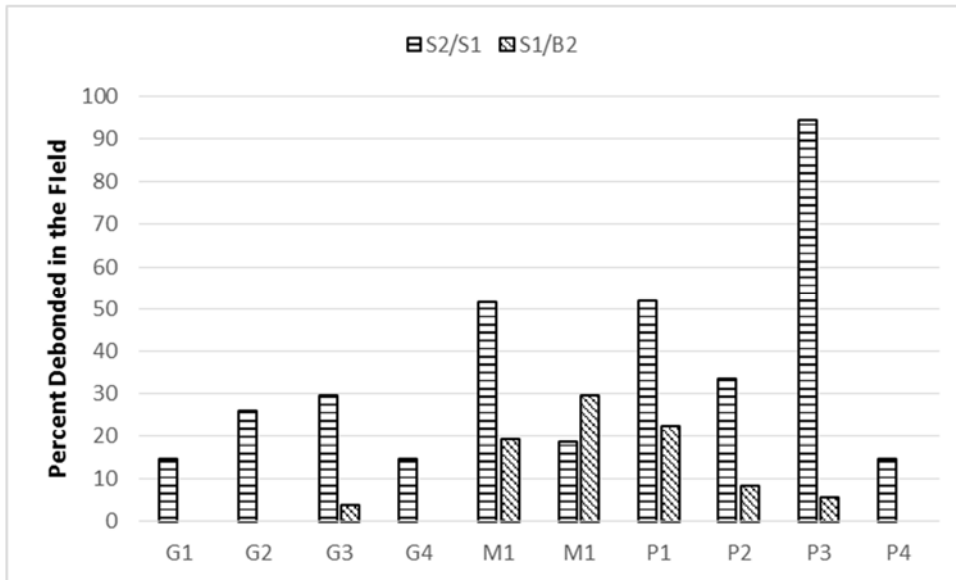
Figure 4.2 – Percentage of Samples Debonded on Arrival to Lab

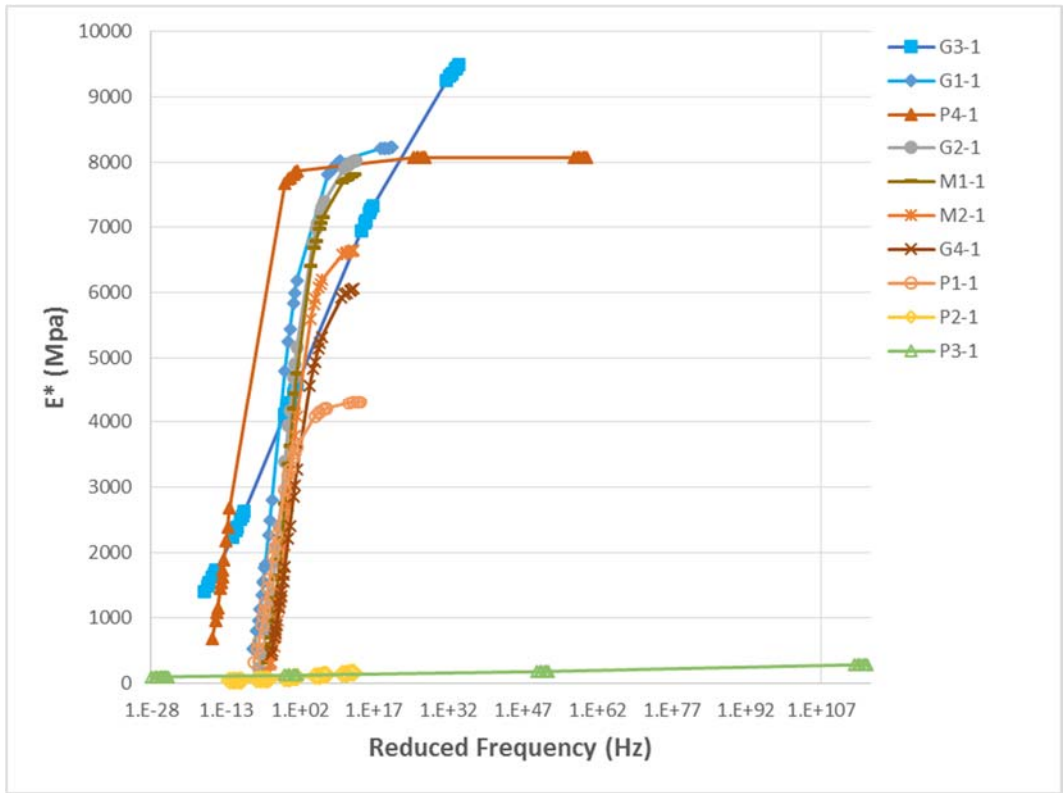
Figure 4.3a – IDT Dynamic Modulus Master Curve for S2 (top surface)

Figure 4.3b – IDT Dynamic Modulus Master Curve for S1 (bottom surface)

In general, the good sections had the highest IDT dynamic modulus, while the poor sections had lowest modulus, with medium sections also showing poor stiffness. However, there were several exceptions. For example, the poor section P4's modulus at low temperature or high frequencies was in-between a good section and medium section, for both surface courses. Also, the good section G4 had a lower modulus than the medium sections but higher than poor sections in top surface course S2. Although there were some exceptions, the dynamic modulus was able to predict higher values for the better sections (a stiffer, more cohesive material) and lower values for the poorer sections (a softer, less cohesive material). Figure 4.3a shows the dynamic modulus curves for the S2 (top surface) and Figure 4.3b shows the dynamic modulus curves for the S1 (bottom surface).

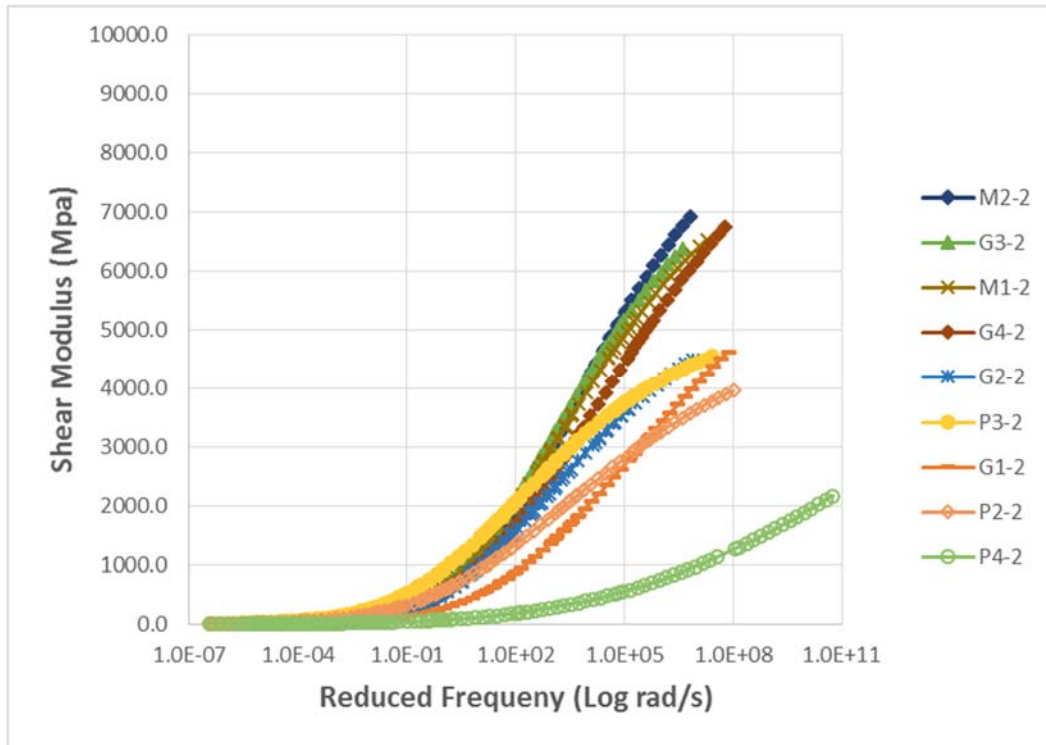
Figure 4.4a – Torsion Bar Dynamic Modulus Master Curve for S2 (top surface)

Figure 4.4b – Torsion Dynamic Modulus Master Curve for S1 (bottom surface)

In addition to the IDT dynamic modulus, torsion bar dynamic modulus tests were run. The advantage to the torsion bar dynamic modulus is that up to 15 torsion bar samples can be extracted from the typical size of an IDT dynamic modulus sample. Eight testing temperatures (-10, 0, 10, 20, 30, 40, 50, and 60°C) were used, with frequencies from 100rad/s to 0.03 rad/s at each temperature. The geometry of the sample was 50×12.5×6.5mm. The trends for the torsion bar were similar to the IDT dynamic modulus, with the majority of good samples having higher stiffness than the poor sections, but like the IDT configurations, there were some exceptions. From this data, it appears that the torsion bar dynamic modulus can be used as a substitute for the IDT dynamic modulus, creating significant savings in field extraction of samples. Figure 4.4a shows the dynamic modulus curves for the S2 (top surface) and Figure 4.4b shows the dynamic modulus curves for the S1 (bottom surface).

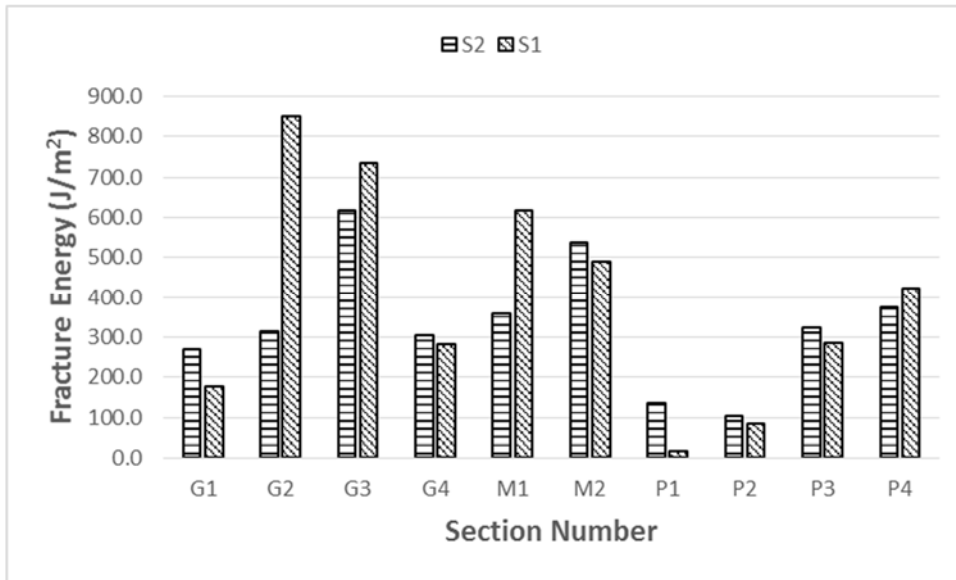
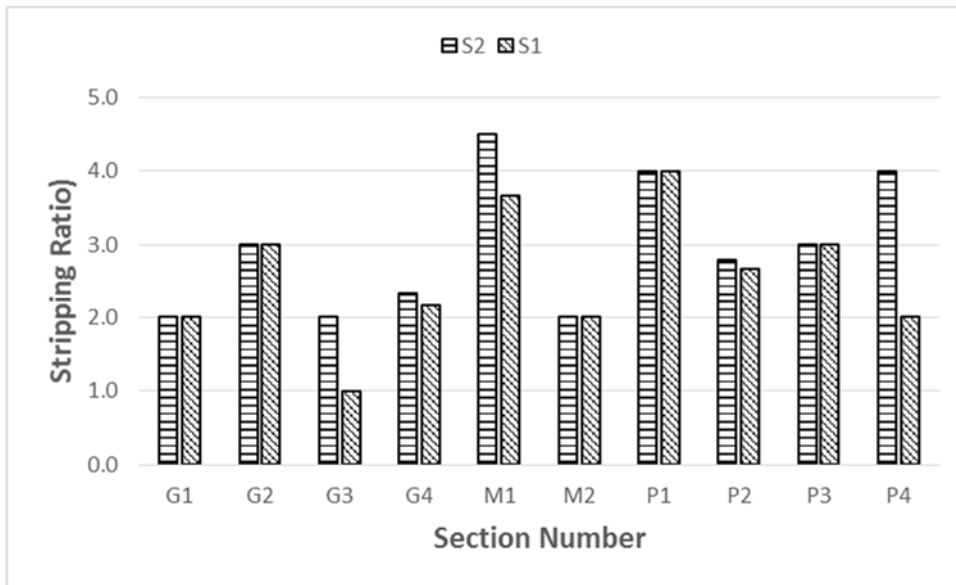
Figure 4.5 – Fracture Energy for Surface S2 and S1

Figure 4.6 – Stripping Ratio for Surface S2 and S1

Fracture energy can be an indication of how easily cracks can form. The SC(B) fracture test clearly showed that the good sections had higher fracture energy versus the poor sections. A zero fracture energy indicates that the peak load did not reach the minimum requirement (0.5 kN) before the crack propagated through the entire sample. Figure 4.5 shows the fracture energy for each section and pavement layer. In addition to the calculating the fracture energy, a stripping ratio was calculated based on the face created by the crack. The stripping ratio was based on a one to five number, with one exhibiting no stripping and five exhibiting significant stripping. The stripping ratio in AASHTO T273 was used as a guide. Figure 4.6 shows the stripping ratios for each section and layer, and indicates that there was no clear correlation between good performance and the stripping of the asphalt binder off the aggregate.

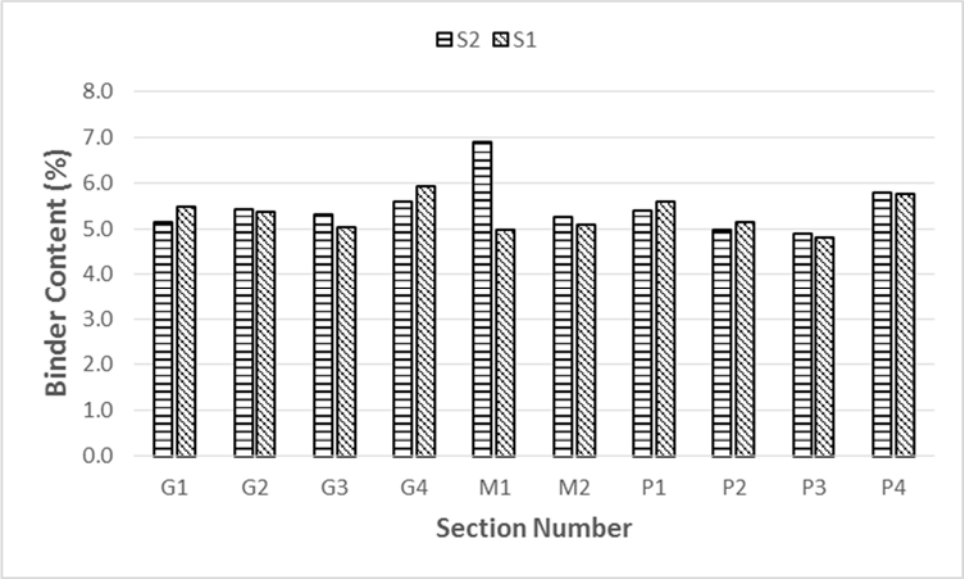
Figure 4.7 – Ignition Oven Binder Content for S2 and S1

The ignition oven tests, run according to AASHTO T308, did not show any clear trends between binder content and pavement performance, as seen in Figure 4.7.

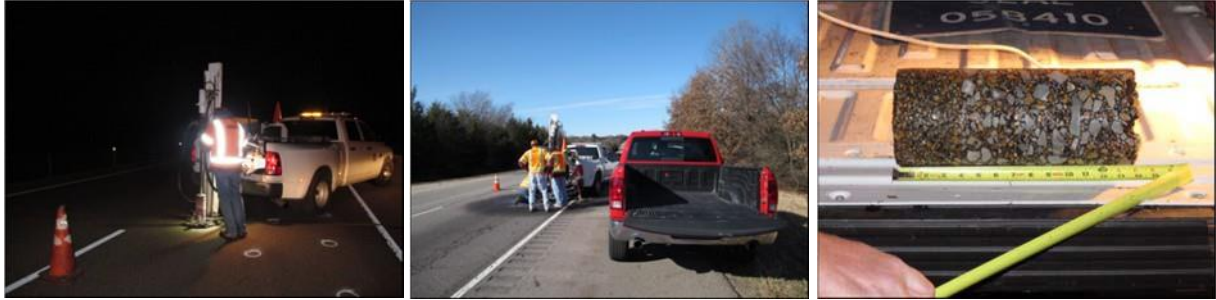
Figure 2 – Coring operations

Twenty seven cores were taken from each of the ten sections as part of the forensic investigation. Collection of the cores was performed by AHTD's Materials Division. Coring operations are shown in Figure 2.

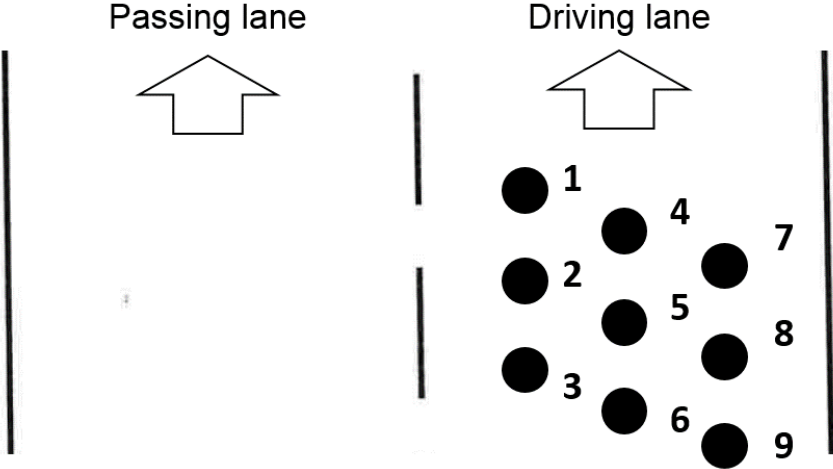
Figure 3 – Standard coring pattern (arrows indicate direction of traffic)

Coring operations were consistent in the field, with three sets of nine cores collected from each section. Within each set of nine, six cores were taken within the right and left wheel paths and three from cores were taken from between the wheel paths. Figure 3 illustrates the standard coring pattern. This coring pattern was repeated a total of three times for each 0.2-mile section; with 27 cores recovered for each section. Table 1 provides a summary of the ten sections.

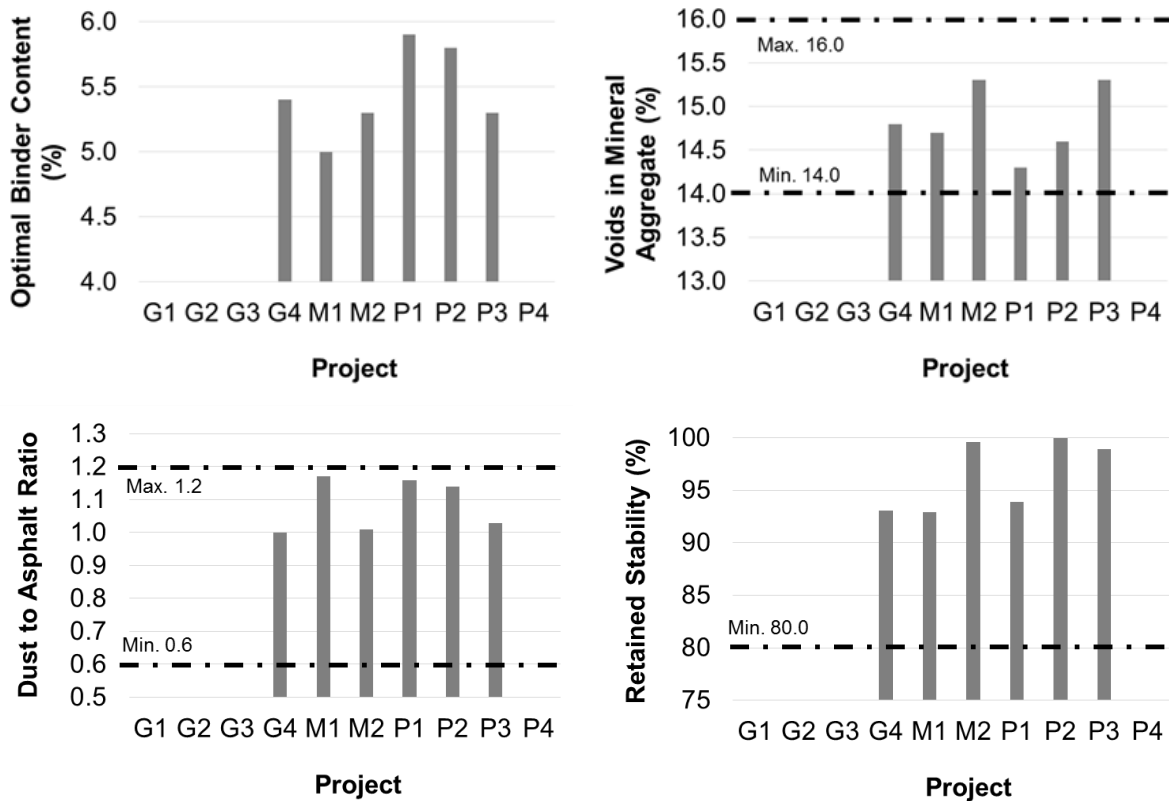
Figure 5 – Summary of laboratory mix design properties

These exceptions could have been due to specification changes since construction. The ten sections were constructed utilizing either the 1993 or 2003 specifications. While there is no specification for asphalt content, the levels seemed in line with expectations compared to successfully performing interstate sections and no particular grouping of sections was different than the others. AHTD specifications require the VMA to fall between 14% - 16% for 12.5mm NMAS surface mixtures. The dust to asphalt ratio has minimum and maximum limits of 0.6 and 1.2, respectively. The retained stability is required to be greater than 80%. As seen in Figure 5, all of the specifications were met for the available data.

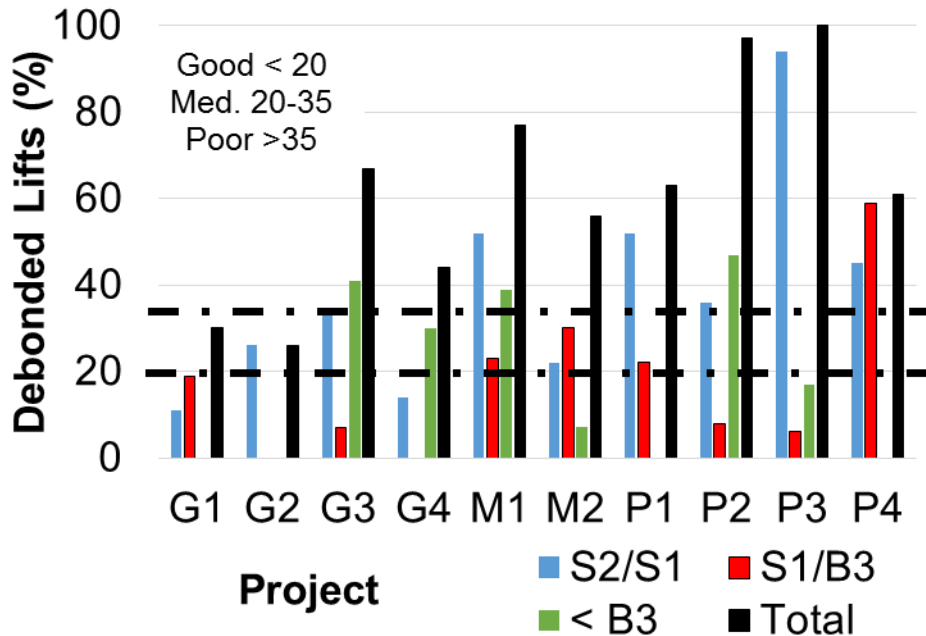
Figure 7 – Percentage of debonded lifts on arrival at lab

Based on visual inspection and data in Figures 6 and 7, it was estimated that good performing sites had less than 20% debonded lifts upon arrival, medium (or fair) sites had 20-35%, and poor sites had more than 35% debonded lifts. Figures 7a and 7b summarize the percent of debonded lifts.

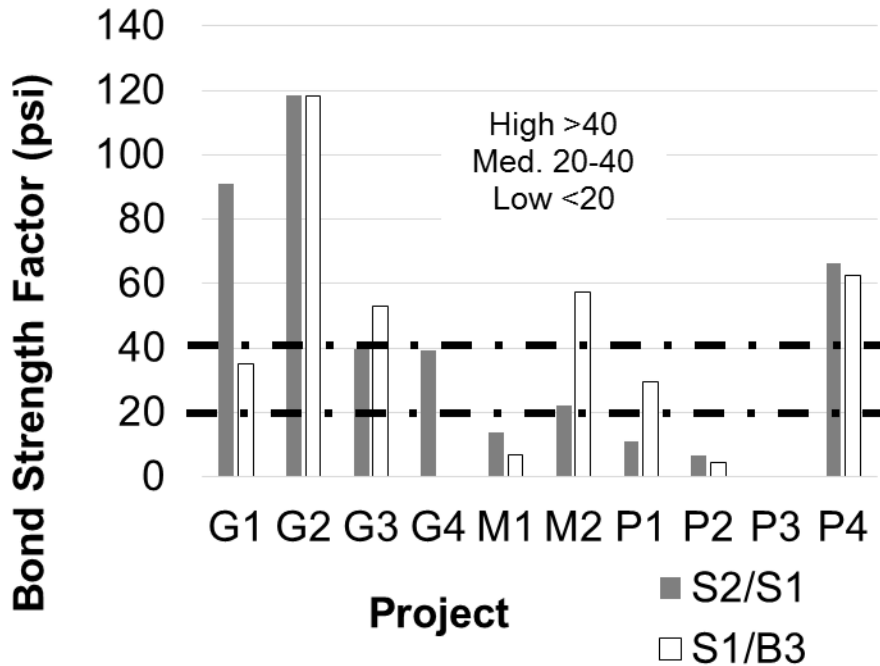
Figure 8 – Bond strength factor

This bond strength factor accounts for both the bond strength itself, and the number of cores that arrive in the lab that were still bonded together. Figure 8 shows the bond strength factor and potential specification limits for performance measures based on the ten sections analyzed.

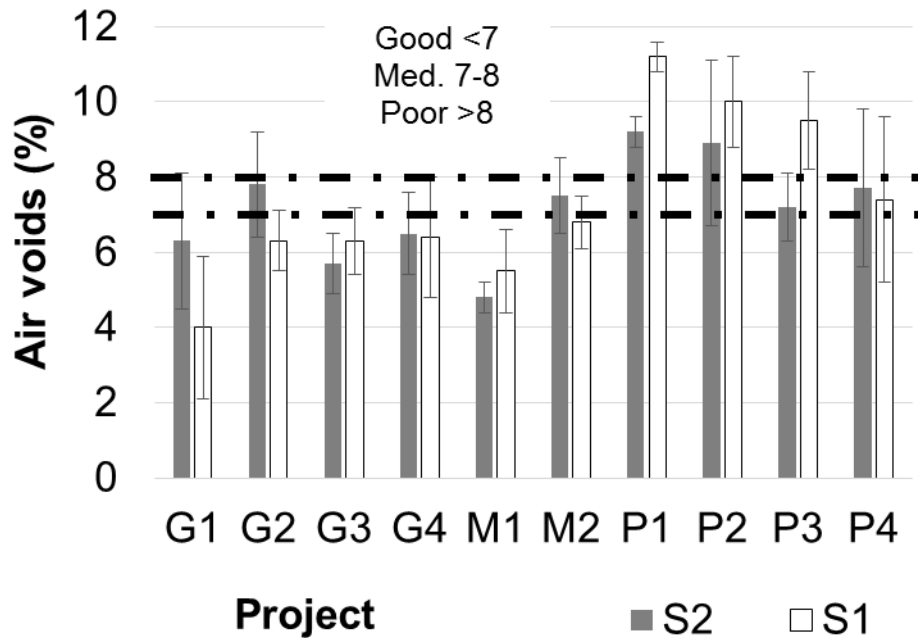
Figure 9 – Surface course air voids

After performing the bond strength test, the bulk specific gravity of the mixture ( $G_{mb}$ ) was determined for each lift of each core per AASHTO T166. The air voids were determined per AASHTO T209; and were expected to be near the laboratory mix design air voids of 4.0% after approximately 9-12 years of interstate traffic. Figure 9 shows the average air voids for each project, along with proposed criteria for performance measures based on the ten sections analyzed.

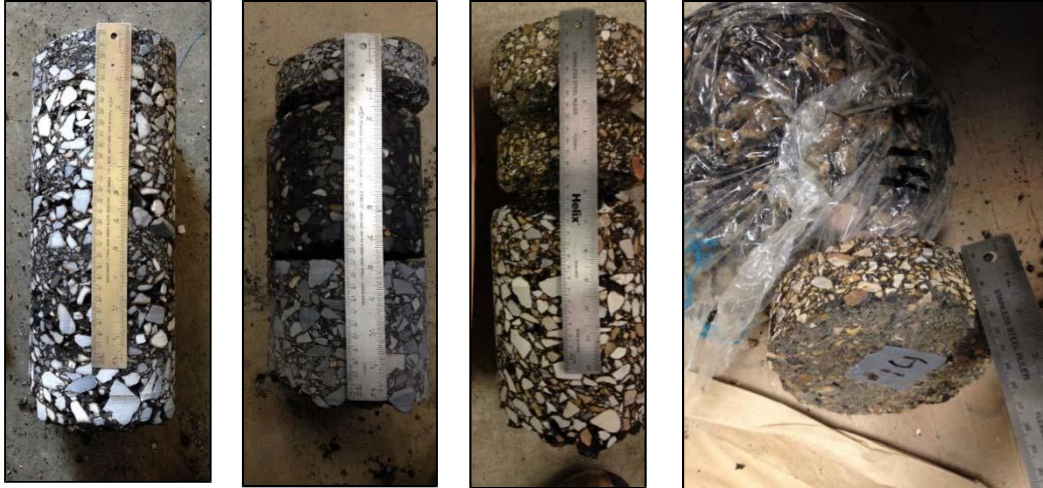
Figure 10 – Core degradation, Left to right: good, medium, severe, very severe (rubble in bag)

In Figure 10, as moisture damage increased, the top and bottom of each lift deteriorated at the edges, forming a distinct hour glass shape. This shape was quantified with a good rating equaling one for those cores that had smooth sides and were intact, a medium rating equaling two for those cores that were separated and / or had an hourglass shape forming, and a poor rating equaling three for those cores that had a severe or very severe formed hourglass shape and/or substantial loose material. With these criteria, the core degradation was quantified. The results are shown in Figures 11, along with potential criteria for performance measures based on the ten sections analyzed. The quantification of the core degradation is a new metric designed to evaluate the condition of cores visually based on moisture damage after extraction from the field.

identified by the formation of an hourglass shape in the core on each lift. This shape indicates the beginning of deterioration at the lift interfaces, which is associated with moisture damage. Figure 10 shows examples of four levels of core degradation.

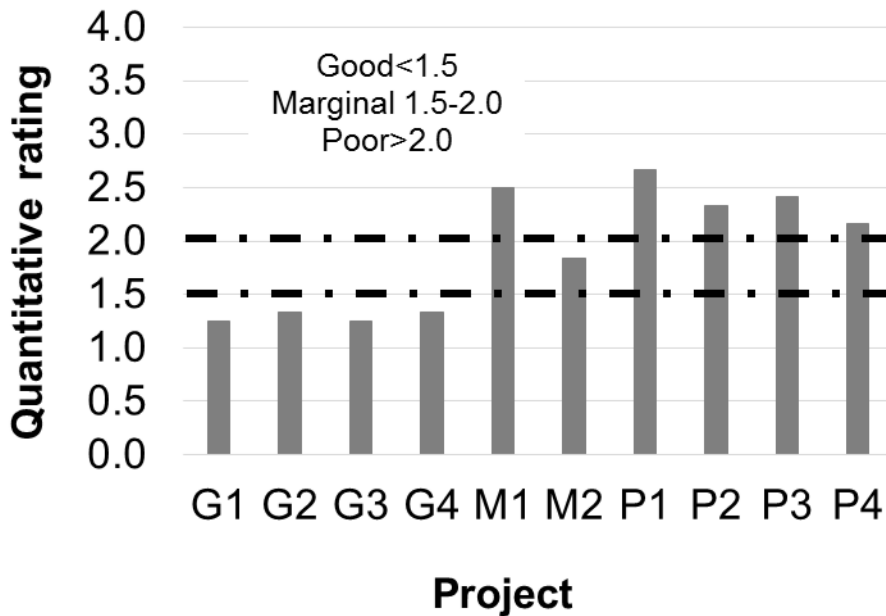
Figure 13 – Final ratings of ten sections over three properties

bond strength factor), in-place air voids, and moisture damage (core degradation and stripping rating) be examined together. By assigning a quantitative rating of one, two, and three for good, marginal, and poor, respectively, a direct comparison was made among the ten sections as shown in Figure 13.
