COLD RECYCLING OF ASPHALT PAVEMENTS

Interim Report
Transportation Research Project No. 90

Alan Meadors
Materials and Research Division
Arkansas State Highway and Transportation Department

March 1987

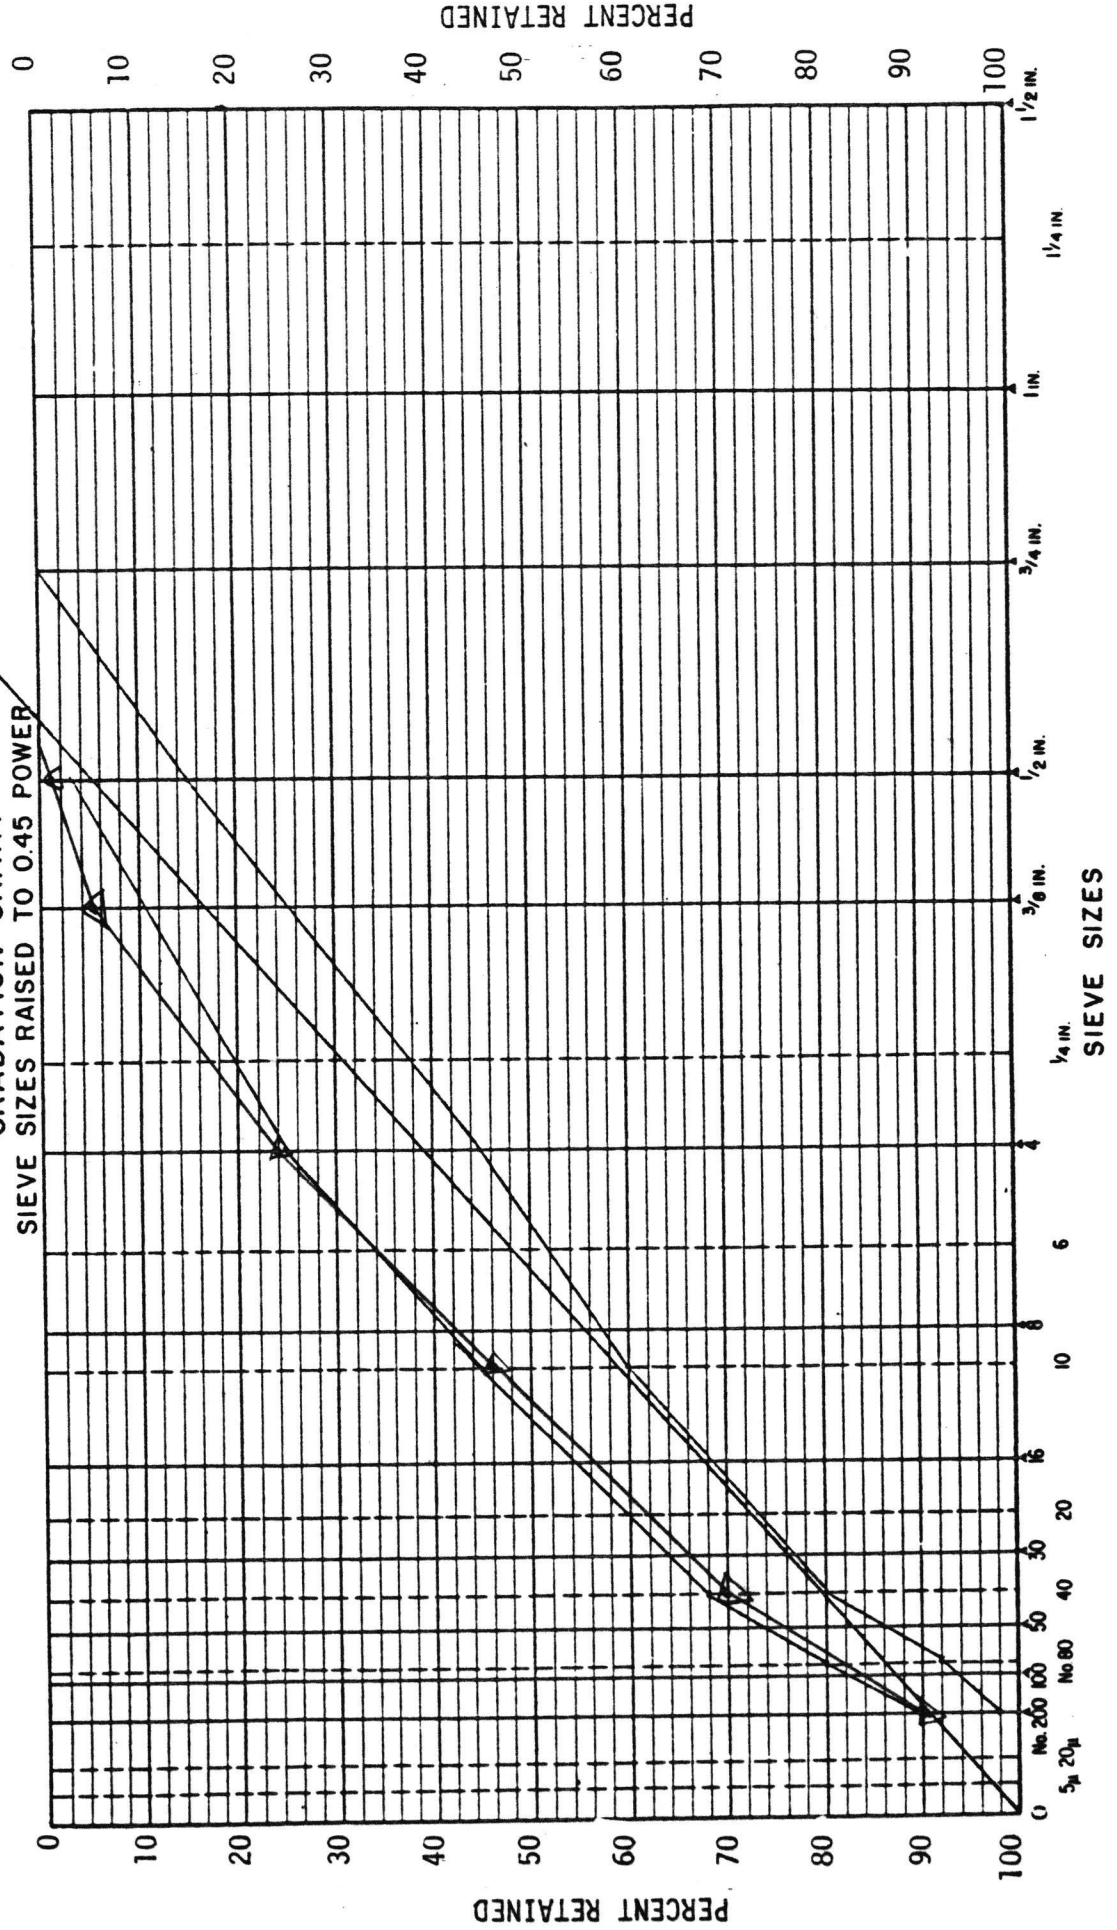
Figure 2

Samples of the stockpile were secured and taken to the central laboratory for analysis. The samples were found to contain less than 1% moisture and approximately 5.7% asphalt content. The gradation analysis of the aggregate showed it to be finer than the AHTD's normal surface course but maintains a fairly uniform gradation distribution. The gradation of the material is shown in Figure 2.

Identification of gradations: \triangle — Gradation of Stockpile
ACHMSC - Type Z 50 BLOW MARSHALL

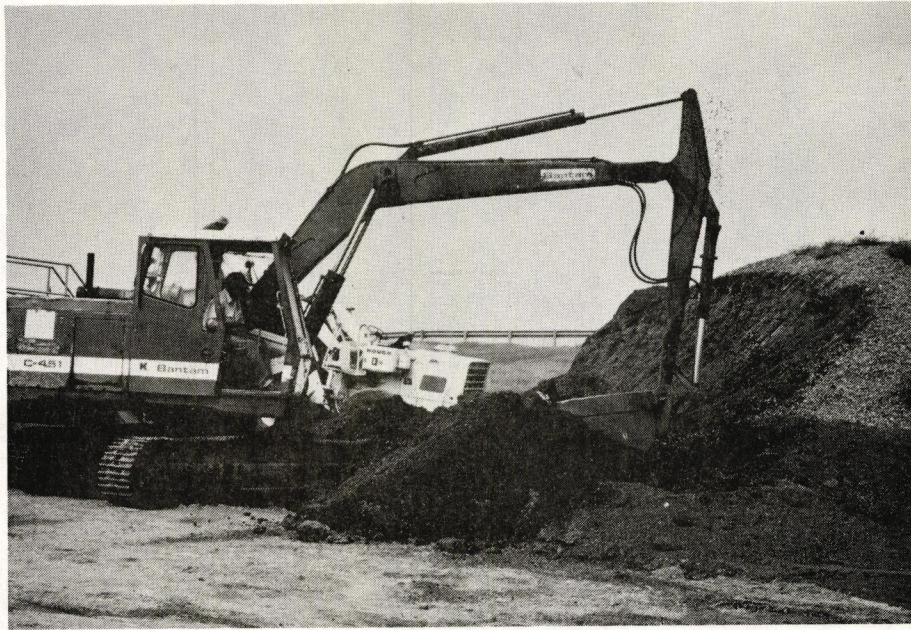
The pavement millings were stockpiled several years ago and had consolidated into one hard mass. The contractor used a track backhoe to shell off the material and a front end loader to charge the hopper.

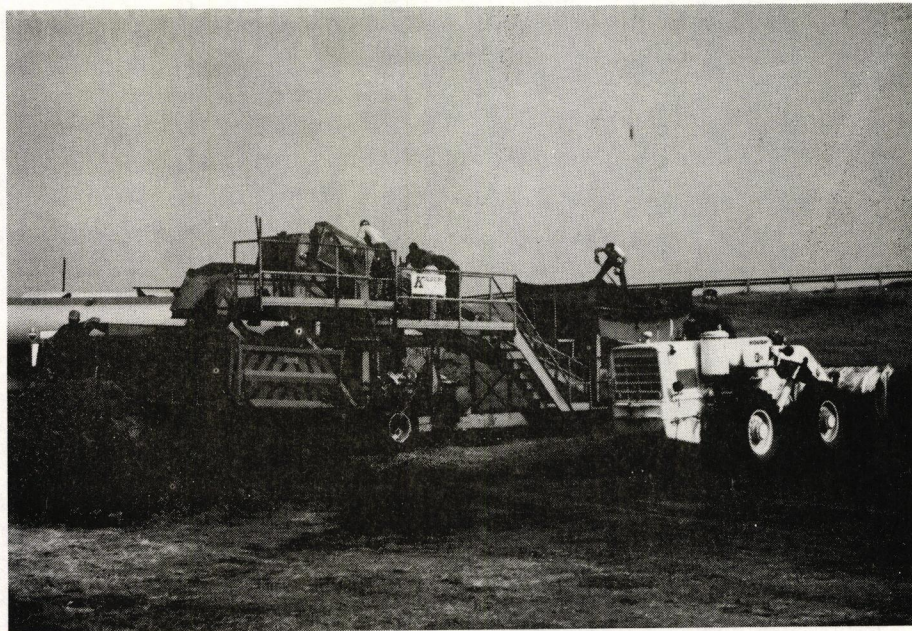
The traveling pugmill was equipped with a charging hopper and rigged to dose water on the mix at the belt and dose emulsion at the entrance of the mix into the pugmill. The tanks in the background contain emulsion and water.

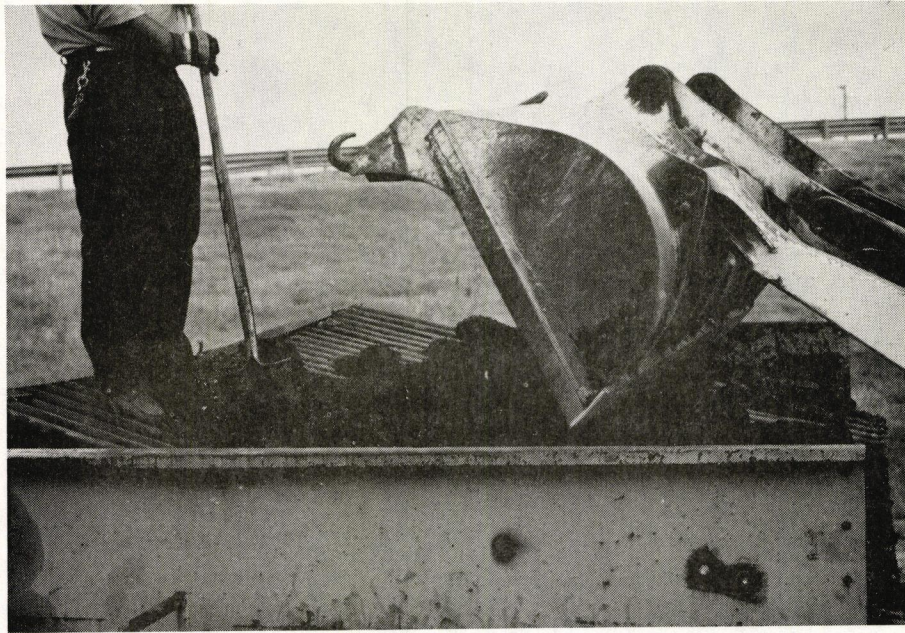
At first large clumps of material hampered charging of the hopper. The contractor increased his efforts to pulverize the material with some success.

The contractor moved his equipment onto the job site on September 9, 1986. The contractor immediately had considerable problems pulverizing the stockpile with a front end loader into small enough particles to pass through a 2 inch scalping screen. The contractor worked on pulverizing the stockpile all day on September 10th. At the end of the second day District maintenance trucks were employed to make some trial batches for calibration purposes. Samples of pulverized millings from the stockpile were tested for moisture and asphalt content. These samples showed that as much as 5% moisture existed in portions of the stockpile while the asphalt content was found to vary between 4.8 and 5.4 percent of the mix. Since the moisture and asphalt content varied widely, it was decided to allow field adjustments outside the specification limits originally prescribed.

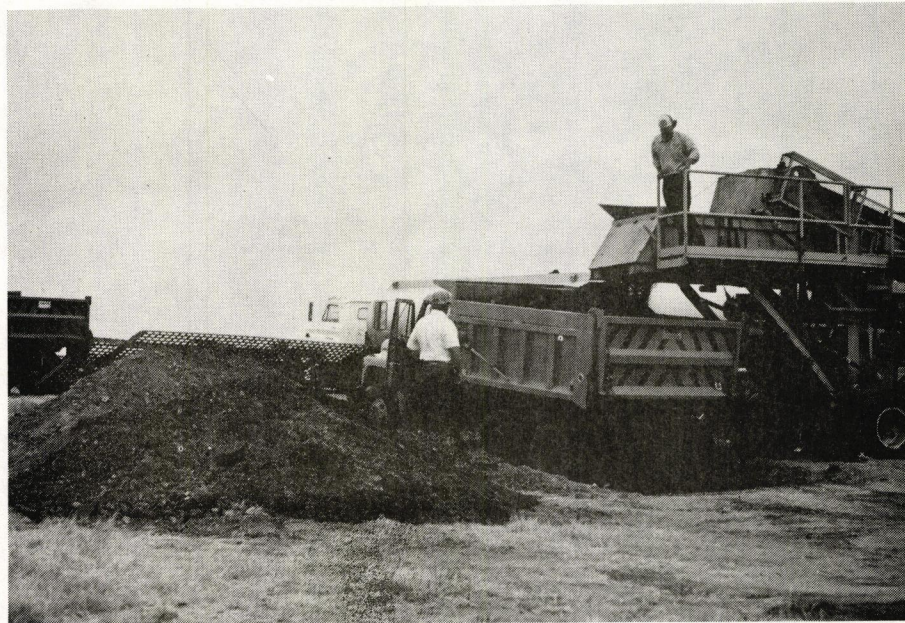
Calibration of the pugmill was accomplished by relating the weight of material through the pugmill with belt speed and time.

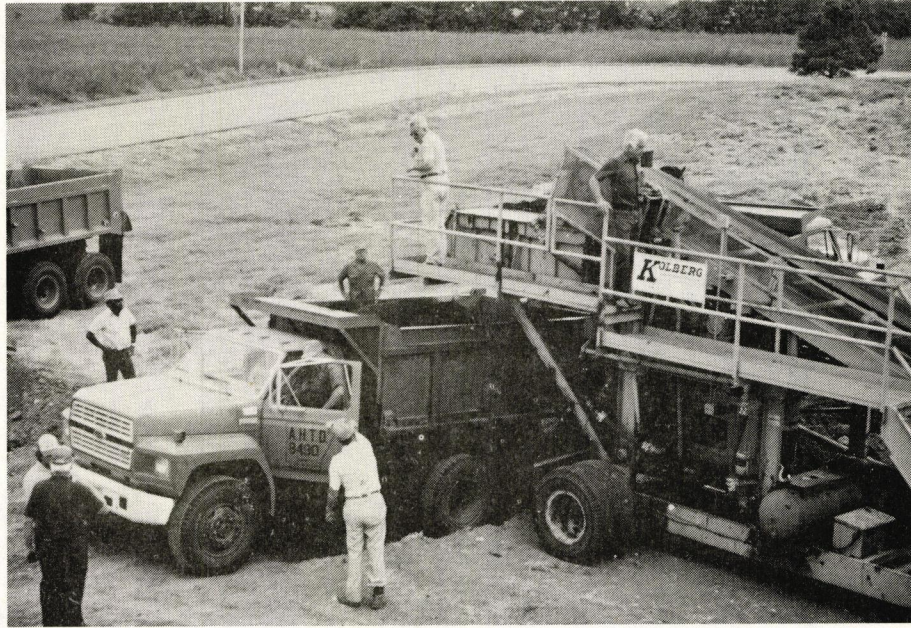
Field adjustments were made in the amount of water and emulsion added as necessary due to stockpile variability.

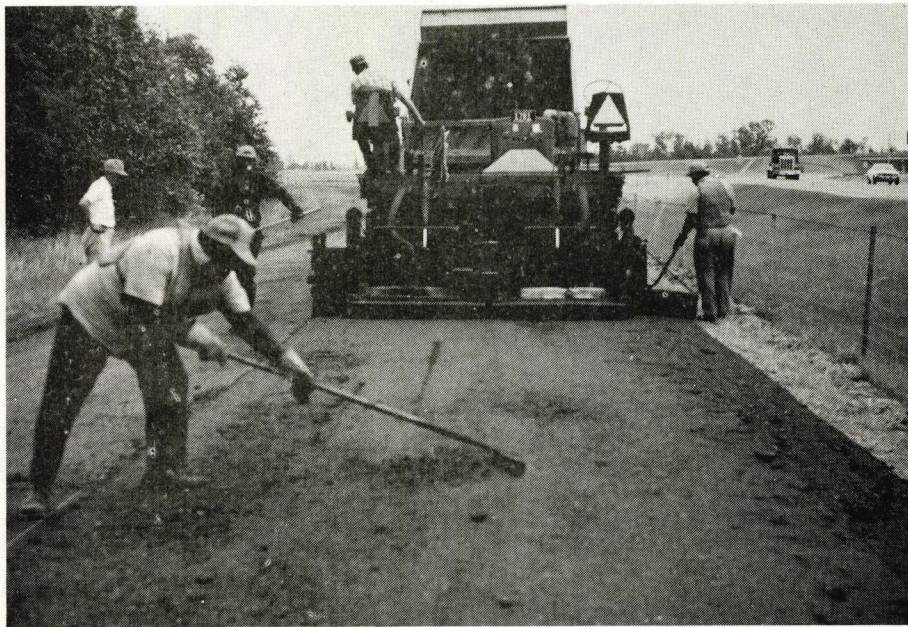
Large clumps in the mix caused some tearing in the mat. Constant hand raking was required to repair the mat.

The first day of production and placement of the cold recycling mix was Thursday, September 11th. The production was steady during the morning hours. Maintenance crews placed a 3 inch lift of the material starting in the northbound lane. Several clumps that refused to break up during mixing caused tearing the mat during placement. Therefore, much raking and spreading was required behind the screed.

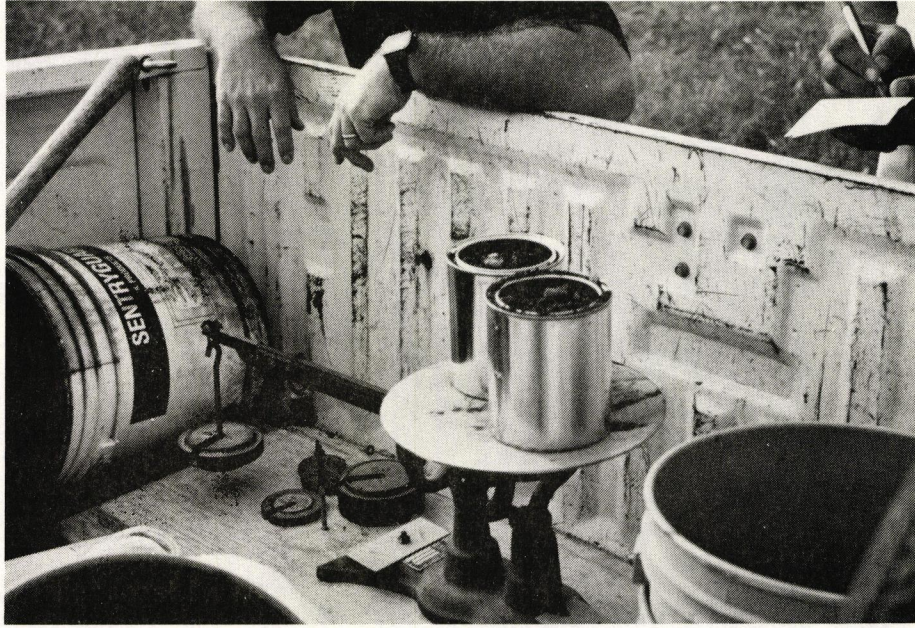
Samples of the mix were taken in the field to monitor moisture content and asphalt content.

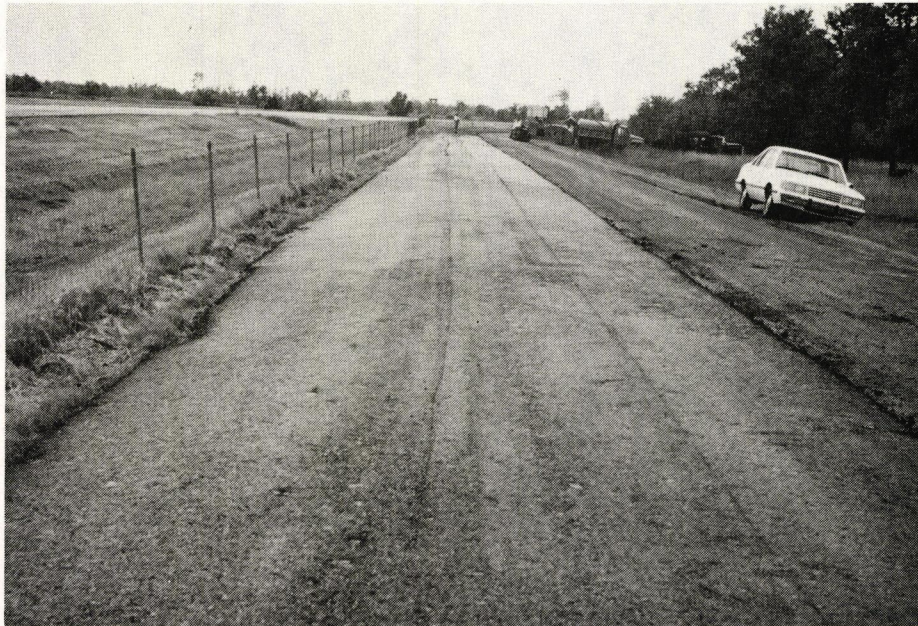
The freshly rolled mat seemed fairly tight with only a few segregated spots showing.

On Tuesday, September 16, work proceeded at a good pace. Segregation was noticed on the roadway and was traced back to the discharging of the pugmill into the trucks. The forward momentum of the mix from the mixing paddles seemed to sling the larger clumps of material to the far side of the truck bed. This was confirmed by reversing the direction of the trucks during loading. This reversal switched the segregation from one side of the mat to the other. Later the same day, a further increase in emulsion content was tried. Approximately 3% emulsion was used. No problems were encountered that could be traced to the increase in emulsion content. The mix was not observed to be particularly rich or tender during placement and compaction.

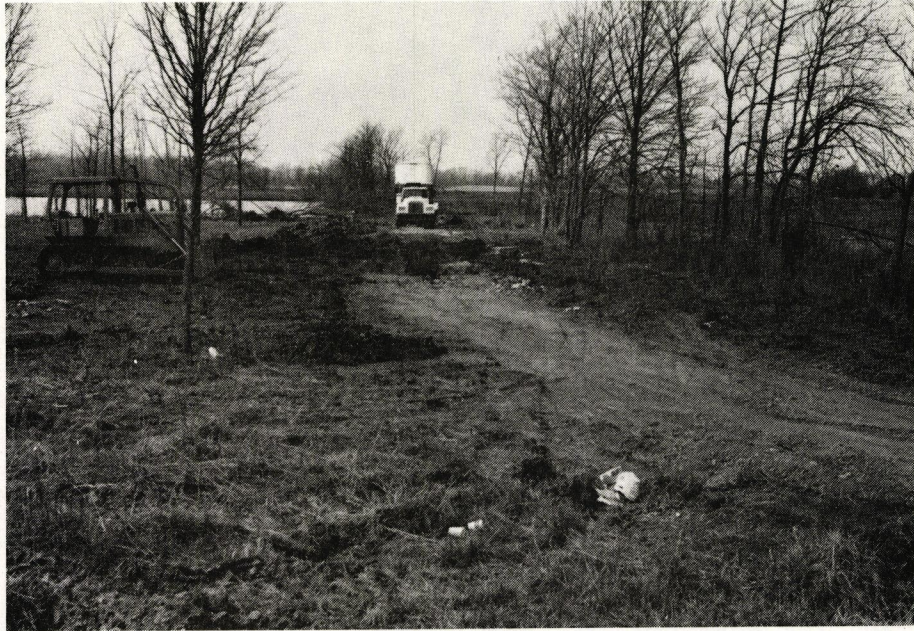
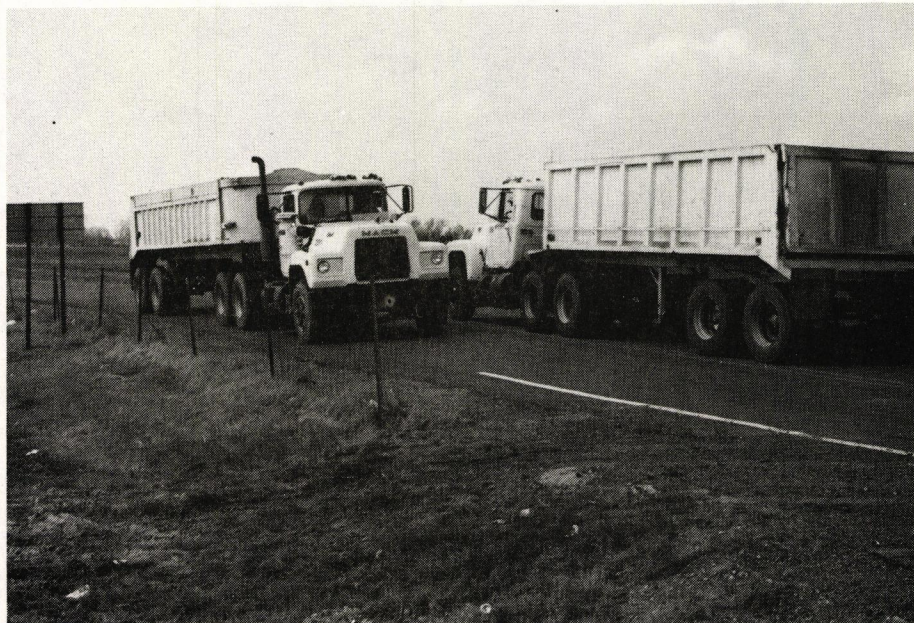
Construction directly off the frontage road has caused truck traffic to increase substantially.

The performance of the pavement was monitored periodically throughout the fall and winter by District and Research personnel. The performance of the recycled mix is adequate to date. However, very little traffic exists on this roadway. Traffic has increased lately with construction activity in the area. Therefore, the performance will be monitored closely over the next few months. The site may be sealed if the pavement shows any signs of increased distress.

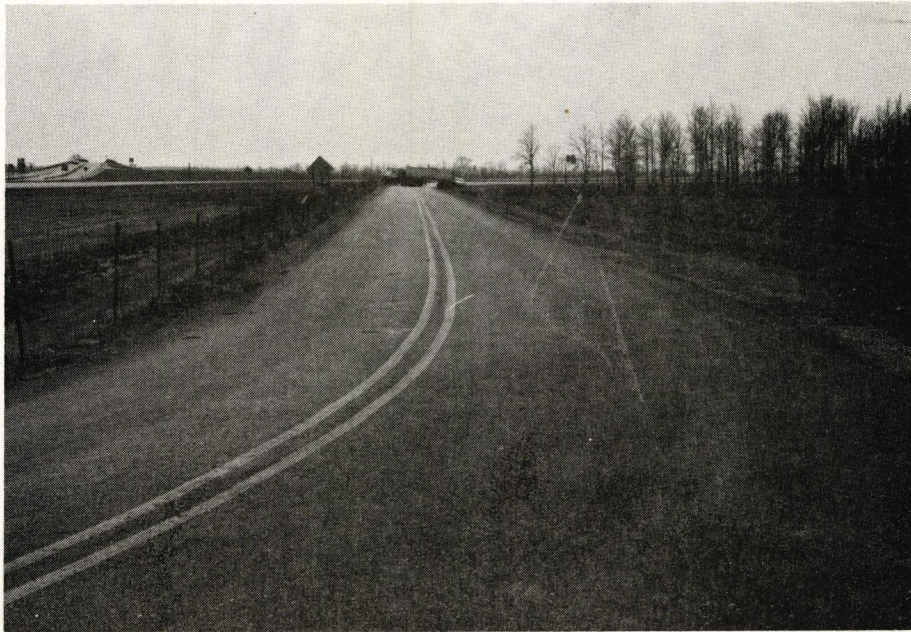
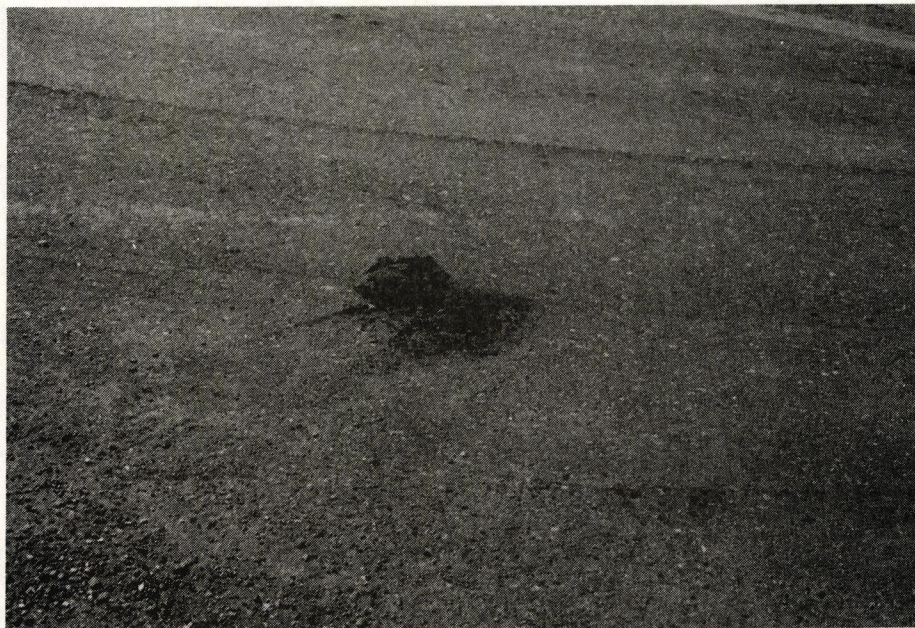
The truck seen backing into the side road in the top photo caused the damage shown below by turning his steering axle while stationary.
