A
STUDY
OF
LANDSLIDES

Highway Research Project 14

FINAL REPORT

May 1964

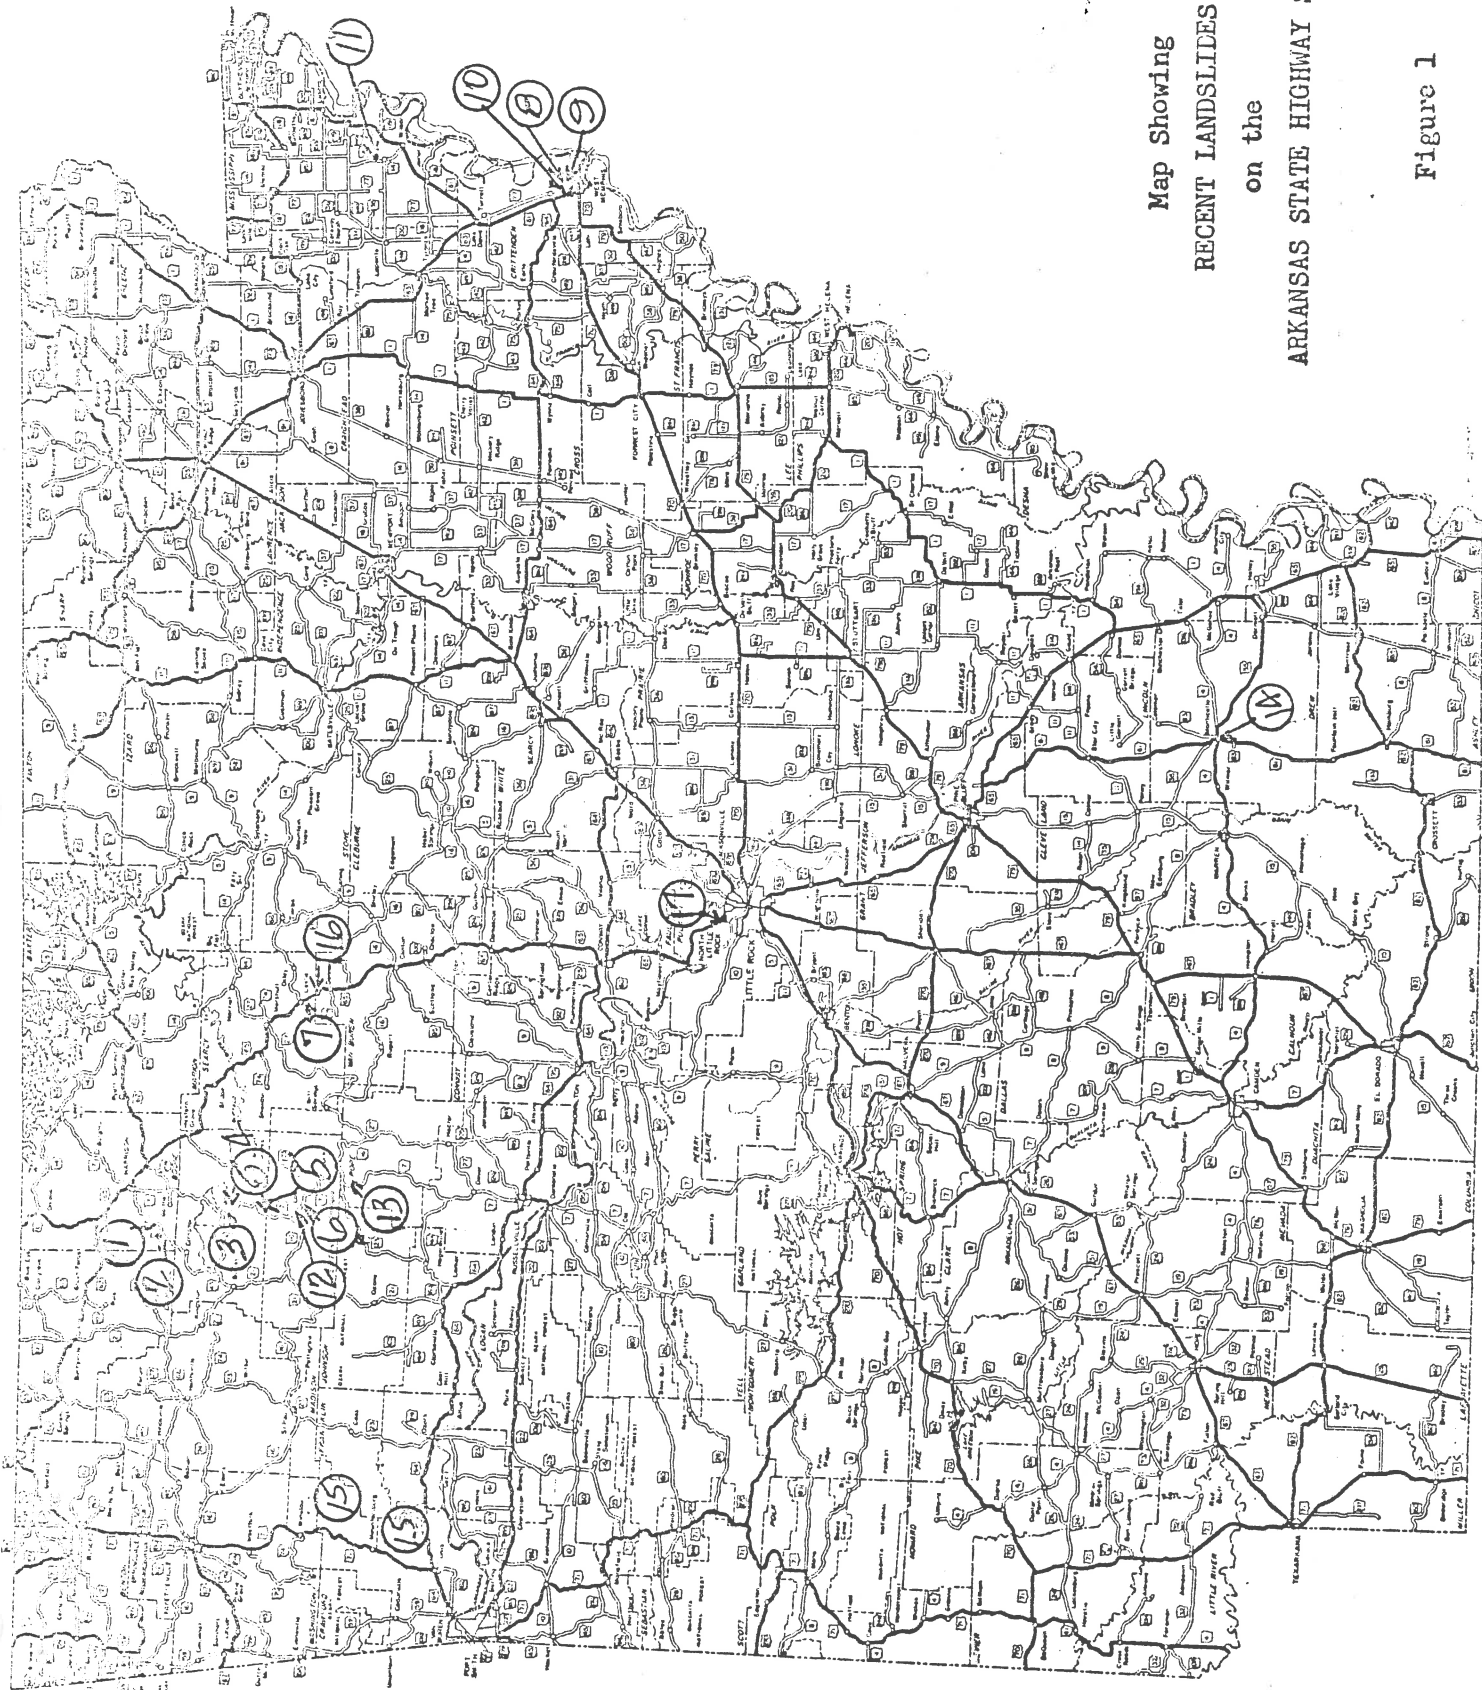
It can be seen from the map Figure 1 that the slide prone areas of Arkansas are the Ozarks of Northwest Arkansas and the embankments constructed from the soils of the Mississippi River Delta. There is a possibility of a slide on any highway constructed in the Ozarks of Northwest Arkansas. It can be expected that there will be many slipouts and failures of the backslopes on sidehill construction. These failures can be expected in any location where shales and other sedimentary rocks are interbedded. In all such locations provision should be made in the design for these slide conditions.

Map Showing
RECENT LANDSLIDES
on the
ARKANSAS STATE HIGHWAY SYSTEM

The slide prone areas of Arkansas are the Ozark Mountains in the Northwestern part of the State. The Map of Figure 1 shows this very distinctly. Those shown on this map are by no means all of the slides that have occurred. A casual inspection of the backslopes of any of the highways traversing this region will show many slides. Some are small while others are rather large in extent. Only those on high backslopes have created serious problems. This does not mean that the slides on lower backslopes are no problem. All of them are troublesome and expensive to correct. The cost of correcting these slides and dressing the backslopes is a very large maintenance item. No solution for these so called small slides is presented. It appears that the most economical method of caring for these is to provide flat slopes, greater than 2:1 where possible and make allowance in the maintenance budget for the extra work that is required to make the slopes presentable.
