TRC0703

Evaluation of Silicone Sealants on Bridge Deck Expansion Joints

R. Taylor Robertson, W. Micah Hale

Final Report

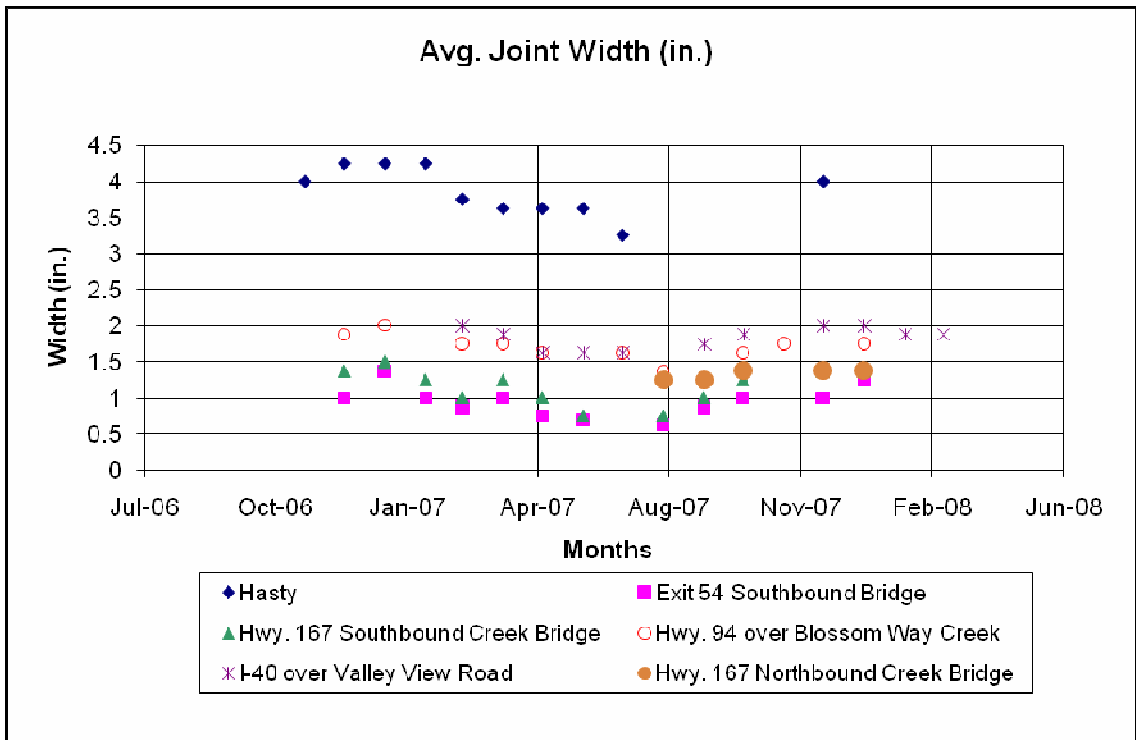
Figure 28: Average Joint Width for Monitored Bridges

In Figures 28-30, one can see a few trends such as in Figure 28 the increase in joint width toward the winter months and the decrease in joint width towards the summer months. Also, Figure 28 shows that most installed joints or replaced joints are between 1-2 inches in width. The extra wide joint at Hasty is not seen very often for silicone applications. The closest to any trend found in Figure 29 with recess depths to silicone monitored was that possibly the recess depth decreases as the temperature gets warmer or as one heads into the warmer summer months. Extra recess depth may need to be required for the colder months due to this trend as Table 4 clearly shows. Although, in Figure 29, the data is fairly scattered so no concrete conclusions can be made. Figure 30 shows very effectively the temperature changes throughout the year in which the bridges were monitored.

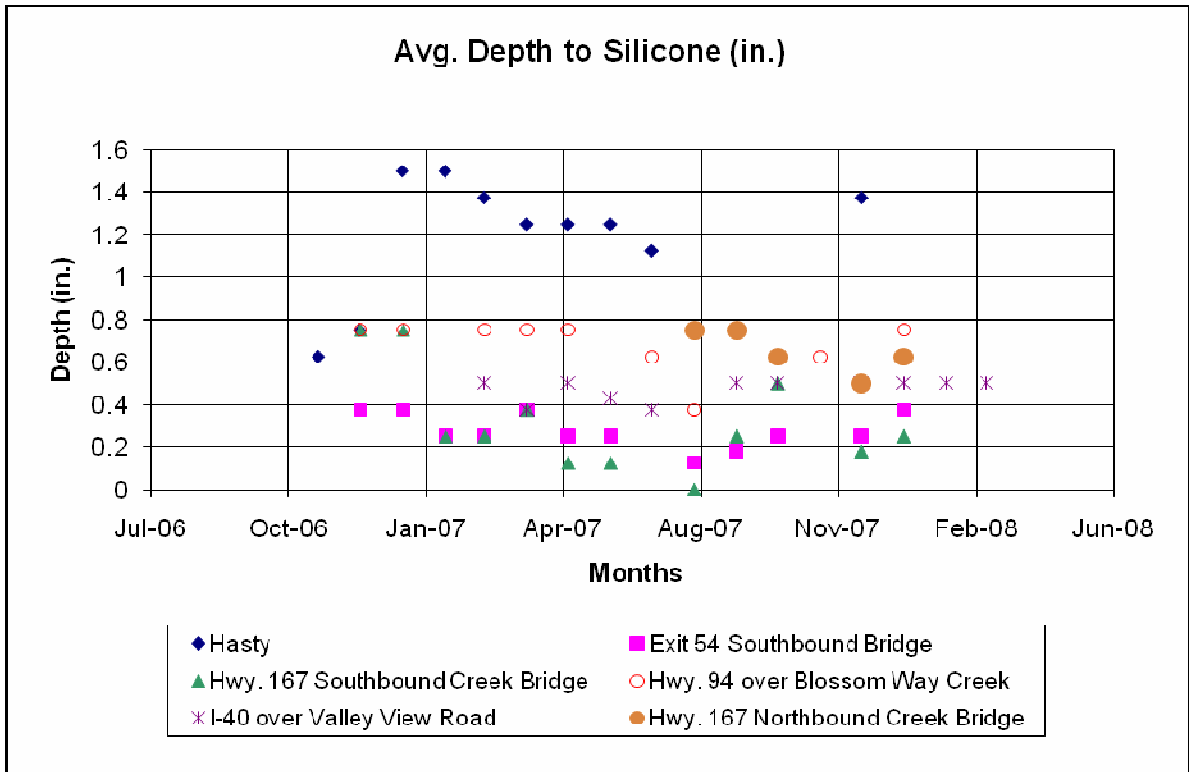
Figure 29: Average Depth to Silicone for Monitored Bridges
