**TRC 84**  
**SLOPE STABILITY**  
Interim Report

Construction on Job #110066  
Lehi - West Memphis Structures and Approaches  
July 1986

## SLOPE STABILITY

Job #110066

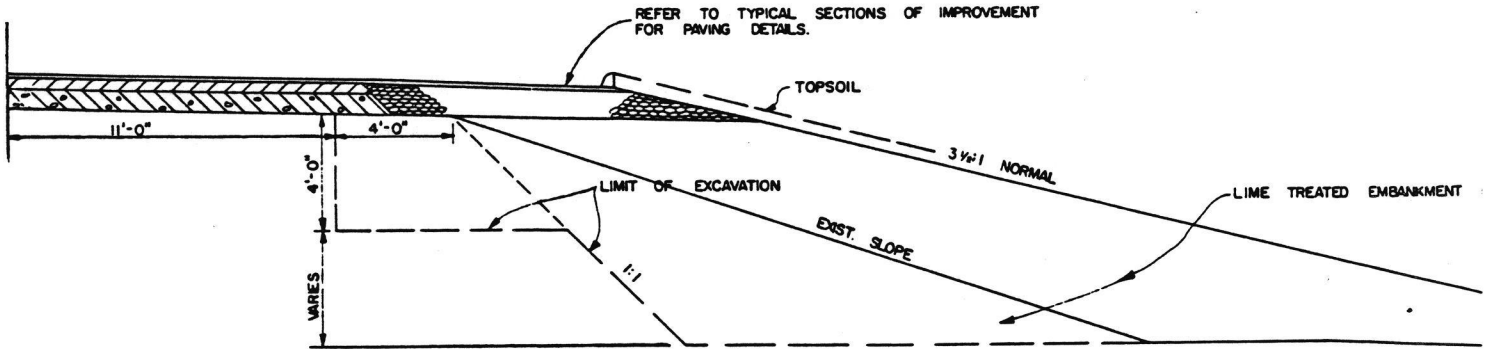
**SLOPE CORRECTION AIRPORT ROAD**  
 STA. 6+50 TO STA. 11+08.84 LT. & RT. SIDE  
 STA. 14+91.16 TO STA. 20+00 LT. & RT. SIDE

The Airport Road overpass of I-40 is in the process of being raised. The northbound lane of Airport Road is closed and has been raised with deck work underway. The embankments on the east side have been cut out to a 1:1 slope. Lime treatment of the embankment slope material began in mid-June. Scrapers are placing the treated material in 6 to 8 inch lifts and adequate density using a Sheep's foot roller is being obtained. Mixing of the lime into the soil is being done on site using lime pellets mixed in three passes (See Figure 3). This work should be completed in the next 30 days. Slopes on the west side (See Figure 4) will not be cut out until traffic is detoured to the northbound lane.

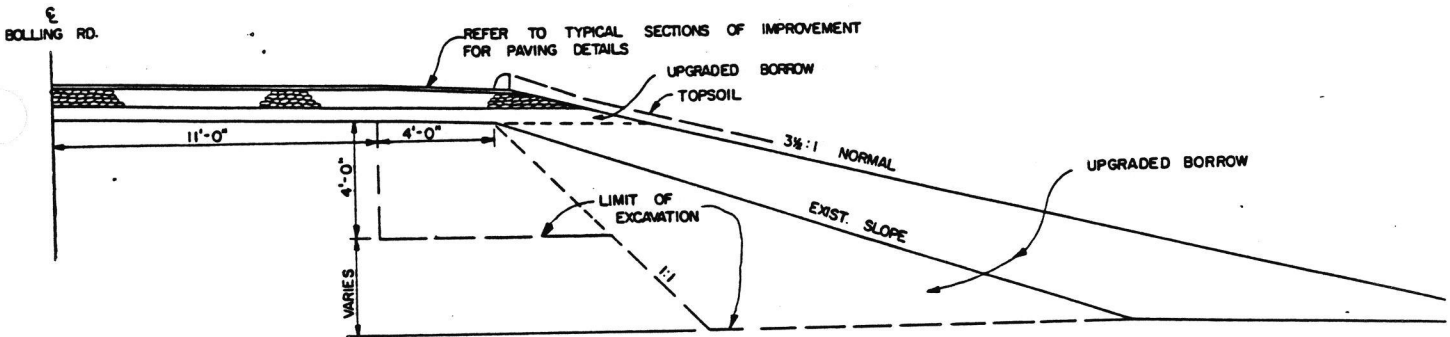
**SLOPE CORRECTION BOLLING ROAD**  
 STA. 7+00 TO STA. 11+68.84 LT. SIDE  
 STA. 14+31.16 TO STA. 19+00 LT. & RT. SIDE

Bolling Road embankments have been cut out and upgraded borrow consisting of uniform clean sand from a pit approximately 5 miles away has been installed on all four sides (See Figure 5). The side slopes have been topped with 12 inches of high P.I. clay and 6 inches of native soil and the end slopes are ready for the installation of concrete rip-rap. Ponding has occurred at the toe of the southeast slope.

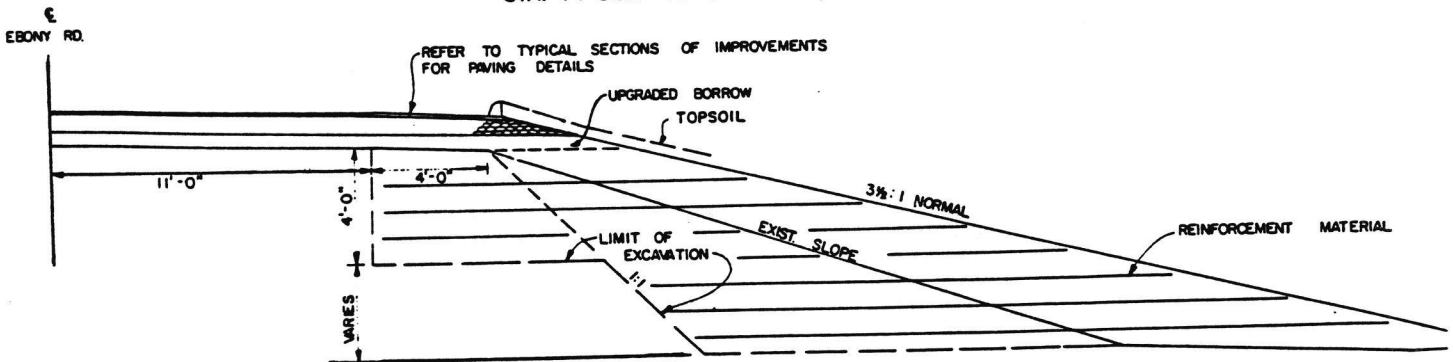
**SLOPE CORRECTION EBONY ROAD**  
 STA. 7+00 TO STA. 11+47.34 LT. & RT. SIDE  
 STA. 14+31.16 TO STA. 18+50 LT. & RT. SIDE

Ebony Road overpass has had three out of four embankments cut out (See Figure 6). The slopes in the northeast quadrant appear to be steeper than the 1:1 required. No significant erosion or failure have occurred on these exposed slopes. According to the Resident Engineer these slopes will not be replaced this year. Plans call for wire mesh on the south side placed at 2 foot vertical intervals. Fabric reinforcement will be used on the north side slopes, also at 2 foot intervals. An area of ponding was noted at the edge of the previous slope on the northwest side.
