Damage Assessment Continues on State Highway 1-B Overpass

JONESBORO, ARK. (6-27) – Structural engineers have spent the afternoon assessing damage to the State Highway 1-B overpass on Interstate 555 in Craighead County, according to Arkansas State Highway and Transportation (AHTD) Officials.

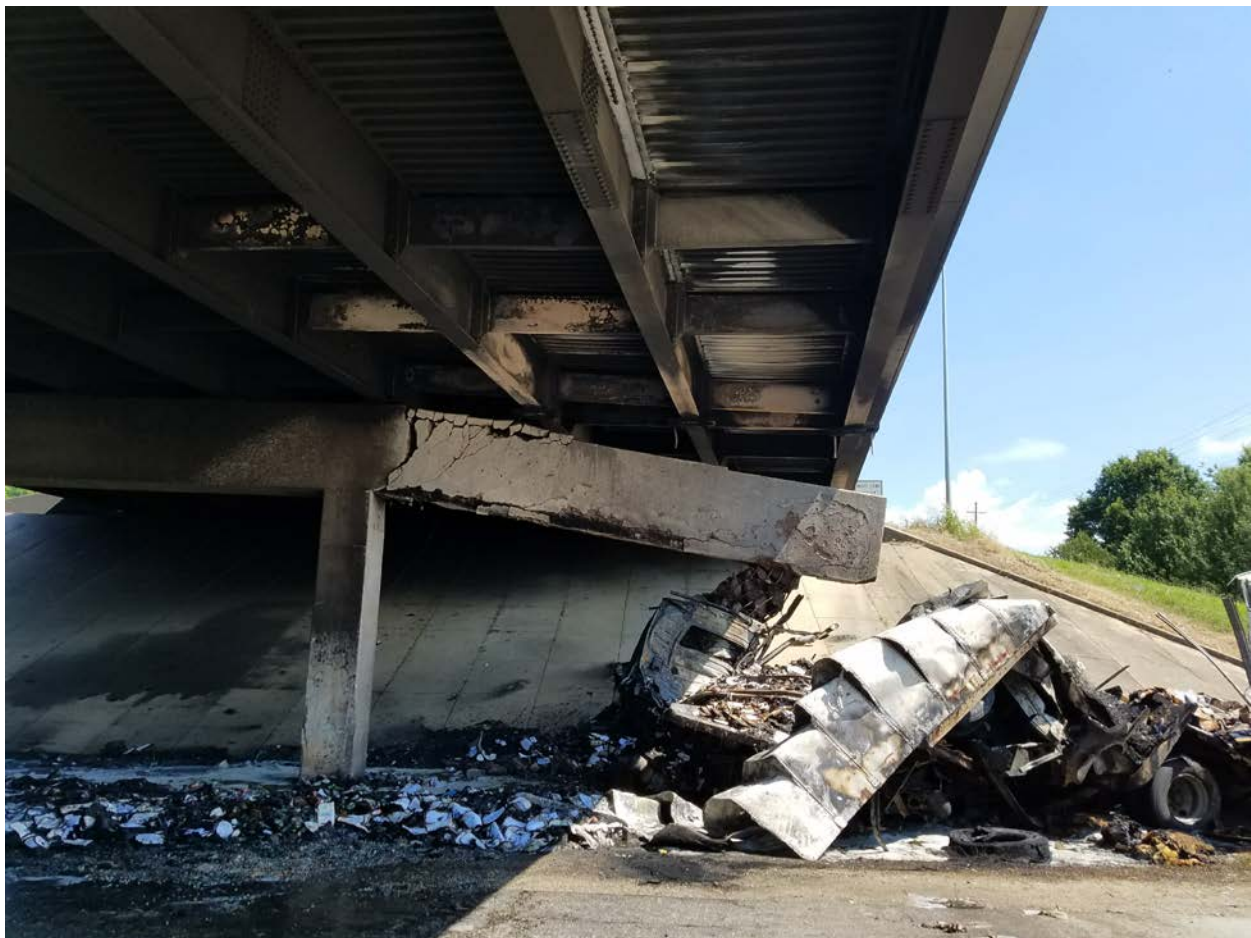
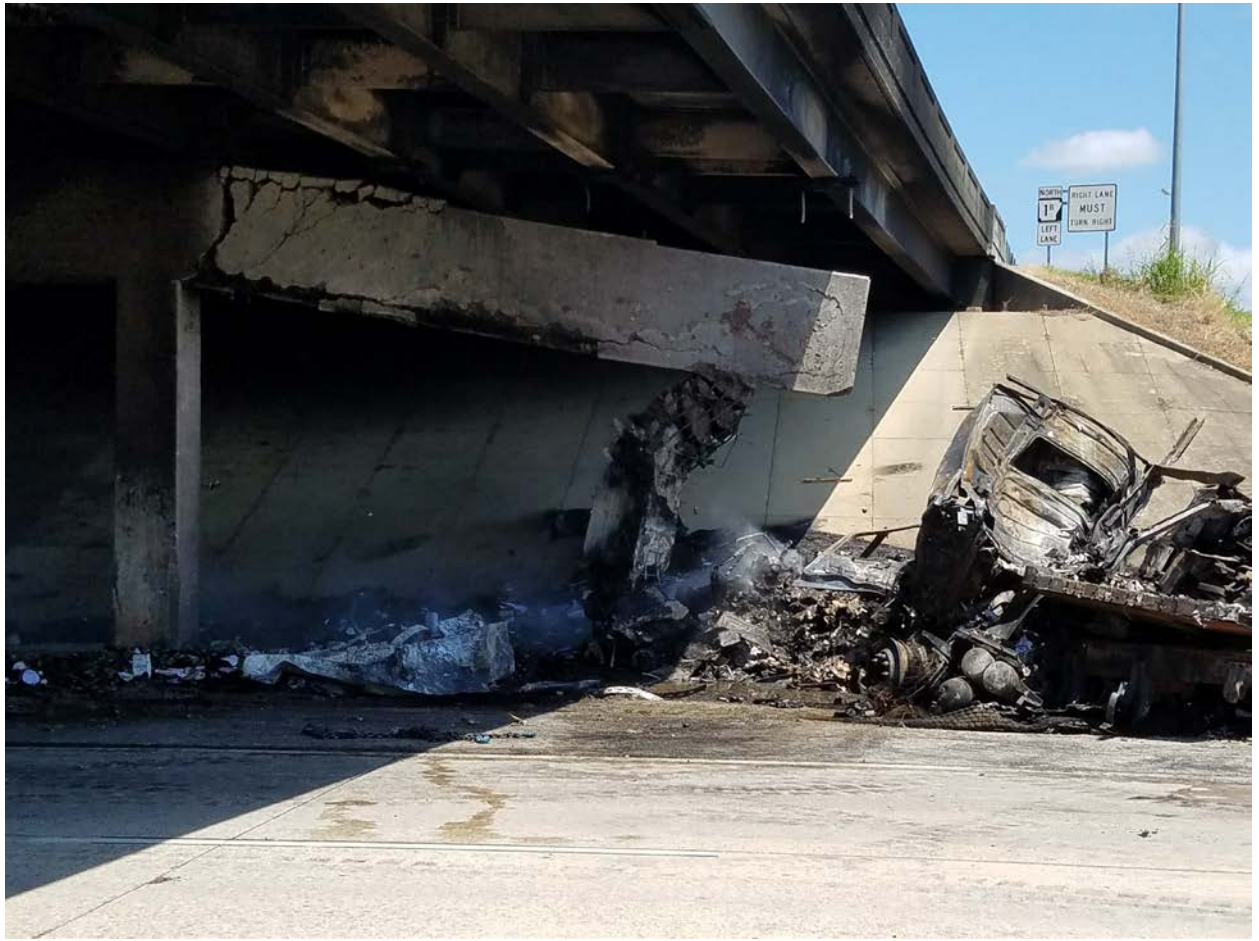
All four columns supporting the bridge at this location were impacted. The first (easternmost) column is totally destroyed (see attached photos) and about 25 feet of the cap (the horizontal part of the bent) has been pulled out from under three of the steel beams it supported.

The second and third columns also sustained heavy damage. The fourth column was the least impacted but showed signs of significant spall due to the intense fire.

Three of the 10 beams supporting the bridge deck have no support underneath and have begun to sag under the weight of the bridge deck. This has caused the deck to crack in the immediate area. **Regardless, AHTD structural engineers have determined the bridge is stable and not in danger of collapse.**

At this time, crews cannot install temporary shoring until all of the truck debris has been removed.

AHTD Heavy Bridge engineers are on-scene and will determine the best approach for repairing the structure. One of the first goals is to install shoring that will enable traffic to resume on northbound I-555. At this time AHTD expects that to be by the end of the week.
